RE: Mr J Vella : Environmental Authority Application A-EA-New 100200594 – Final Response

This letter is in reply to a request for further information regarding the above Application lodged to accompany an application for ML 100296, Cordalba.

The ML application is being made to allow for planning and **small scale underground** mining of a defined (1980 Dept Drilling) Resource of some 700 tonnes of gold and base metal bearing ore at 30 - 50m depth.

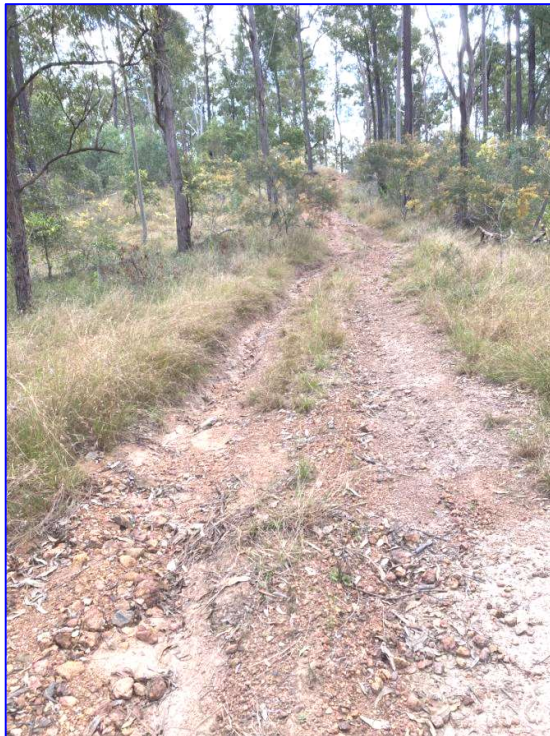
Plate 1 Access Road

The road is in shale country and has been used for forest access for some time – the ML holder will be using this road for **light vehicle access only** once initial set up (rehabilitation and small pond construction) has been completed.. ie no hauling or trucks.
