APPENDIX E AQUATIC VALUES ASSESSMENT REPORT

Mahalo North Coal Seam Gas Project – Aquatic Values Assessment

14 July 2023

Prepared by:
DPM Envirosiences Pty Ltd
ABN: 54 602 226 460
PO Box 1298, Mooloolaba QLD 4557
Ph: 0427 694 433

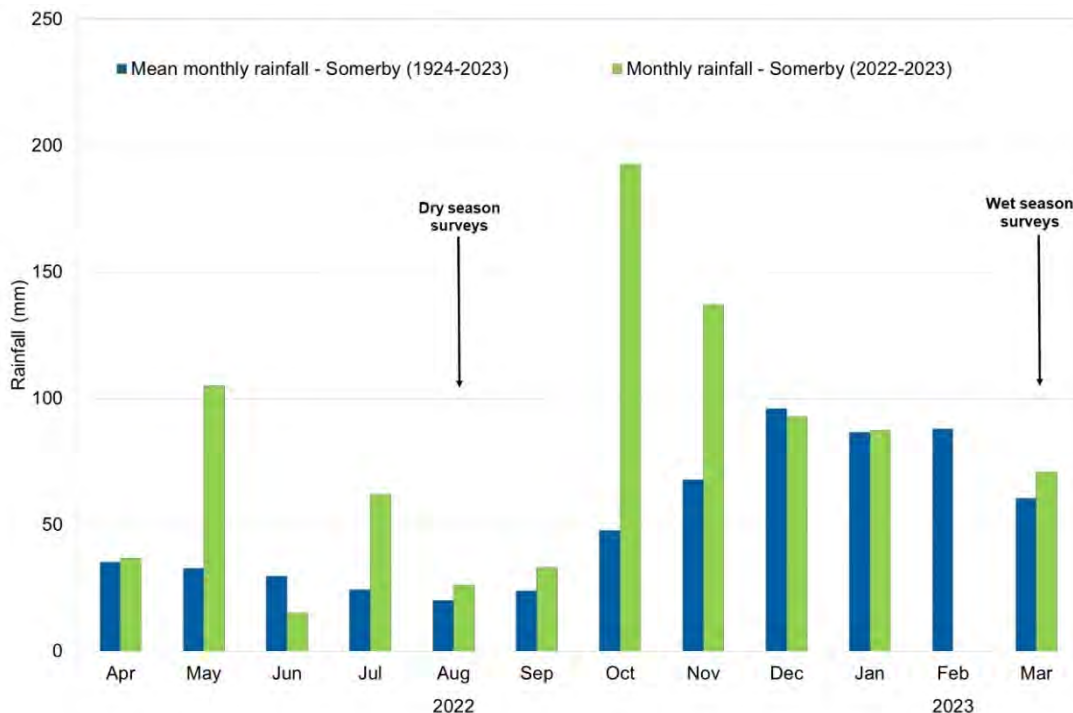
Figure 3 Rainfall statistics for Somerby (Bureau station 35063, The Bureau 2023b)

Average annual rainfall of 612 mm has been recorded from the nearby Somerby Bureau of Meteorology station 35063 (approximately 14 km to the south) over the period 1924 to 2023, with the summer months generally the wettest when, on average, 50% of the annual rainfall occurs (Figure 3) (The Bureau 2023b). Dry season surveys were undertaken in August 2022. Wet season surveys were undertaken in March 2023, following a wet season that incurred well-above-average rainfall in October and November 2022 (Figure 3). Survey timing is discussed further in Section 3.5.1.

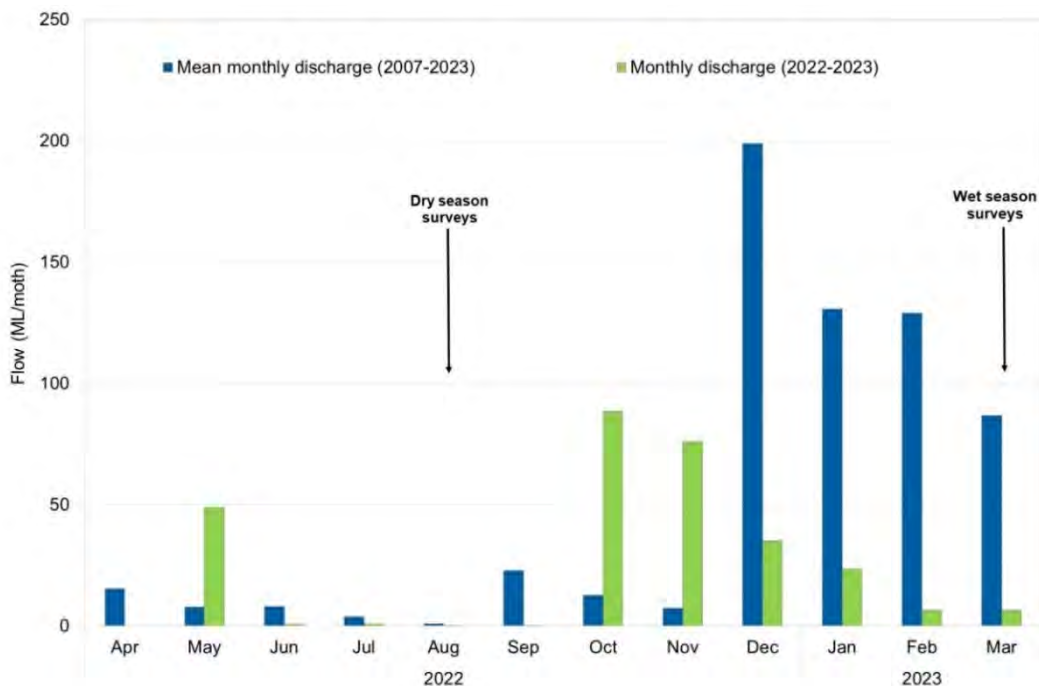
Figure 4 Flow volume statistics and observations for the Comet River at Springsure Creek (DNRME station 1302510A)

Historical flow monitoring data (2007-2023) for the Comet River at Springsure Creek (Department of Regional Development, Manufacturing and Water [DRDMW] monitoring station 1302510A), located approximately 25 km downstream of the Project area, provides an indication of the local flow regime (Figure 4). Flow in the Comet River is seasonal, alternatively wet and dry most years, according to season. Stream flows are highly variable, with the channel typically drying during winter to early spring when rainfall and runoff is historically low, although some pools may persist in deeper sections and on substrates with higher clay content. Surface flows are more likely in the wetter months from November to March (Figure 4).

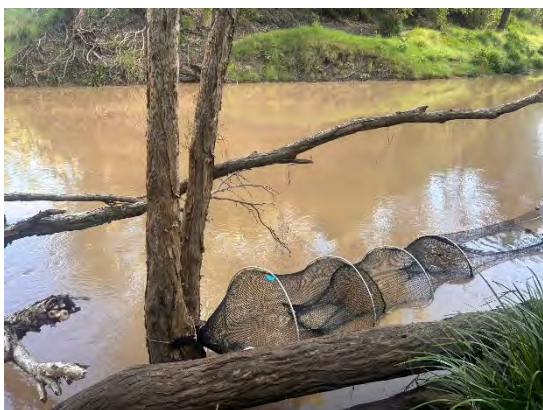
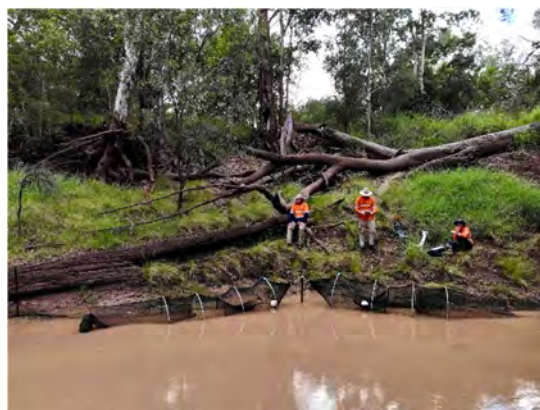
Plate 1 Fyke nets positioned on the Comet River, 14-15 March 2023

Fyke nets being deployed at site R11

Fyke nets deployed at site R12 the previous night, about to be processed

Freshwater turtles were surveyed at sites R11 and R12 on the Comet River in March 2023 (Section 3.5.1) by overnight deployment of two baited fyke nets at each site, as well as observations of the bank and water surface for sunning and breaching turtles. Fyke nets (Plate 1) were baited with a mix of meat, fruit and vegetables, including beef, rinsed sardines, apple, banana and spinach, in an attempt to attract omnivorous white-throated snapping turtles. The stream profile and high flows encountered at the time of survey necessitated the positioning of fyke nets in the edge habitat (Plate 1). The falling water levels were also factored into the positioning of nets, ensuring any fish bycatch did not become stranded from the water overnight.

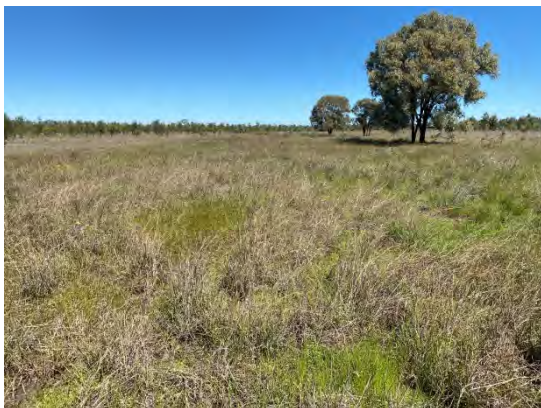
Site HES3 – State-mapped HES wetland comprising State-mapped (DoR 2023a) non-remnant vegetation

One WPA is mapped as occurring within the Project area (DES 2023d; Figure 12). This WPA has been established around a HES wetland mapped in an earlier version of the Queensland RE mapping. A larger area of palustrine wetland RE 11.5.16 had been mapped in an earlier version of the Queensland RE mapping, which formed the basis for the extent of the State-mapped HES wetland. The latest version of RE mapping (version 12.02, DoR 2023a) has removed the cleared component of this RE polygon comprising the eastern half of the State-mapped HES wetland. Sites HES2 and HES3 (Plate 2 and Figure 12) were positioned within this cleared component. The remaining half of this HES wetland is mapped as RE 11.5.16 (palustrine wetland dominated by *Acacia harpophylla* and/or *Casuarina cristata* open forest) but was field verified at site HES1 as being RE 11.5.3 (*Eucalyptus populnea* on Cainozoic sand plains; not a wetland) (Plate 2 and Figure 12). Notwithstanding, the Proponent does not intend to challenge the accuracy of the HES wetland mapping and will instead avoid the mapped HES wetland with a separation of at least 200 m (Section 5.1.2).

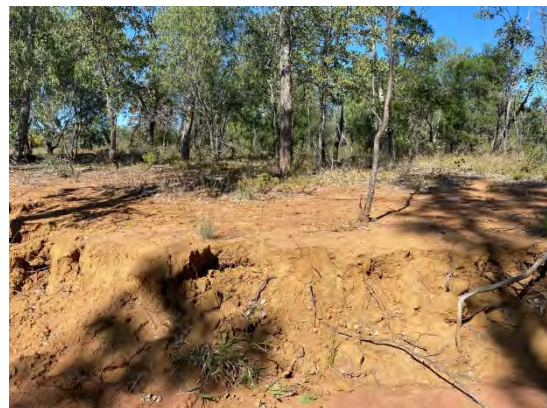
Site HES1 – State-mapped HES wetland comprising State-mapped palustrine RE 11.5.16, field verified as RE 11.5.3 (not a wetland)

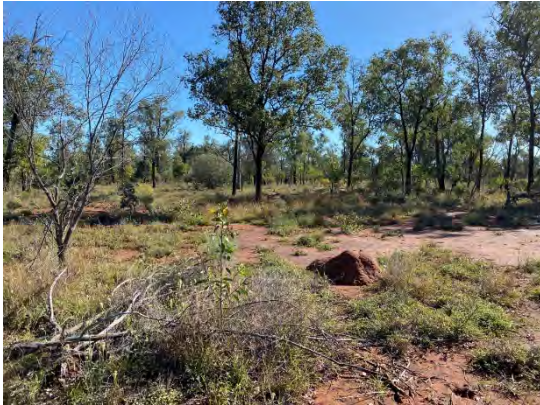
Site P1 – State-mapped GES wetland mapped as palustrine wetland RE 11.5.3b, field verified as RE 11.5.3 (not a wetland)

One HES wetland is mapped within the Project area, as identified in the previous paragraph ‘Wetland Protection Areas’ and in Figure 12. One State-mapped GES wetland is mapped as occurring within the Project area (DES 2019; Figure 12). This mapped GES wetland aligns with State-mapped RE 11.5.3 (DoR 2023a) but is mapped as palustrine wetland waterbody RE 11.5.3b in the Queensland Wetland Mapping (DES 2023b). Site P1 (Plate 3 and Figure 12) was positioned within this polygon, which was field verified as being RE 11.5.3 (*Eucalyptus populnea* on Cainozoic sand plains; not a wetland) (Plate 3 and Figure 12). Notwithstanding, the Proponent does not intend to challenge the GES wetland mapping and will avoid the State-mapped GES wetland polygon.

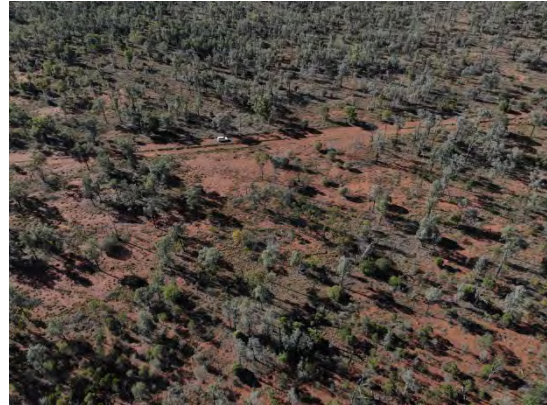
Site P1 aerial photo – State-mapped GES wetland, mapped as palustrine wetland RE 11.5.3b, field verified as RE 11.5.3 (not a wetland)

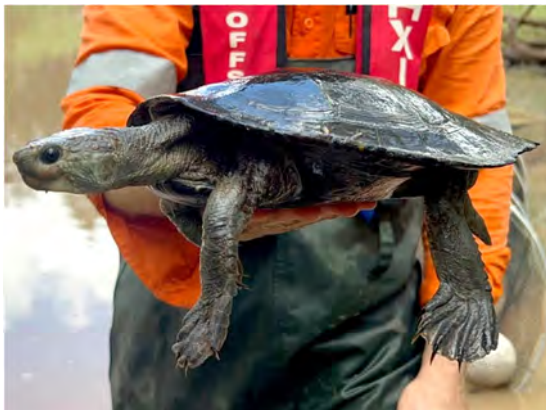
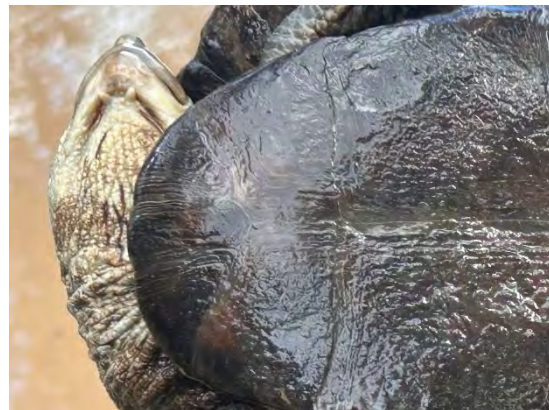
Plate 4 White-throated snapping turtle (*Elseya albagula*) recorded from the Study area

The Critically Endangered (EPBC Act and NC Act) white-throated snapping turtle (*Elseya albagula*) was recorded at site R12 on 14-15 March 2023, comprising two males of approximately 25 cm and 27 cm curved carapace length. Species identification has been confirmed by Principal Aquatic Ecologist Chris Pietsch (Blue Earth Environmental) who has extensive experience in the capture, tagging and tracking of this species; and the Queensland Museum.

Desktop searches and habitat assessments in August 2022 identified potential for the occurrence of white-throated snapping turtle in the Comet River adjoining the Project area. This species is known to utilise productive but often ephemeral riffle zones but falls back to less productive large slow-moving pools or isolated waterholes during the drier months (Cann and Saddler 2017). Turtle survey effort was conducted at the same time as wet season aquatic habitat assessments in March 2023 and confirmed the presence of this species. Although the location of important dry season refuge pools on the Comet River in the Study area is not currently known, review of aerial imagery and on-ground features (including water offtake infrastructure) at site R12 suggests that important dry season refuge pools may persist at this location.

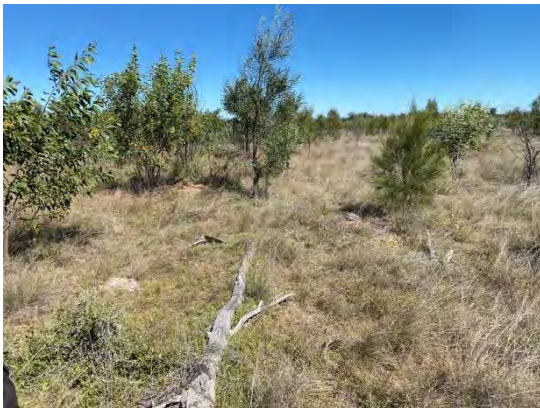
Site HES2 – looking west/downstream, 17/08/2022

Field verification at sites HES2, R1, R2, R7 and R13 (Plate 5) found no evidence of groundwater expressions, salt seeps, hydrophytes or other on-ground indicators of being a GDE (Appendix B). The health, apparent moisture levels and extent of riparian vegetation was consistent with other waterways of the Study area not mapped as potential surface expression GDEs.

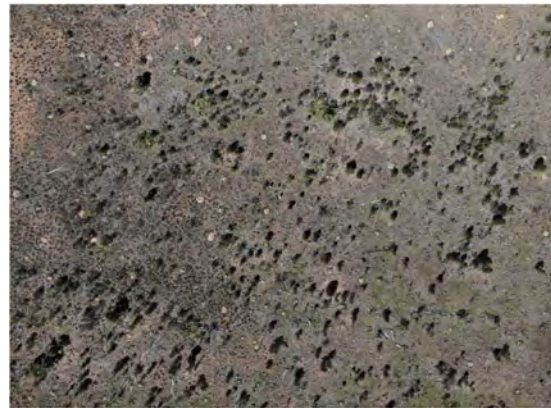
Site HES2 – aerial/drone photo from 120 mAGL

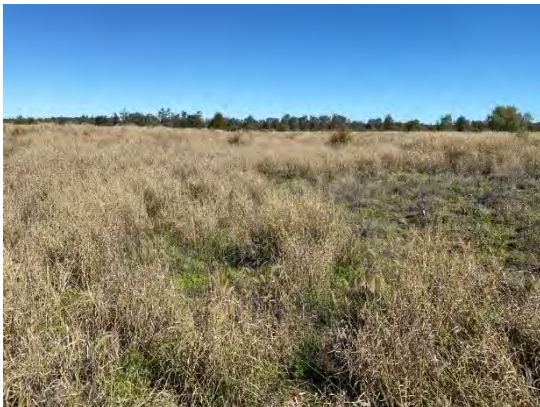
Site R1 – looking downstream, 15/08/2022

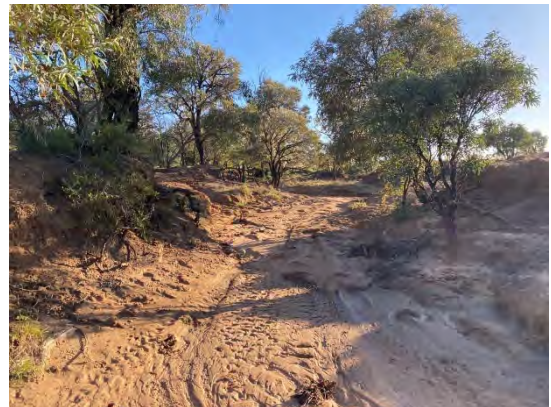
Site R2 – looking upstream, 16/08/2022

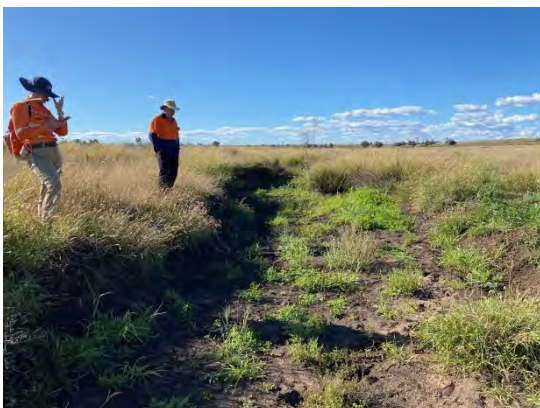
Site R7 – looking upstream, 16/08/2022

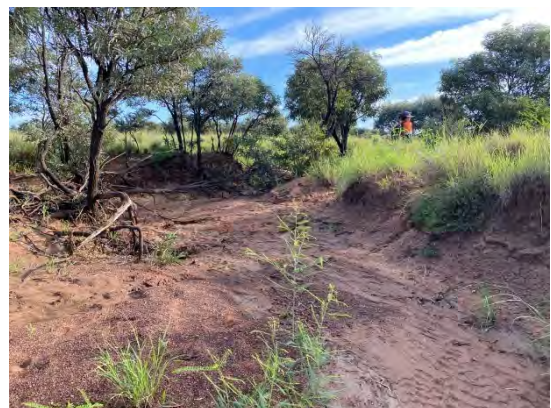
Site R13 – looking upstream, 16/03/2023

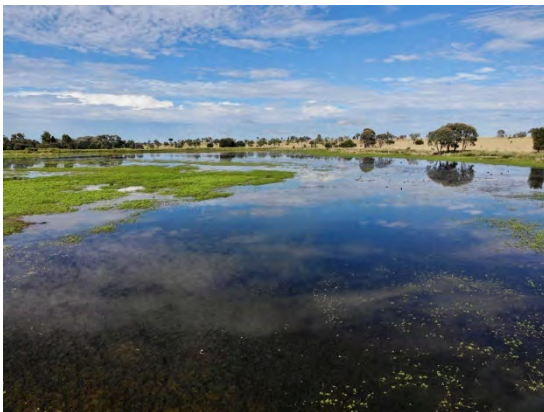
No wells (or infrastructure other than linear infrastructure) would be positioned within any wetland or waterway. A number of waterways would be intersected by linear infrastructure, including gathering lines and access tracks (Figure 15). One lacustrine wetland waterbody (farm dam, site L4) is intersected by a proposed gathering line and access track (Plate 6; Figure 15). This waterbody is allocated a Low aquatic value in accordance with the adopted criteria (Section 3.5.8) and there are no strict regulatory constraints that would inhibit the placement of linear infrastructure through this waterbody. However, the Proponent will relocate both the gas gathering and access track to avoid this waterbody during the detailed design phase.

Site L4 – looking downstream

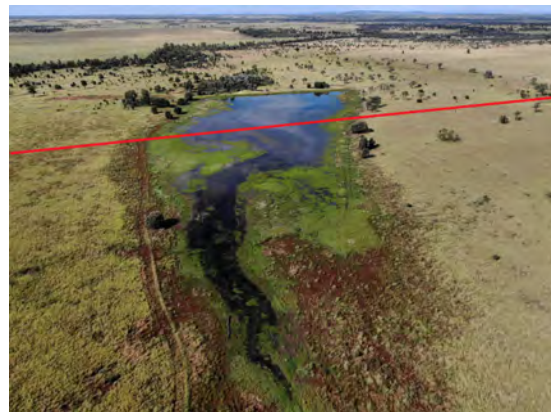
Site L4 – looking downstream, showing V4 access track/gathering line alignment (red line)

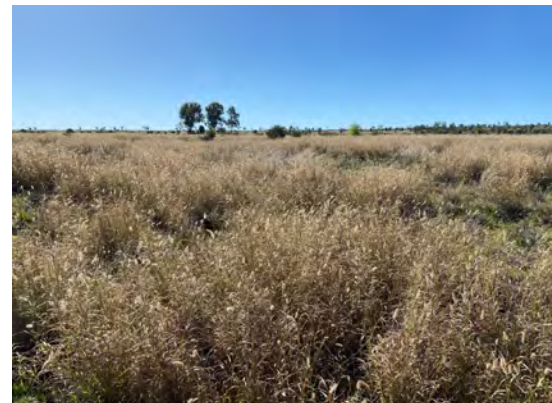
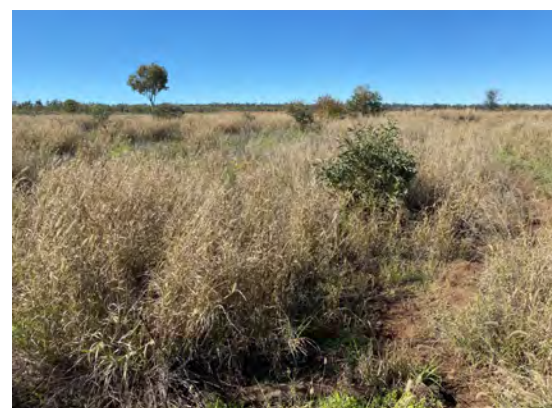
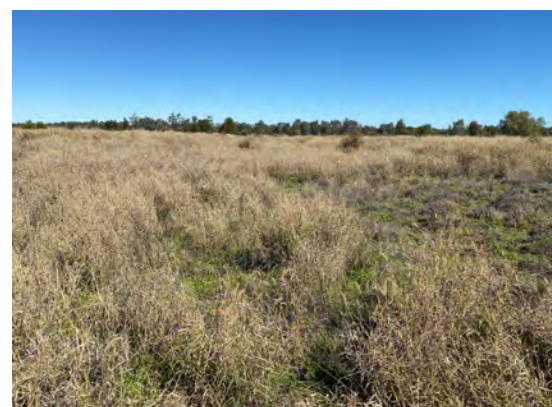
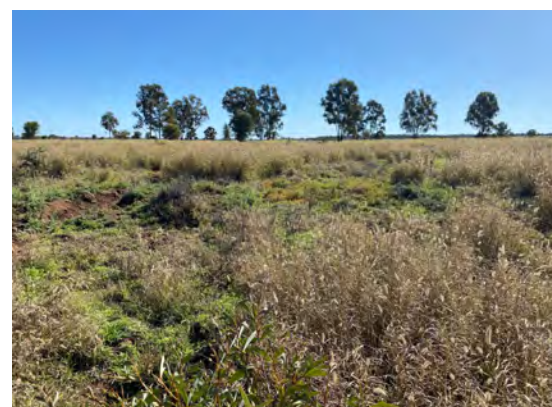
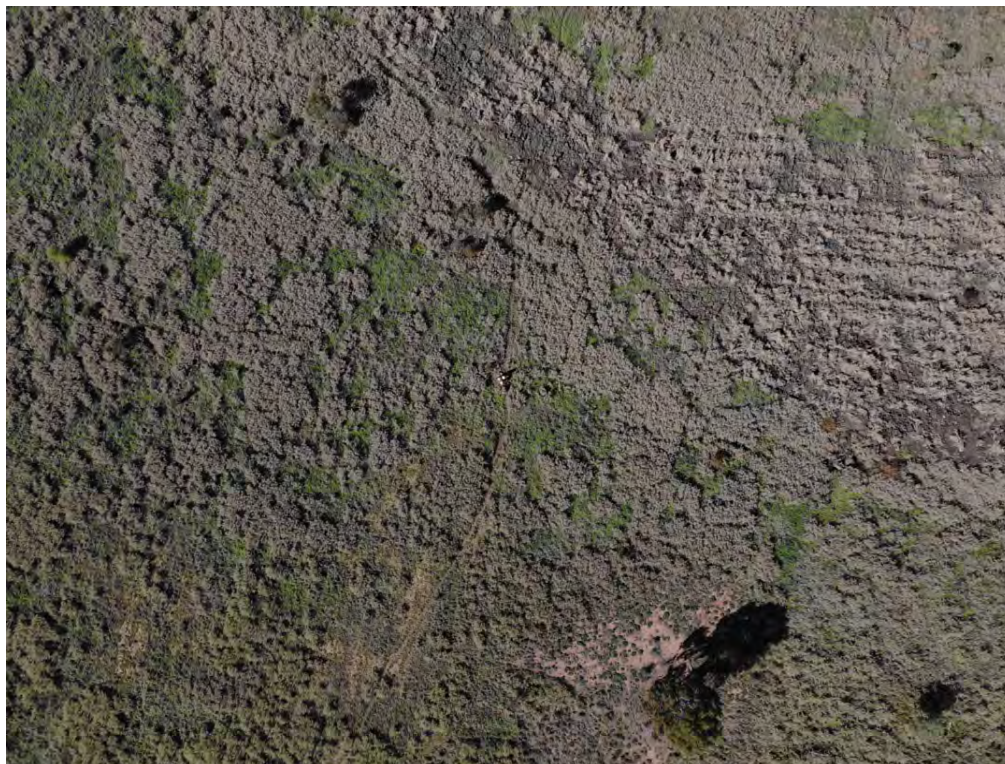
Local catchment erosion: cattle pugging (S)

Riparian vegetation	
Cover	
Width of riparian zone on left bank: 1 m	Width of riparian zone on right bank: 1 m
Bare ground: L	Grasses/forbs: E
Shrubs: L	Trees <10 m: L
Trees >10m: N	Exotic riparian species: E
Composition and health	
State-mapped RE: Non-remnant	Verified RE: Non-remnant
Vegetation status: exotic	Dominant stratum: grassland
Health: degraded	Dieback: not detected
EDL height: 1 m	EDL cover: 90%
Canopy species: <i>Eucalyptus populnea</i> (R), <i>Eucalyptus cambageana</i> (R)	
Sub-canopy species:	
Shrub species: <i>Acacia harpophylla</i> (O), <i>Terminalia oblongata</i> subsp. <i>oblongata</i> (O), <i>Atalaya hemiglauca</i> (O)	
Ground species: <i>Cenchrus ciliaris</i> * (D), <i>Parthenium hysterophorus</i> * (A), <i>Dichanthium sericeum</i> (O), <i>Senecio brigalowensis</i> (F)	
Macrophytes	
Submerged macrophytes: NA	
Floating macrophytes: NA	
Emergent macrophytes: None detected

Aquatic biota	
Aquatic macroinvertebrate sampling undertaken: no	
Habitat for platypus: unlikely	
Habitat for EVNT fish species: unlikely	
Fish sampling undertaken: no	
Suitable habitat for EVNT turtle species: unlikely	
Turtle sampling undertaken: no	
Aquatic vertebrates encountered:	
Notes:	
Aquatic habitat assessment scoring	
1. Bottom substrate/available cover	1 (Poor)
2. Embeddedness	1 (Poor)
3. Velocity/depth category	0 (Poor)
4. Channel alteration	12 (Excellent)
5. Bottom scouring and deposition	10 (Good)
6. Pool/riffle, run/bend ratio	3 (Poor)
7. Bank stability	9 (Excellent)
8. Bank vegetative stability	9 (Excellent)
9. Streamside cover	4 (Fair)
Overall score	49 (Fair)
Notes:	
Overall aquatic value: Low

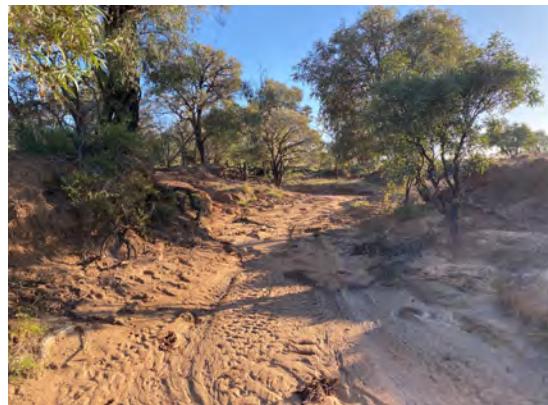
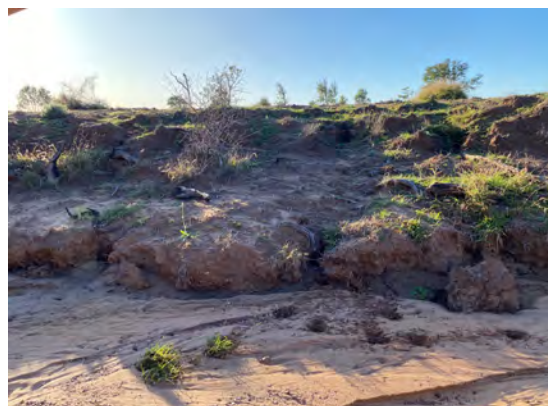
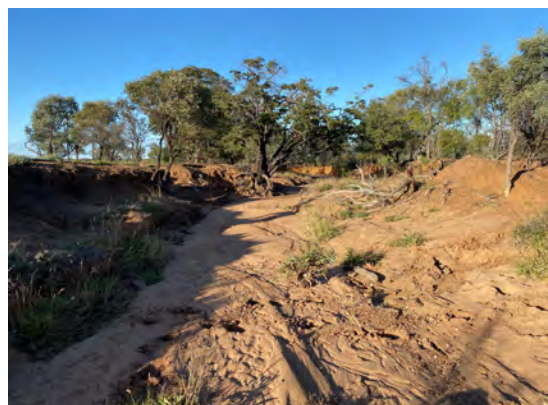
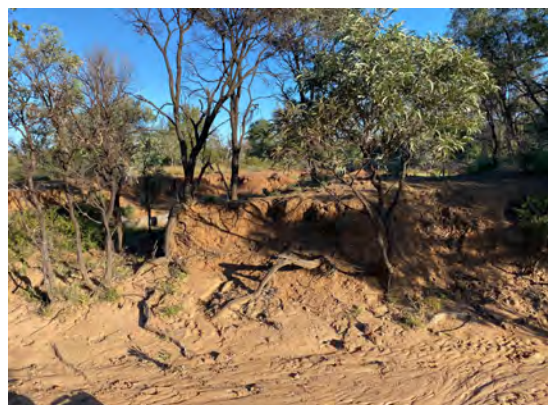
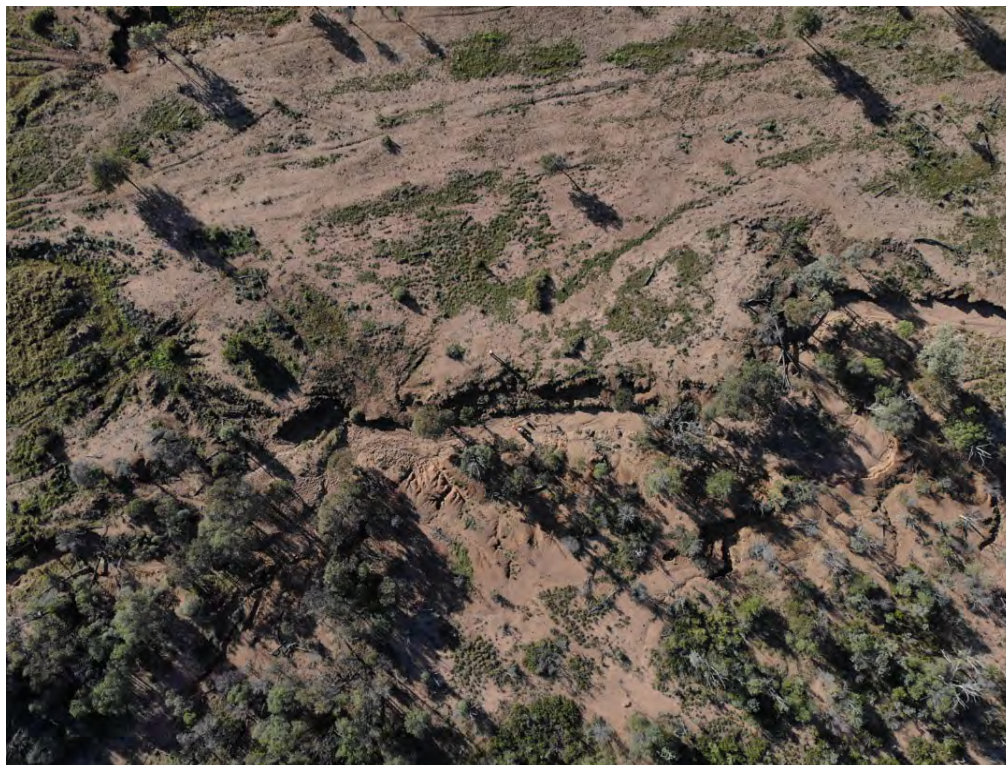
Local catchment erosion: gully (E), rill (S), tunnel (L), sheet (L), bank slumping (L), cattle pugging (L)

Aquatic biota	
Aquatic macroinvertebrate sampling undertaken: no	
Habitat for platypus: unlikely	
Habitat for EVNT fish species: unlikely	
Fish sampling undertaken: no	
Suitable habitat for EVNT turtle species: unlikely	
Turtle sampling undertaken: no	
Aquatic vertebrates encountered:	
Notes:	
Aquatic habitat assessment scoring	
1. Bottom substrate/available cover	1 (Poor)
2. Embeddedness	1 (Poor)
3. Velocity/depth category	0 (Poor)
4. Channel alteration	3 (Poor)
5. Bottom scouring and deposition	3 (Poor)
6. Pool/riffle, run/bend ratio	4 (Fair)
7. Bank stability	5 (Fair)
8. Bank vegetative stability	2 (Poor)
9. Streamside cover	9 (Excellent)
Overall score	28 (Poor)
Notes:	
Overall aquatic value: Low

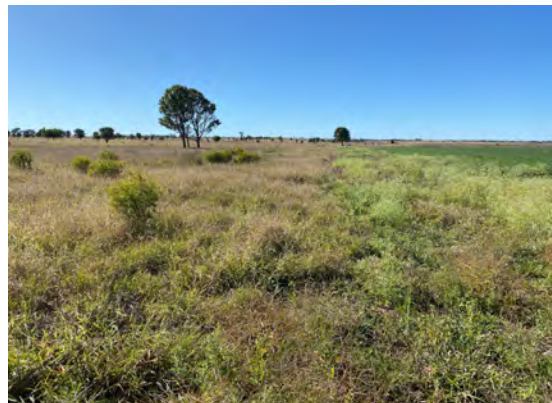
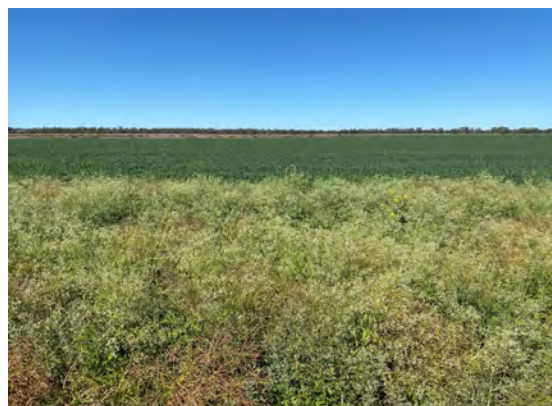
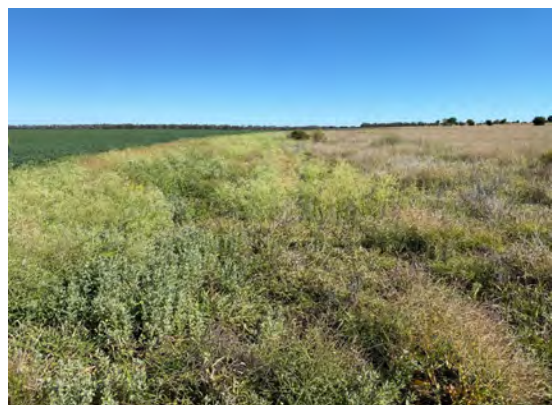
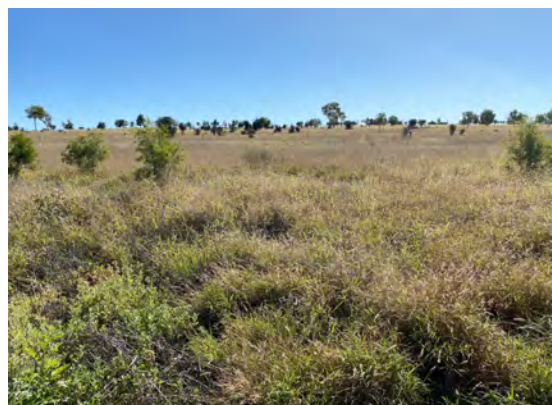
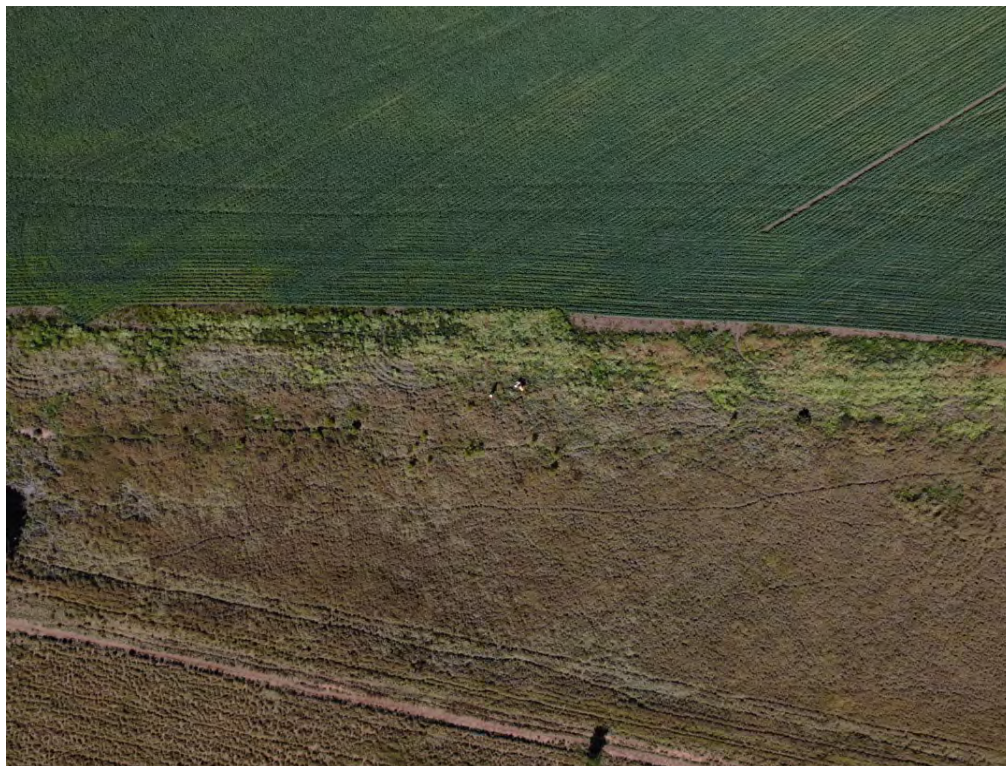
Local catchment erosion: gully (N), rill (N), tunnel (N), sheet (N), bank slumping (N), cattle pugging (N)

Riparian vegetation	
Cover	
Width of riparian zone on left bank: 0 m	Width of riparian zone on right bank: 0 m
Bare ground: L	Grasses/forbs: E
Shrubs: N	Trees <10 m: N
Trees >10m: N	Exotic riparian species: E
Composition and health	
State-mapped RE: Non-remnant	Verified RE: Non-remnant
Vegetation status: exotic	Dominant stratum: grassland
Health: completely degraded	Dieback: not detected
EDL height: 0.5 m	EDL cover: 95%
Canopy species:	
Sub-canopy species:	
Shrub species: <i>Melaleuca linariifolia</i> (O), <i>Eucalyptus coolabah</i> (O)	
Ground species: <i>Parthenium hysterophorus</i> * (D), <i>Cenchrus ciliaris</i> * (D), <i>Atriplex muelleri</i> (O), <i>Portulaca oleracea</i> * (O), <i>Urochloa mosambicensis</i> * (O)	
Macrophytes	
Submerged macrophytes:	
Floating macrophytes:	
Emergent macrophytes:

Aquatic biota	
Aquatic macroinvertebrate sampling undertaken: no	
Habitat for platypus: unlikely habitat	
Habitat for EVNT fish species: unlikely	
Fish sampling undertaken: no	
Suitable habitat for EVNT turtle species: unlikely	
Turtle sampling undertaken: no	
Aquatic vertebrates encountered:	
Notes:	
Aquatic habitat assessment scoring	
1. Bottom substrate/available cover	1 (Poor)
2. Embeddedness	1 (Poor)
3. Velocity/depth category	0 (Poor)
4. Channel alteration	12 (Excellent)
5. Bottom scouring and deposition	11 (Good)
6. Pool/riffle, run/bend ratio	1 (Poor)
7. Bank stability	9 (Excellent)
8. Bank vegetative stability	9 (Excellent)
9. Streamside cover	3 (Fair)
Overall score	47 (Fair)
Notes:	
Overall aquatic value: Low

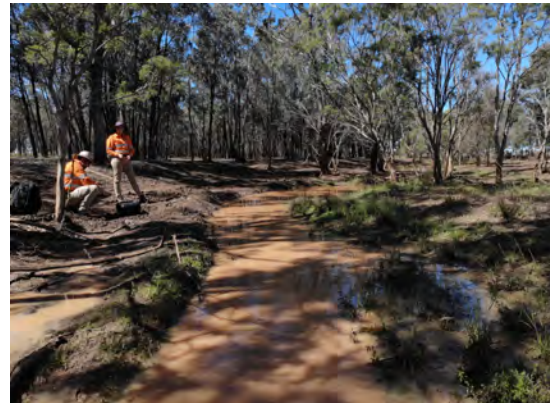
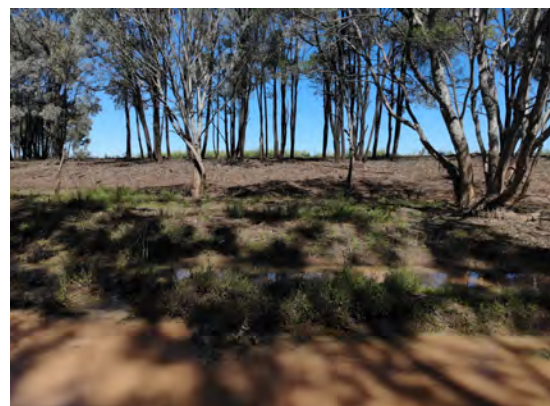
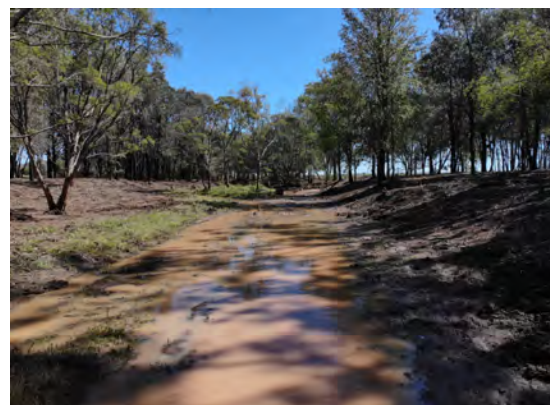
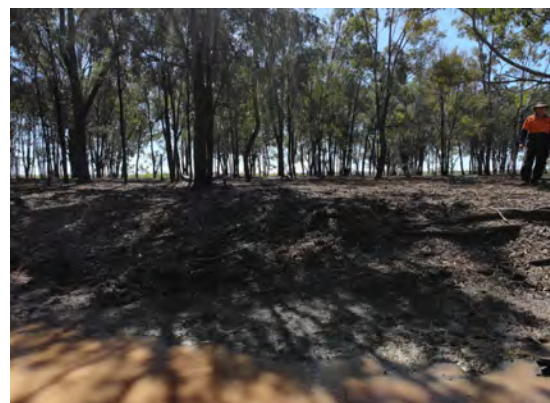
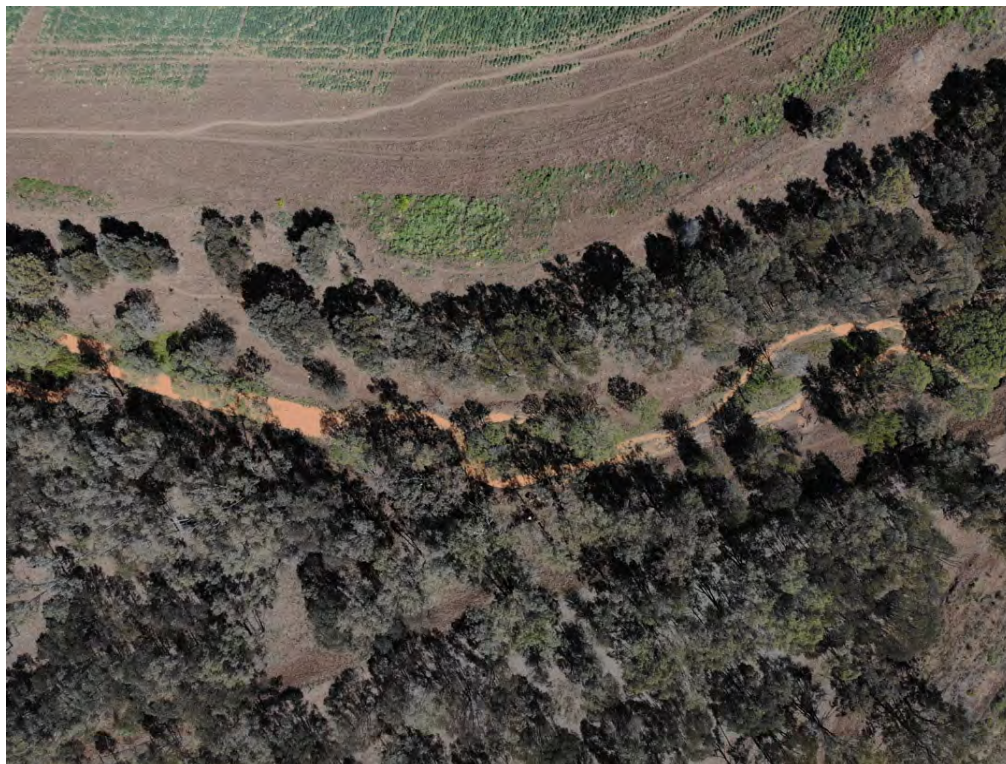
Mean wetted width: 1.5 m	Bankfull width: 20 m
Maximum depth: 0.2 m	Bankfull height: 1.5 m
Habitat types: 0% riffle, 0% run, 100% sandy pool, 0% rocky pool, 0% dry	
Variety of habitat: shallow (<0.5 m) pool, large woody debris, run	
Habitat attributes: detritus (L), sticks (L), branches (L), filamentous algae (L), bank overhang (L), trailing bank vegetation (L), blanketing silt (L)	
Upstream landuse: moderate grazing	
Adjacent landuse (right bank): moderate grazing, natural	
Adjacent landuse (left bank): non-irrigated cropping, natural	
Bed, edge and bank characteristics	
Bed substrates: 60% silt/clay (<0.05 mm), 39% sand (0.05-2 mm), 1% gravel (2-4 mm), 0% pebble (4-64 mm), 0% cobble (64-256 mm), 0% boulder (>256 mm), 0% bedrock	
Edge substrates: 80% silt/clay (<0.05 mm), 19% sand (0.05-2 mm), 1% gravel (2-4 mm), 0% pebble (4-64 mm), 0% cobble (64-256 mm), 0% boulder (>256 mm), 0% bedrock	
Bank soils: clay	Bank stability: stable

Bed stability: moderate deposition	Bank shape: concave
Channel shape: U shaped	Recent deposits: silt (S), sand (S)
Local catchment erosion: cattle pugging (S)

Aquatic biota	
Aquatic macroinvertebrate sampling undertaken: no	
Habitat for platypus: unlikely	
Habitat for EVNT fish species: unlikely	
Fish sampling undertaken: no	
Suitable habitat for EVNT turtle species: unlikely	
Turtle sampling undertaken: no	
Aquatic vertebrates encountered:	
Notes:	
Aquatic habitat assessment scoring	
1. Bottom substrate/available cover	5 (Poor)
2. Embeddedness	5 (Poor)
3. Velocity/depth category	6 (Fair)
4. Channel alteration	2 (Poor)
5. Bottom scouring and deposition	3 (Poor)
6. Pool/riffle, run/bend ratio	5 (Fair)
7. Bank stability	8 (Good)
8. Bank vegetative stability	4 (Fair)
9. Streamside cover	9 (Excellent)
Overall score	47 (Fair)
Notes:	
Overall aquatic value: Moderate

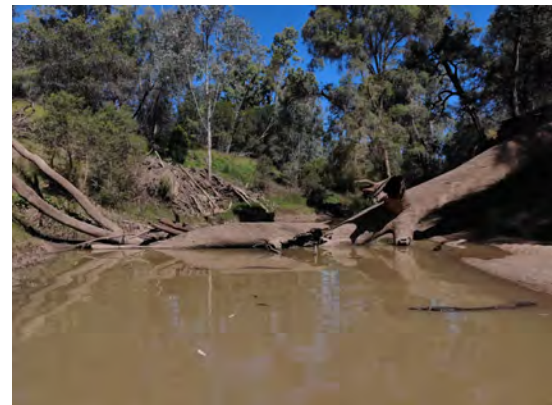
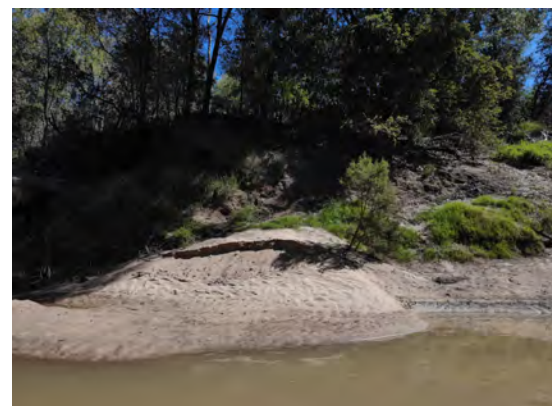
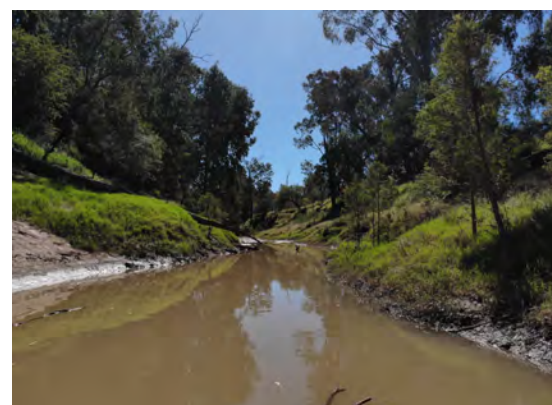
Bed substrates: 80% silt/clay (<0.05 mm), 20% sand (0.05-2 mm), 0% gravel (2-4 mm), 0% pebble (4-64 mm), 0% cobble (64-256 mm), 0% boulder (>256 mm), 0% bedrock	
Edge substrates: 80% silt/clay (<0.05 mm), 20% sand (0.05-2 mm), 0% gravel (2-4 mm), 0% pebble (4-64 mm), 0% cobble (64-256 mm), 0% boulder (>256 mm), 0% bedrock	
Bank soils: loamy sand	Bank stability: moderately stable
Bed stability: moderate deposition	Bank shape: concave
Channel shape: U shaped	Recent deposits: silt (L), sand (M)

Local catchment erosion: bank slumping (L)

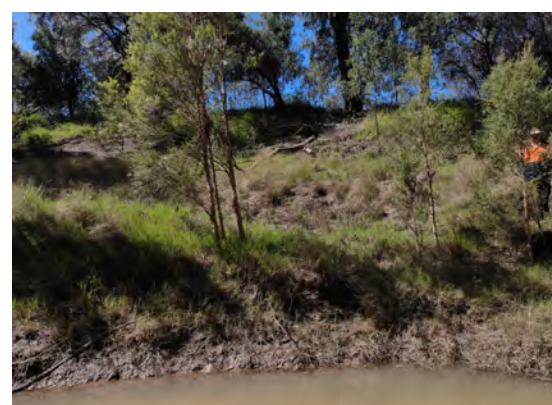
Right bank

Aquatic biota	
Aquatic macroinvertebrate sampling undertaken: no	
Habitat for platypus: unlikely	
Habitat for EVNT fish species: unlikely	
Fish sampling undertaken: no	
Suitable habitat for EVNT turtle species: yes	
Turtle sampling undertaken: no	
Aquatic vertebrates encountered:	
Notes: Permanency of water unknown; requires dry season survey	
Aquatic habitat assessment scoring	
1. Bottom substrate/available cover	3 (Poor)
2. Embeddedness	2 (Poor)
3. Velocity/depth category	6 (Fair)
4. Channel alteration	5 (Fair)
5. Bottom scouring and deposition	3 (Poor)
6. Pool/riffle, run/bend ratio	6 (Fair)
7. Bank stability	6 (Good)
8. Bank vegetative stability	9 (Excellent)
9. Streamside cover	9 (Excellent)
Overall score	49 (Fair)
Notes:	
Overall aquatic value: High

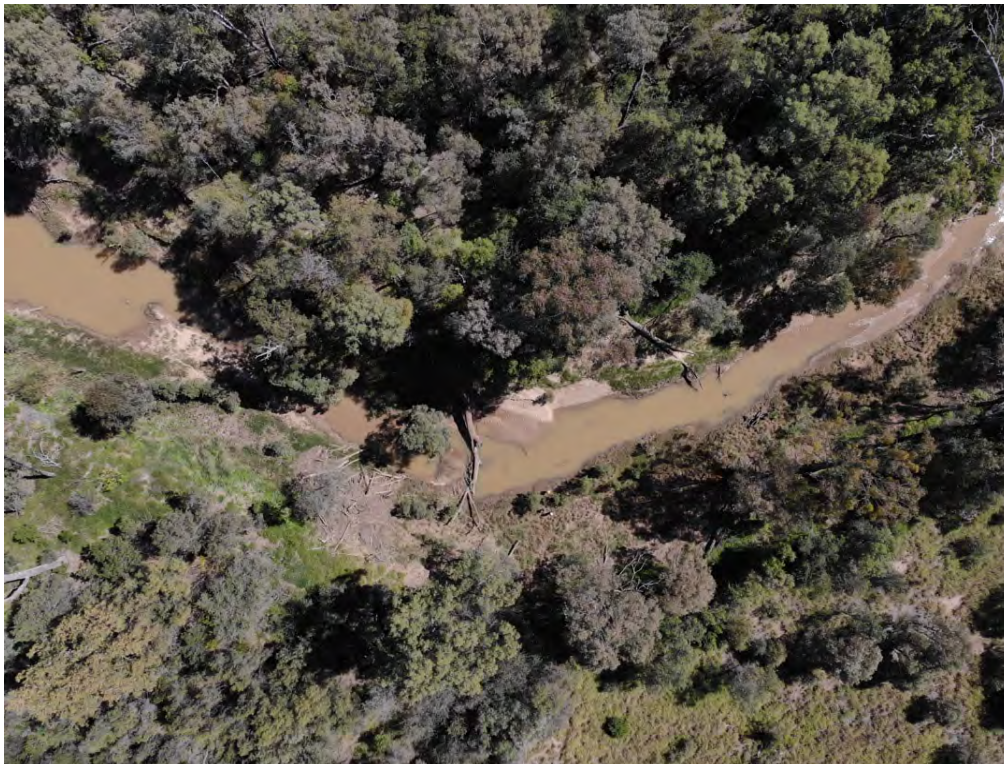
Aerial photograph from 100 m above ground level; upstream (left) to downstream (right)

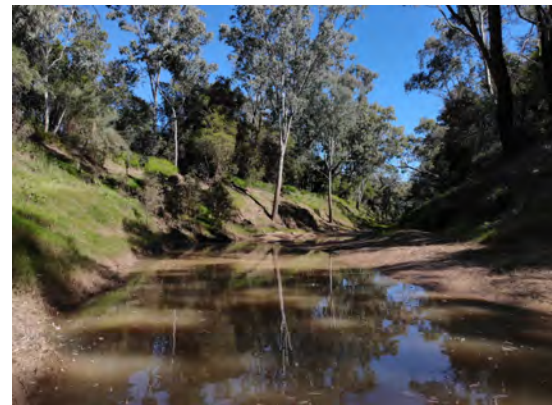
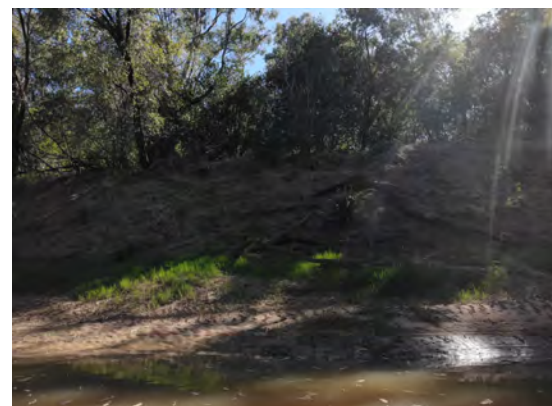
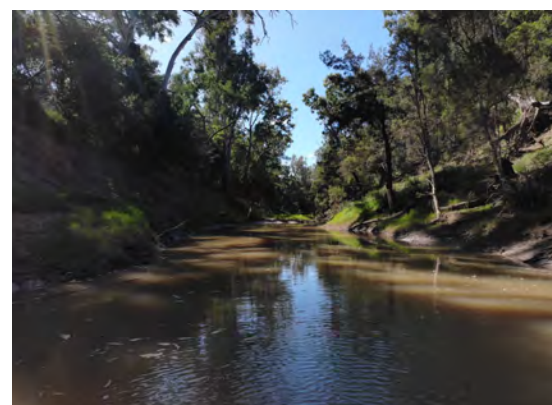
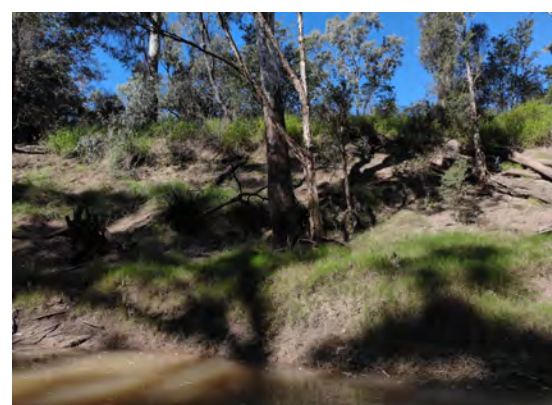
Channel shape: flat U shaped
 Recent deposits: silt (L), sand (M) |

Local catchment erosion: None detected

Aquatic biota	
Aquatic macroinvertebrate sampling undertaken: no	
Habitat for platypus: unlikely	
Habitat for EVNT fish species: unlikely	
Fish sampling undertaken: no	
Suitable habitat for EVNT turtle species: yes	
Turtle sampling undertaken: no	
Aquatic vertebrates encountered:	
Notes: Permanency of water unknown; requires dry season survey	
Aquatic habitat assessment scoring	
1. Bottom substrate/available cover	5 (Poor)
2. Embeddedness	5 (Poor)
3. Velocity/depth category	6 (Fair)
4. Channel alteration	6 (Fair)
5. Bottom scouring and deposition	3 (Poor)
6. Pool/riffle, run/bend ratio	6 (Fair)
7. Bank stability	8 (Good)
8. Bank vegetative stability	8 (Good)
9. Streamside cover	9 (Excellent)
Overall score	56 (Fair)
Notes:	
Overall aquatic value: High

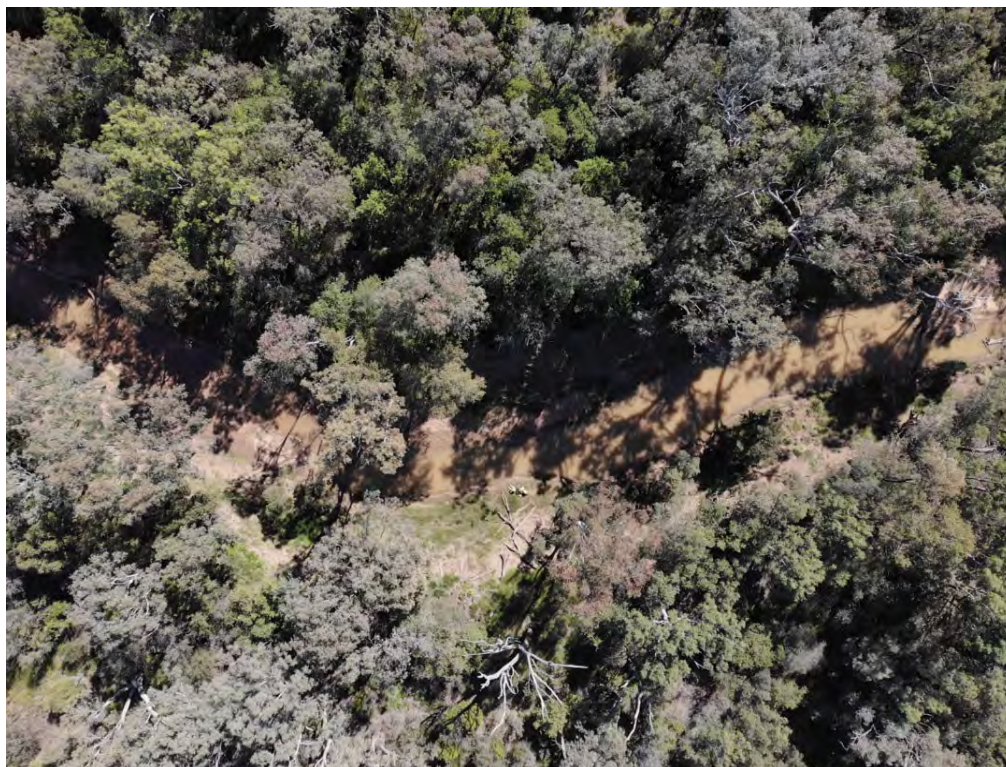
Aerial photograph from 100 m above ground level; upstream (left) to downstream (right)

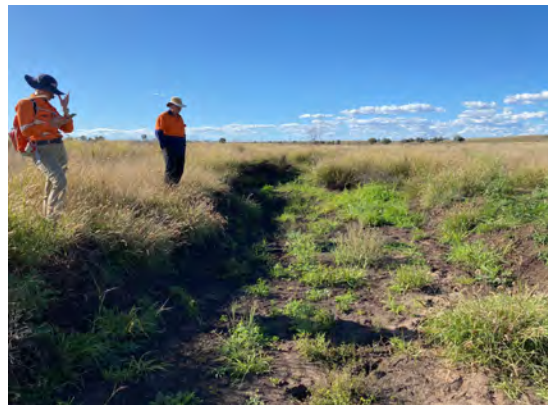
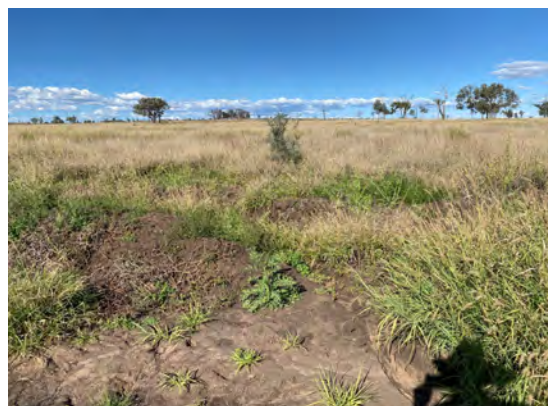
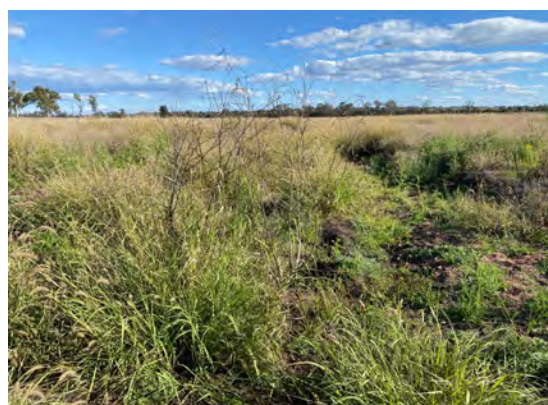
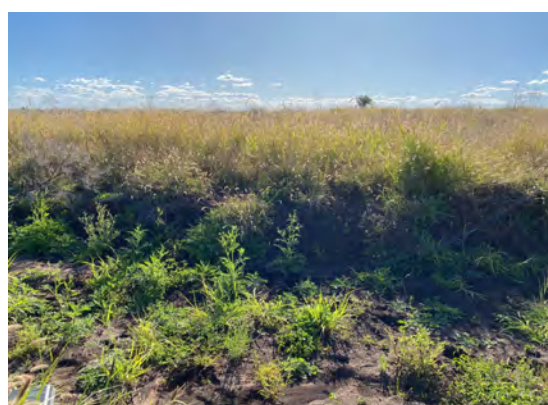
Recent deposits: silt (N), sand (L)

Local catchment erosion: rill (L), bank slumping (L)

Riparian vegetation	
Cover	
Width of riparian zone on left bank: 0 m	Width of riparian zone on right bank: 0 m
Bare ground: L	Grasses/forbs: E
Shrubs: L	Trees <10 m: N
Trees >10m: N	Exotic riparian species: E
Composition and health	
State-mapped RE: Non-remnant	Verified RE: Non-remnant
Vegetation status: exotic	Dominant stratum: grassland
Health: completely degraded	Dieback: not detected
EDL height: 0.5 m	EDL cover: 95%
Canopy species:	
Sub-canopy species:	
Shrub species: <i>Acacia harpophylla</i> (R), <i>Sesbania cannabina</i> (R)	
Ground species: <i>Cenchrus ciliaris</i> * (D), <i>Parthenium hysterophorus</i> * (F), <i>Malvastrum americanum var. stellatum</i> (O)	
Macrophytes	
Submerged macrophytes:	
Floating macrophytes:	
Emergent macrophytes: <i>Echinochloa colona</i> * (L)

Aquatic biota	
Aquatic macroinvertebrate sampling undertaken: no	
Habitat for platypus: unlikely	
Habitat for EVNT fish species: unlikely	
Fish sampling undertaken: no	
Suitable habitat for EVNT turtle species: unlikely	
Turtle sampling undertaken: no	
Aquatic vertebrates encountered:	
Notes:	
Aquatic habitat assessment scoring	
1. Bottom substrate/available cover	1 (Poor)
2. Embeddedness	1 (Poor)
3. Velocity/depth category	0 (Poor)
4. Channel alteration	3 (Poor)
5. Bottom scouring and deposition	3 (Poor)
6. Pool/riffle, run/bend ratio	0 (Poor)
7. Bank stability	8 (Good)
8. Bank vegetative stability	9 (Excellent)
9. Streamside cover	3 (Fair)
Overall score	28 (Poor)
Notes: Blade-ploughed paddock	
Overall aquatic value: Low

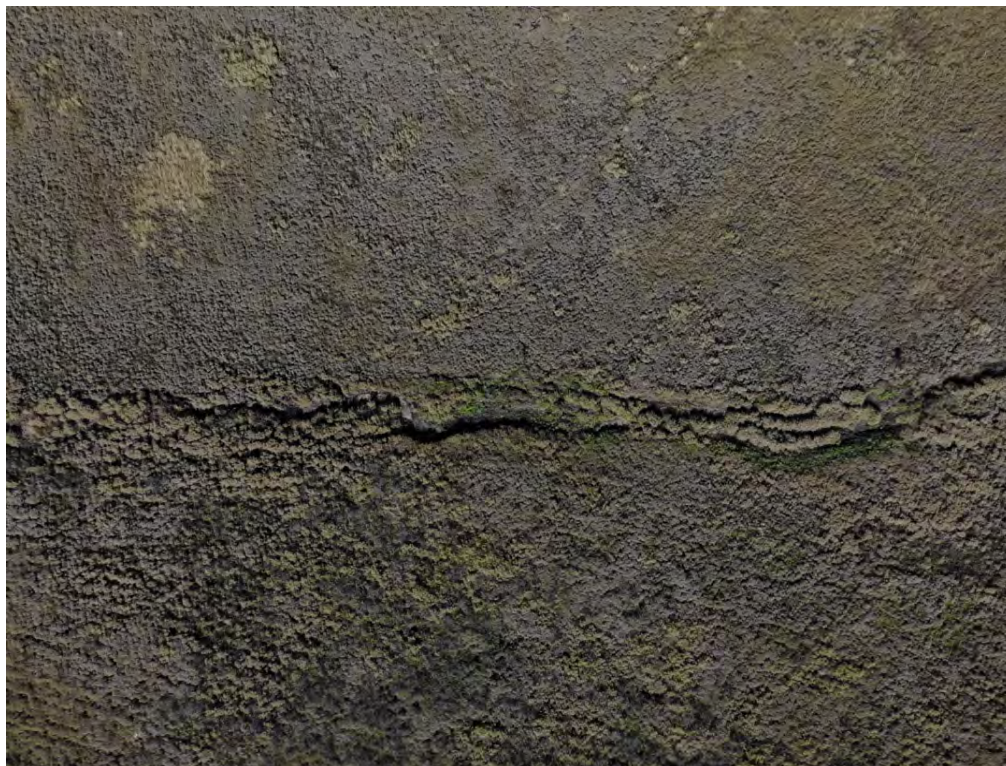
Aerial photograph from 100 m above ground level; upstream (left) to downstream (right)
