APPENDIX E AQUATIC VALUES ASSESSMENT REPORT

Mahalo North Coal Seam Gas Project – Aquatic Values Assessment

14 July 2023

Prepared by:
DPM Envirosiences Pty Ltd
ABN: 54 602 226 460
PO Box 1298, Mooloolaba QLD 4557
Ph: 0427 694 433

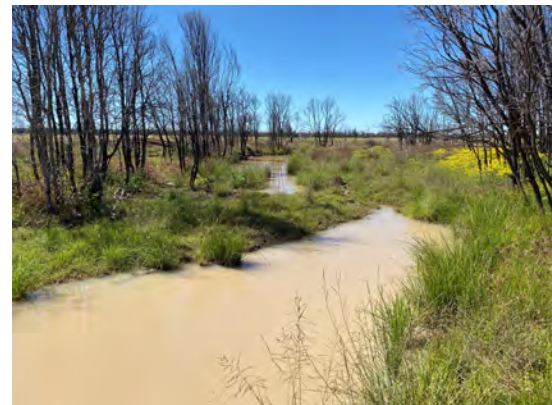
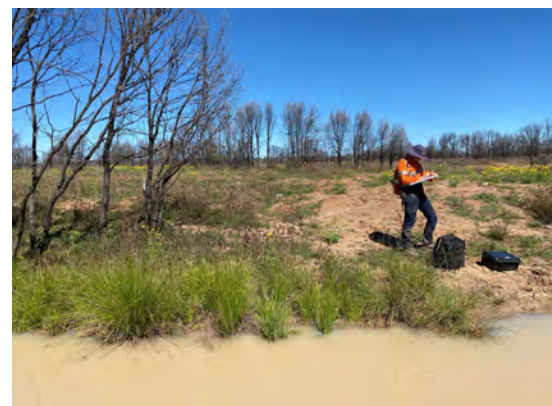
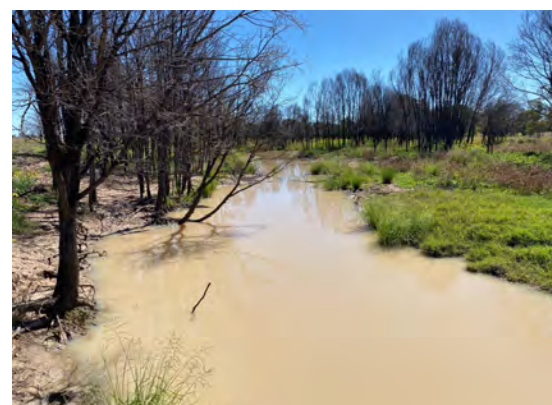
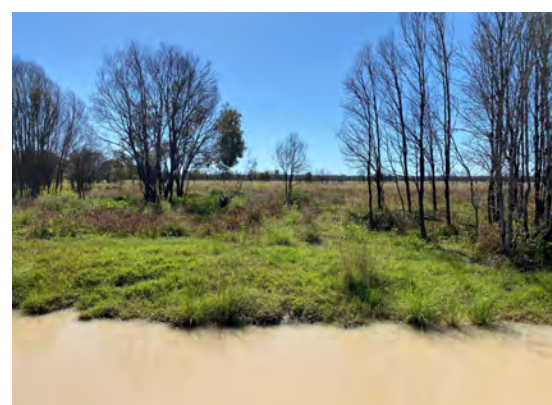
Recent deposits: silt (S), sand (N)

Local catchment erosion: gully (L), rill (L), cattle pugging (S)

Riparian vegetation	
Cover	
Width of riparian zone on left bank: 8 m	Width of riparian zone on right bank: 8 m
Bare ground: L	Grasses/forbs: E
Shrubs: L	Trees <10 m: L
Trees >10m: N	Exotic riparian species: E
Composition and health	
State-mapped RE: Non-remnant	Verified RE: Non-remnant
Vegetation status: exotic	Dominant stratum: grassland
Health: poor	Dieback: 26-75
EDL height: 0.5 m	EDL cover: 80%
Canopy species: <i>Acacia harpophylla</i> (O)	
Sub-canopy species:	
Shrub species:	
Ground species: <i>Chloris</i> sp. (D), <i>Senecio brigalowensis</i> (F), <i>Echinochloa colona</i> * (F), <i>Diplachne fusca</i> (O), <i>Leptochloa digitata</i> (O), <i>Portulaca oleracea</i> * (O), <i>Ammannia multiflora</i> (O), <i>Cynodon dactylon</i> var. <i>dactylon</i> * (F)	
Macrophytes	
Submerged macrophytes: None detected	
Floating macrophytes: None detected	
Emergent macrophytes: <i>Diplachne fusca</i> (L), <i>Cyperus difformis</i> (L), <i>Leptochloa digitata</i> (L), <i>Echinochloa colona</i> * (L), <i>Cyperus concinnus</i> (L), <i>Cyperus exaltatus</i> (L)

Aquatic biota	
Aquatic macroinvertebrate sampling undertaken: no	
Habitat for platypus: unlikely	
Habitat for EVNT fish species: unlikely	
Fish sampling undertaken: no	
Suitable habitat for EVNT turtle species: unlikely	
Turtle sampling undertaken: no	
Aquatic vertebrates encountered:	
Notes:	
Aquatic habitat assessment scoring	
1. Bottom substrate/available cover	1 (Poor)
2. Embeddedness	1 (Poor)
3. Velocity/depth category	4 (Poor)
4. Channel alteration	3 (Poor)
5. Bottom scouring and deposition	3 (Poor)
6. Pool/riffle, run/bend ratio	4 (Fair)
7. Bank stability	7 (Good)
8. Bank vegetative stability	6 (Good)
9. Streamside cover	5 (Fair)
Overall score	34 (Poor)
Notes:	
Overall aquatic value: Low

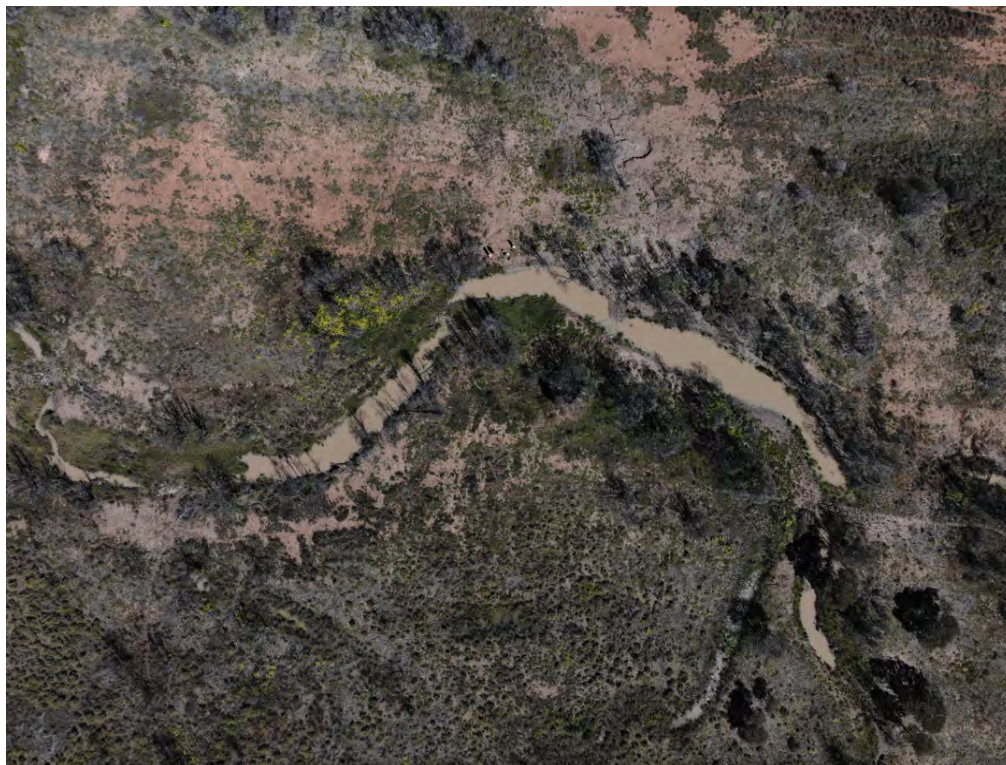
Aerial photograph from 100 m above ground level; upstream (left) to downstream (right)

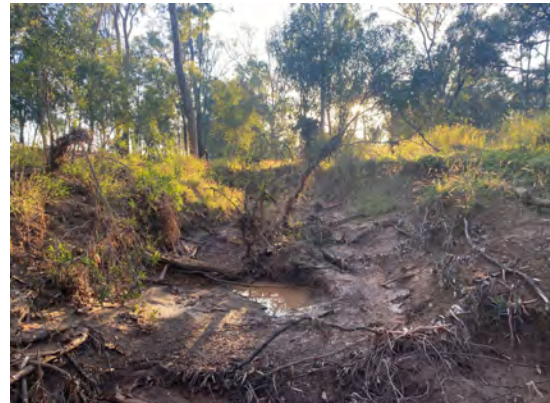
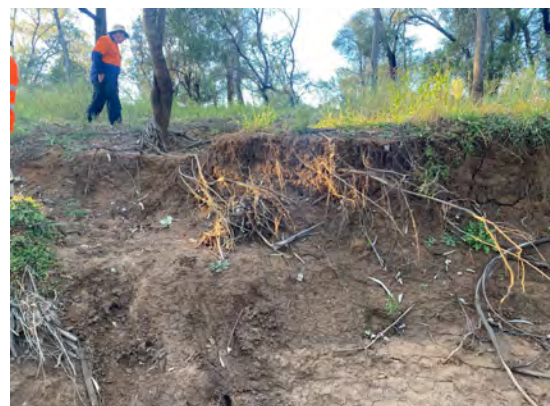
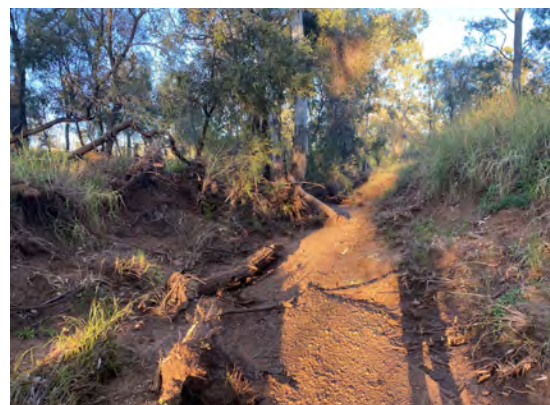
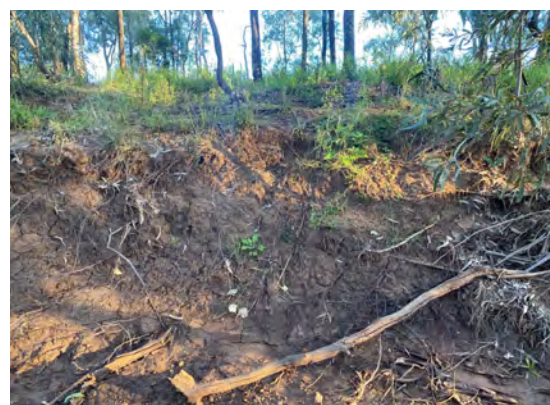
Reach observations (100 m reach, or 10 x modal width)	
Mean wetted width: 1 m	Bankfull width: 12 m
Maximum depth: 0.3 m	Bankfull height: 2 m
Habitat types: 0% riffle, 0% run, 15% sandy pool, 0% rocky pool, 85% dry	
Variety of habitat: shallow (<0.5 m), pool, large woody debris	
Habitat attributes: detritus (L), sticks (L), branches (L), logs (L), bank overhang (L), blanketing silt (L)	
Upstream landuse: moderate grazing	
Adjacent landuse (right bank): moderate grazing, natural	
Adjacent landuse (left bank): moderate grazing, natural	
Bed, edge and bank characteristics	
Bed substrates: 45% silt/clay (<0.05 mm), 10% sand (0.05-2 mm), 2% gravel (2-4 mm), 40% pebble (4-64 mm), 3% cobble (64-256 mm), 0% boulder (>256 mm), 0% bedrock	
Edge substrates: 82% silt/clay (<0.05 mm), 15% sand (0.05-2 mm), 1% gravel (2-4 mm), 1% pebble (4-64 mm), 1% cobble (64-256 mm), 0% boulder (>256 mm), 0% bedrock	
Bank soils: sandy loam	Bank stability: moderately unstable

Bed stability: bed stable	Bank shape: concave
Channel shape: U shaped	Recent deposits: silt (L), sand (L)
Local catchment erosion: gully (L), rill (L), bank slumping (S), cattle pugging (L)

Aquatic biota	
Aquatic macroinvertebrate sampling undertaken: no	
Habitat for platypus: unlikely	
Habitat for EVNT fish species: unlikely	
Fish sampling undertaken: no	
Suitable habitat for EVNT turtle species: unlikely	
Turtle sampling undertaken: no	
Aquatic vertebrates encountered:	
Notes:	
Aquatic habitat assessment scoring	
1. Bottom substrate/available cover	15 (Good)
2. Embeddedness	15 (Good)
3. Velocity/depth category	1 (Poor)
4. Channel alteration	10 (Good)
5. Bottom scouring and deposition	7 (Fair)
6. Pool/riffle, run/bend ratio	5 (Fair)
7. Bank stability	5 (Fair)
8. Bank vegetative stability	7 (Good)
9. Streamside cover	9 (Excellent)
Overall score	74 (Good)
Notes:	
Overall aquatic value: Moderate

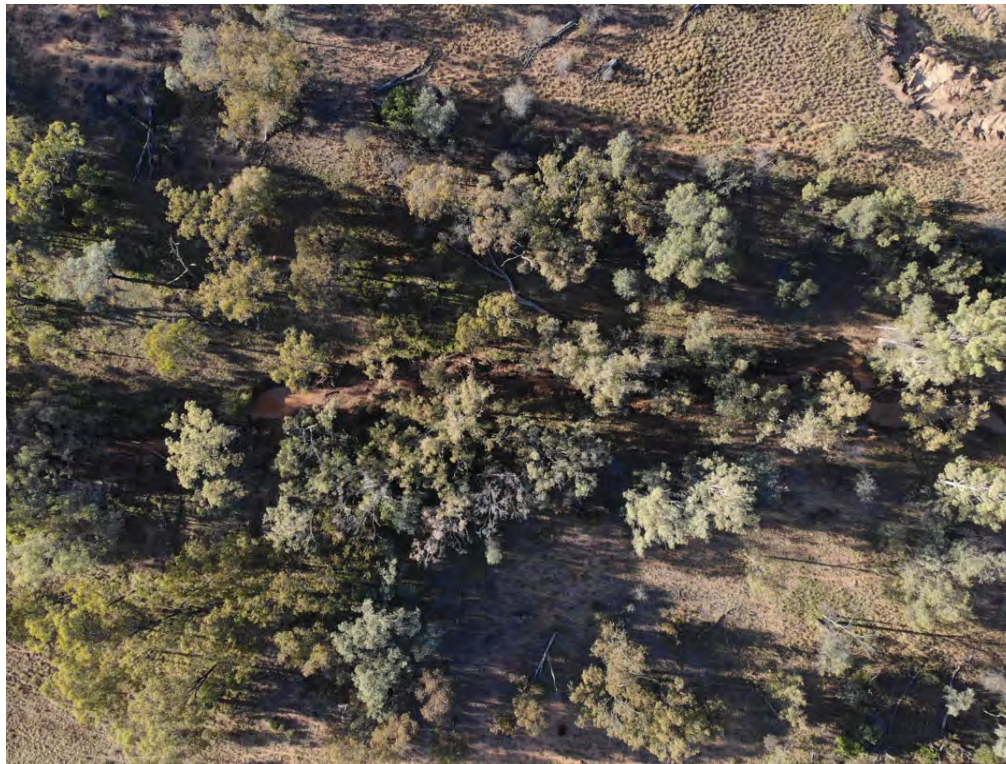
Aerial photograph from 100 m above ground level; upstream (left) to downstream (right)

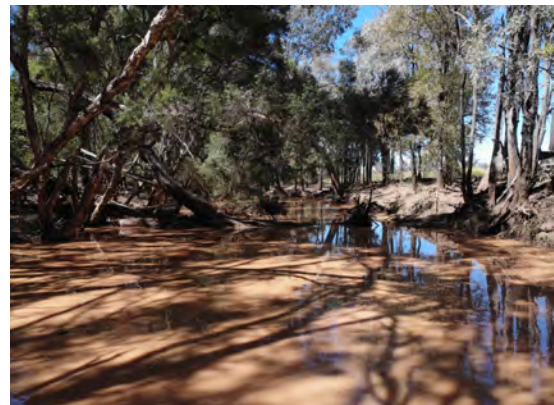
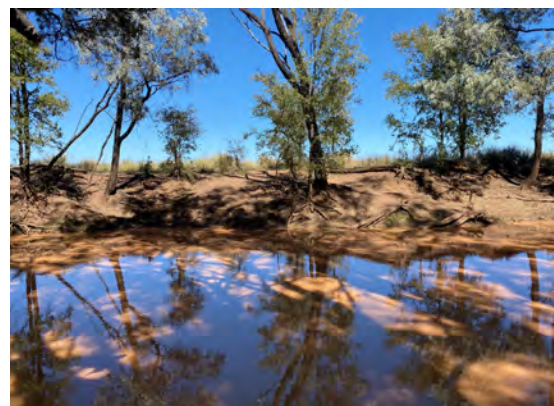
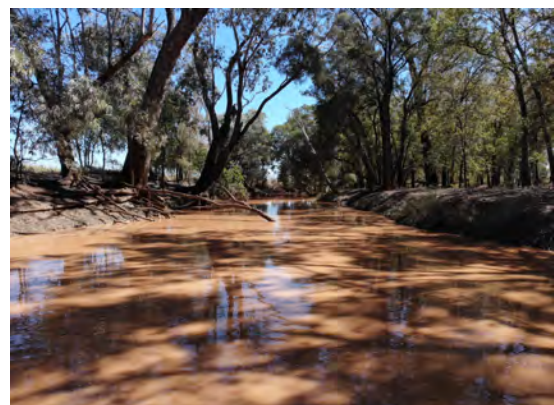
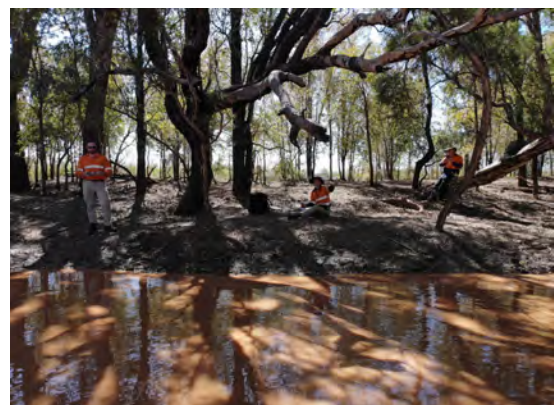
Bed substrates: 98% silt/clay (<0.05 mm), 2% sand (0.05-2 mm), 0% gravel (2-4 mm), 0% pebble (4-64 mm), 0% cobble (64-256 mm), 0% boulder (>256 mm), 0% bedrock	
Edge substrates: 99% silt/clay (<0.05 mm), 1% sand (0.05-2 mm), 0% gravel (2-4 mm), 0% pebble (4-64 mm), 0% cobble (64-256 mm), 0% boulder (>256 mm), 0% bedrock	
Bank soils: clay	Bank stability: stable
Bed stability: bed stable	Bank shape: concave
Channel shape: U shaped	Recent deposits: silt (L), sand (N)

Local catchment erosion: pugging (L)

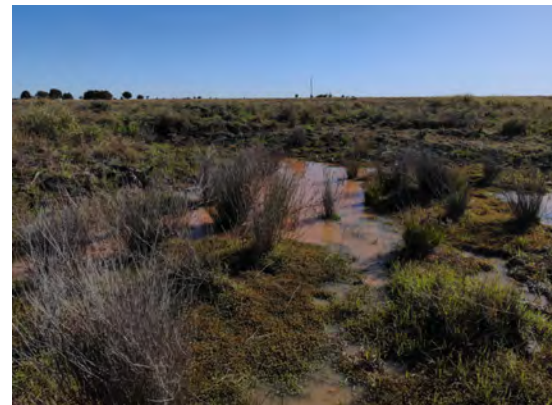
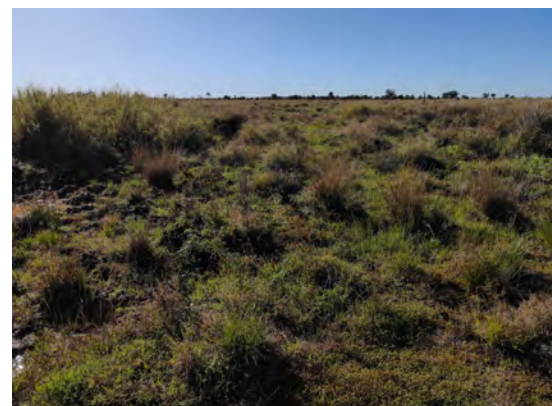
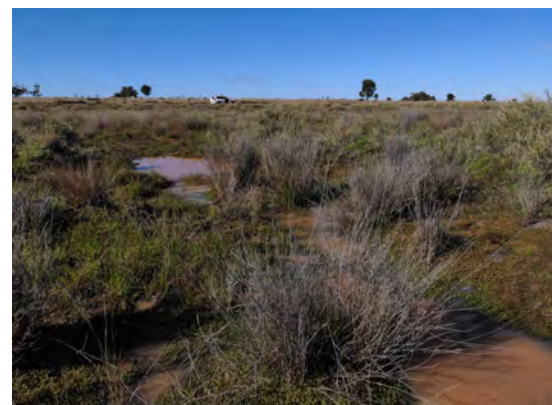
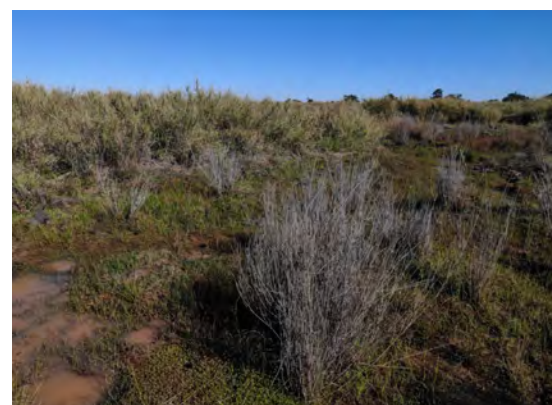
Site code: L1	Location: lacustrine wetland, Meroo Downs
Date: 16/08/2022	Season: dry
Assessor: DM	Coordinates: -24.0606; 148.5751 (GDA 2020)
Water level: no flow - isolated	Likely flow nature: episodic
State-mapped watercourse (DoR 2022): no, unmapped	
Likely a watercourse: no, likely a drainage feature	
State-mapped waterway providing for fish passage (DAF 2020): no	
Water quality	
Time (EST): 08:43	Water temperature: 10.9°C
Sp. Conductivity: 205.2 µS/cm	pH: 7.3
Dissolved oxygen: 49.6%	Dissolved oxygen: 5.47 mg/L
Turbidity: 346 NTU	Ion sample collected: yes
Observations within 2 m of sampling point	
Shading: 0%	Water colour: opaque
Water odour: none detected	Water surface: normal
Algae on substrate: L	Algae in water column: N
Emergent macrophytes: M	Submerged macrophytes: N
Floating macrophytes: N	
Reach observations (100 m reach, or 10 x modal width)	
Mean wetted width: 7 m	Bankfull width: 100 m
Maximum depth: 0.2 m	Bankfull height: 1 m

Habitat types: 0% riffle, 0% run, 5% sandy pool, 0% rocky pool, 95% dry	
Variety of habitat: macrophytes, shallow (<0.5 m) pool	
Habitat attributes: detritus (L), macrophytes (L), blanketing silt (L)	
Upstream landuse: moderate grazing	
Adjacent landuse (right bank): moderate grazing	
Adjacent landuse (left bank): moderate grazing	
Bed, edge and bank characteristics	
Bed substrates: 94% silt/clay (<0.05 mm), 5% sand (0.05-2 mm), 1% gravel (2-4 mm), 0% pebble (4-64 mm), 0% cobble (64-256 mm), 0% boulder (>256 mm), 0% bedrock	
Edge substrates: 94% silt/clay (<0.05 mm), 5% sand (0.05-2 mm), 1% gravel (2-4 mm), 0% pebble (4-64 mm), 0% cobble (64-256 mm), 0% boulder (>256 mm), 0% bedrock	
Bank soils: clay	Bank stability: moderately stable
Bed stability: bed stable	Bank shape: concave
Channel shape: U shaped	Recent deposits: silt (N), sand (N)
Local catchment erosion: cattle pugging (L)

Macrophytes
Submerged macrophytes:
Floating macrophytes:
Emergent macrophytes: <i>Cyperus concinnus</i> (L), <i>Marsilea hirsuta</i> (L), <i>Leptochloa digitata</i> (L), <i>Cyperus sp.</i> (L), <i>Eleocharis sp.</i> (L), <i>Echinochloa colona</i> * (L)
Aquatic biota
Aquatic macroinvertebrate sampling undertaken: no
Habitat for platypus: unlikely
Habitat for EVNT fish species: unlikely
Fish sampling undertaken: no
Suitable habitat for EVNT turtle species: unlikely
Turtle sampling undertaken: no
Aquatic vertebrates encountered:
Notes:

Overall aquatic value: Low

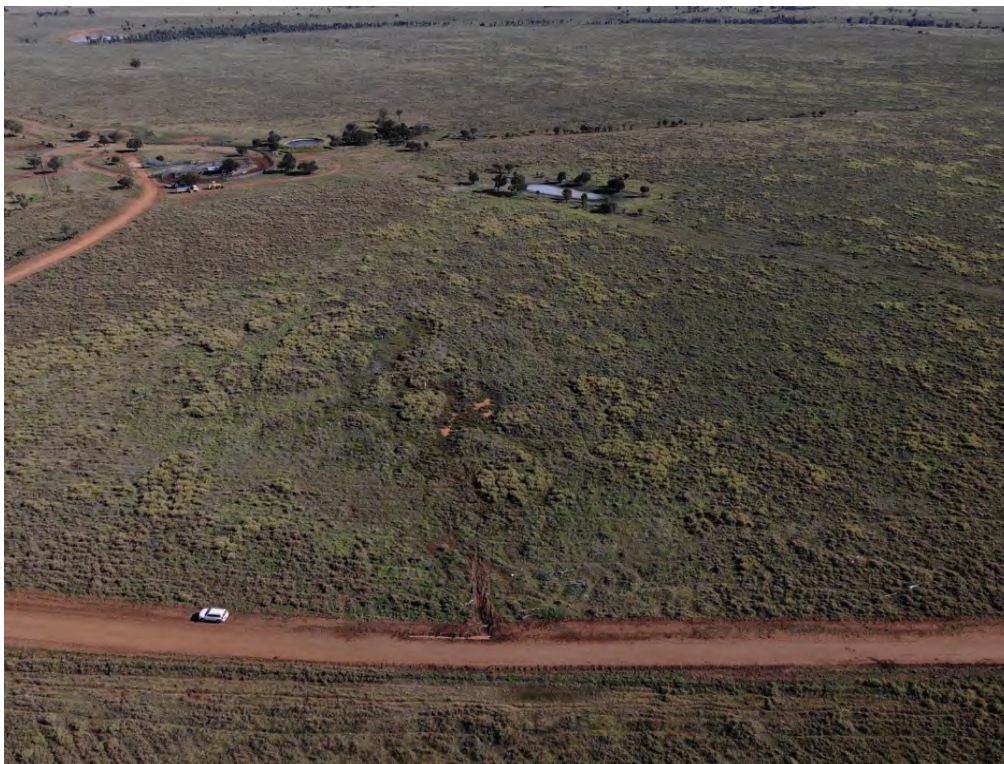
Aerial photograph from 100 m above ground level; upstream (left) to downstream (right)

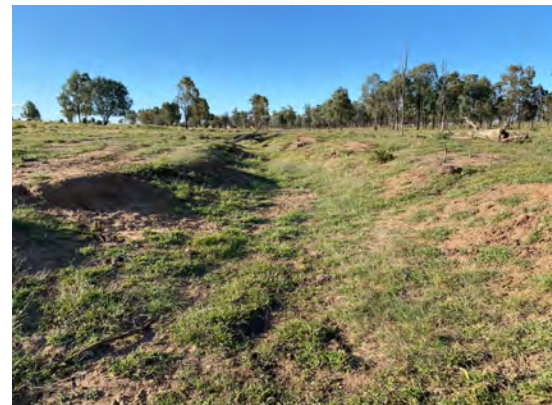
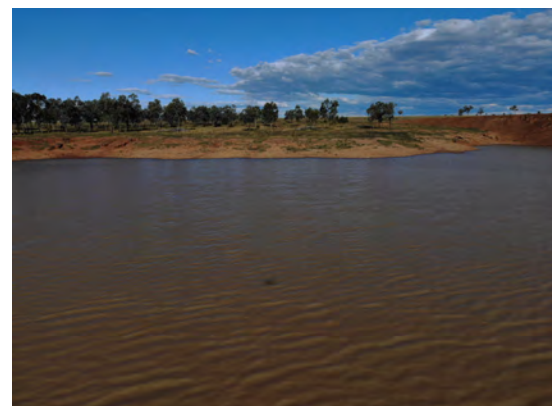
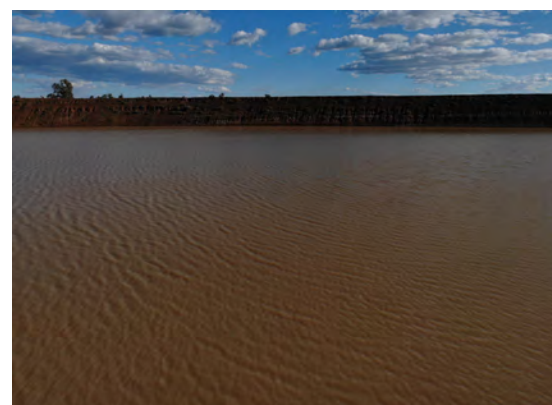
Bed substrates: 90% silt/clay (<0.05 mm), 10% sand (0.05-2 mm), 0% gravel (2-4 mm), 0% pebble (4-64 mm), 0% cobble (64-256 mm), 0% boulder (>256 mm), 0% bedrock	
Edge substrates: 80% silt/clay (<0.05 mm), 20% sand (0.05-2 mm), 0% gravel (2-4 mm), 0% pebble (4-64 mm), 0% cobble (64-256 mm), 0% boulder (>256 mm), 0% bedrock	
Bank soils: sandy clay	Bank stability: moderately stable
Bed stability: moderate erosion	Bank shape: concave
Channel shape: U shaped	Recent deposits: none detected
Local catchment erosion: gully (L), rill (L), tunnel (L), sheet (L), bank slumping (L), cattle pugging (E)

Riparian vegetation	
Cover	
Width of riparian zone on left bank: 5 m	Width of riparian zone on right bank: 5 m
Bare ground: S	Grasses/forbs: M
Shrubs: L	Trees <10 m: S
Trees >10m: N	Exotic riparian species: E
Composition and health	
State-mapped RE: Non-remnant	Verified RE: Non-remnant
Vegetation status: regrowth	Dominant stratum: tree
Health: average	Dieback: not detected
EDL height: 8 m	EDL cover: 35%
Canopy species: <i>Eucalyptus populnea</i> (D), <i>Acacia harpophylla</i> (O), <i>A. salicina</i> (O)	
Sub-canopy species:	
Shrub species: <i>Acacia harpophylla</i> (R)	
Ground species: <i>Cenchrus ciliaris</i> * (D), <i>Bothriochloa</i> sp. (O), <i>Gomphrena celosioides</i> * (O), <i>Eragrostis</i> sp. (O), <i>Cynodon dactylon</i> var. <i>dactylon</i> * (O), <i>Chloris inflata</i> * (O), <i>Urochloa mosambicensis</i> * (O)

Macrophytes
Submerged macrophytes: None detected
Floating macrophytes: None detected
Emergent macrophytes: None detected
Aquatic biota
Aquatic macroinvertebrate sampling undertaken: no
Habitat for platypus: unlikely
Habitat for EVNT fish species: unlikely
Fish sampling undertaken: no
Suitable habitat for EVNT turtle species: unlikely
Turtle sampling undertaken: no
Aquatic vertebrates encountered:
Notes:
Overall aquatic value: Low

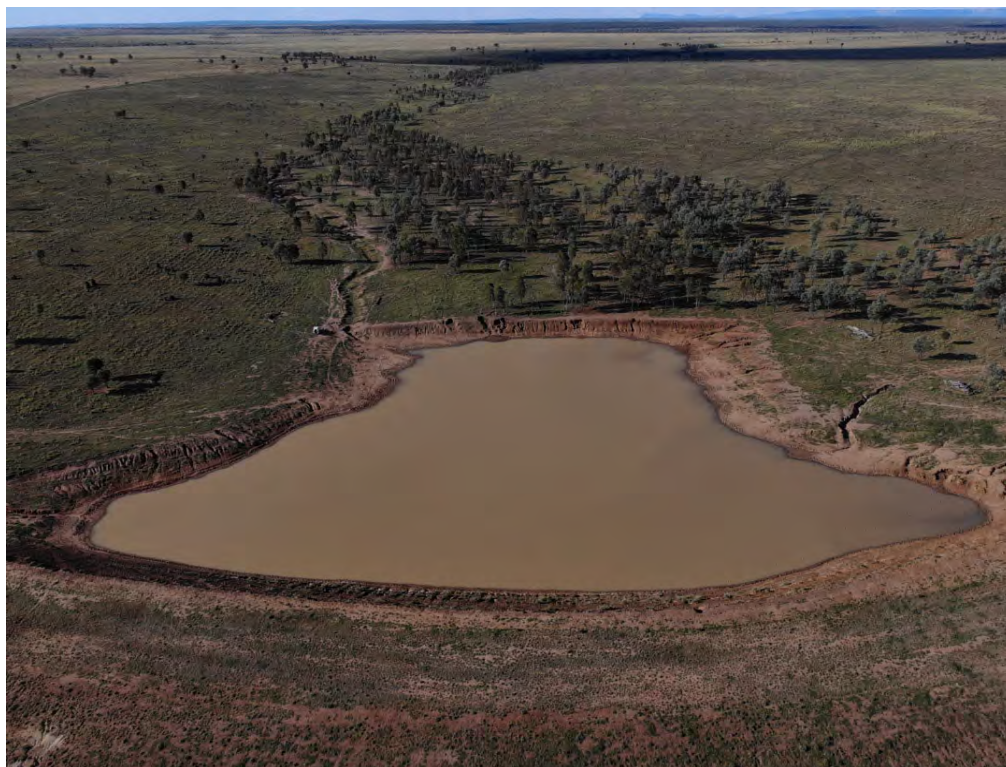
Aerial photograph from 100 m above ground level; upstream (left) to downstream (right)

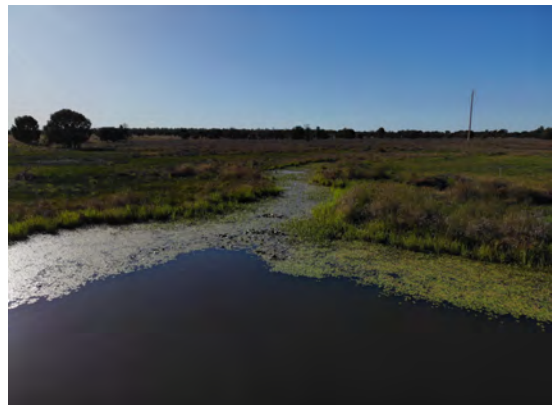
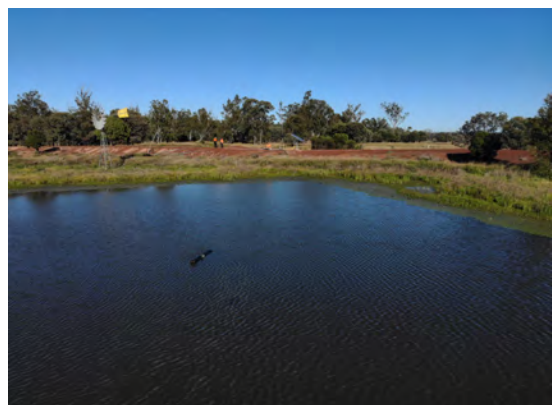
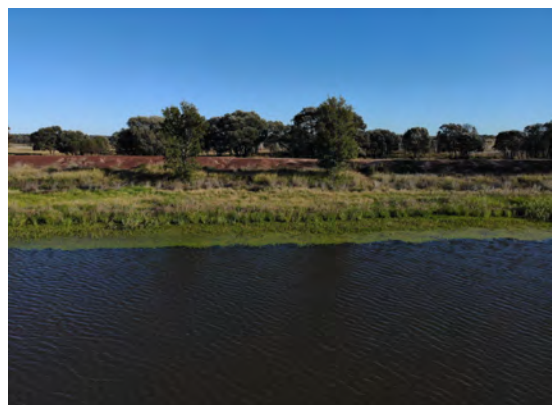
Channel shape: U shaped **Recent deposits:** none detected

Local catchment erosion: gully (L), rill (L), bank slumping (L)

Riparian vegetation	
Cover	
Width of riparian zone on left bank: 8 m	Width of riparian zone on right bank: 8 m
Bare ground: S	Grasses/forbs: M
Shrubs: L	Trees <10 m: L
Trees >10m: L	Exotic riparian species: L
Composition and health	
State-mapped RE: Non-remnant	Verified RE: Non-remnant
Vegetation status: exotic	Dominant stratum: grassland
Health: average	Dieback: not detected
EDL height: 1 m	EDL cover: 95%
Canopy species: <i>Eucalyptus cambageana</i> (D), <i>Eucalyptus tereticornis</i> (O)	
Sub-canopy species: <i>Acacia harpophylla</i> (D), <i>Terminalia oblongata</i> subsp. <i>oblongata</i> (O)	
Shrub species: <i>Acacia harpophylla</i> (R), <i>Carissa ovata</i> (R), <i>Eremophila</i> sp. (R), <i>Eremophila mitchellii</i> (R)	
Ground species: <i>Eleocharis plana</i> (D), <i>Marsilea drummondii</i> (F), <i>Megathyrsus maximus</i> * (F), <i>Cenchrus ciliaris</i> * (O), <i>Urochloa mosambicensis</i> * (O)

Macrophytes
Submerged macrophytes: <i>Potamogeton crispus</i> (L)
Floating macrophytes:
Emergent macrophytes: <i>Eleocharis plana</i> (E), <i>Ludwigia peploides</i> subsp. <i>montevidensis</i> (M), <i>Cyperus exaltatus</i> (S), <i>Persicaria attenuata</i> (S), <i>Marsilea drummondii</i> (E), <i>Leptochloa digitata</i> (L), <i>Ottelia ovalifolia</i> (S), <i>Echinochloa colona</i> * (L), <i>Eclipta prostrata</i> (L), <i>Diplachne fusca</i> (L)
Aquatic biota
Aquatic macroinvertebrate sampling undertaken: no
Habitat for platypus: unlikely
Habitat for EVNT fish species: unlikely
Fish sampling undertaken: no
Suitable habitat for EVNT turtle species: unlikely
Turtle sampling undertaken: no
Aquatic vertebrates encountered:
Notes: Dam fenced off from cattle
Overall aquatic value: Low

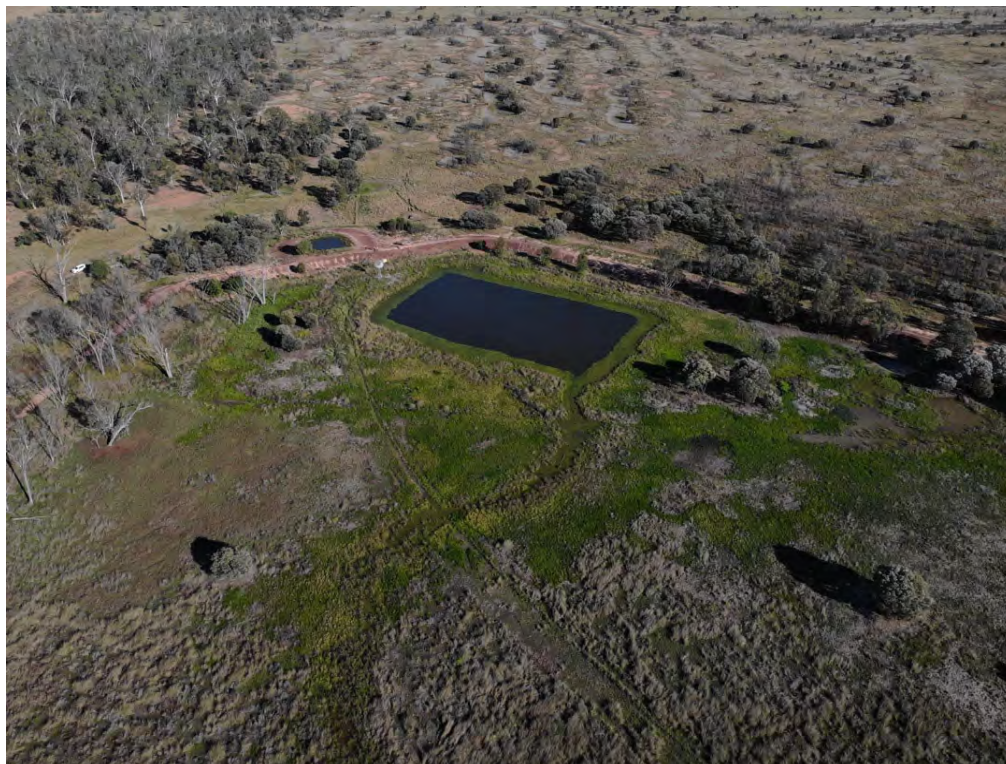
Aerial photograph from 100 m above ground level; upstream (left) to downstream (right)

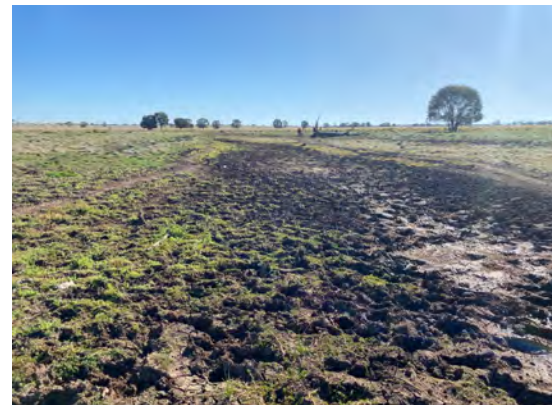
Upstream

Bed, edge and bank characteristics	
Bed substrates: 90% silt/clay (<0.05 mm), 10% sand (0.05-2 mm), 0% gravel (2-4 mm), 0% pebble (4-64 mm), 0% cobble (64-256 mm), 0% boulder (>256 mm), 0% bedrock	
Edge substrates: 90% silt/clay (<0.05 mm), 10% sand (0.05-2 mm), 0% gravel (2-4 mm), 0% pebble (4-64 mm), 0% cobble (64-256 mm), 0% boulder (>256 mm), 0% bedrock	
Bank soils: sandy clay	Bank stability: stable
Bed stability: bed stable	Bank shape: concave
Channel shape: U shaped	Recent deposits: none detected

Local catchment erosion: cattle pugging (E)

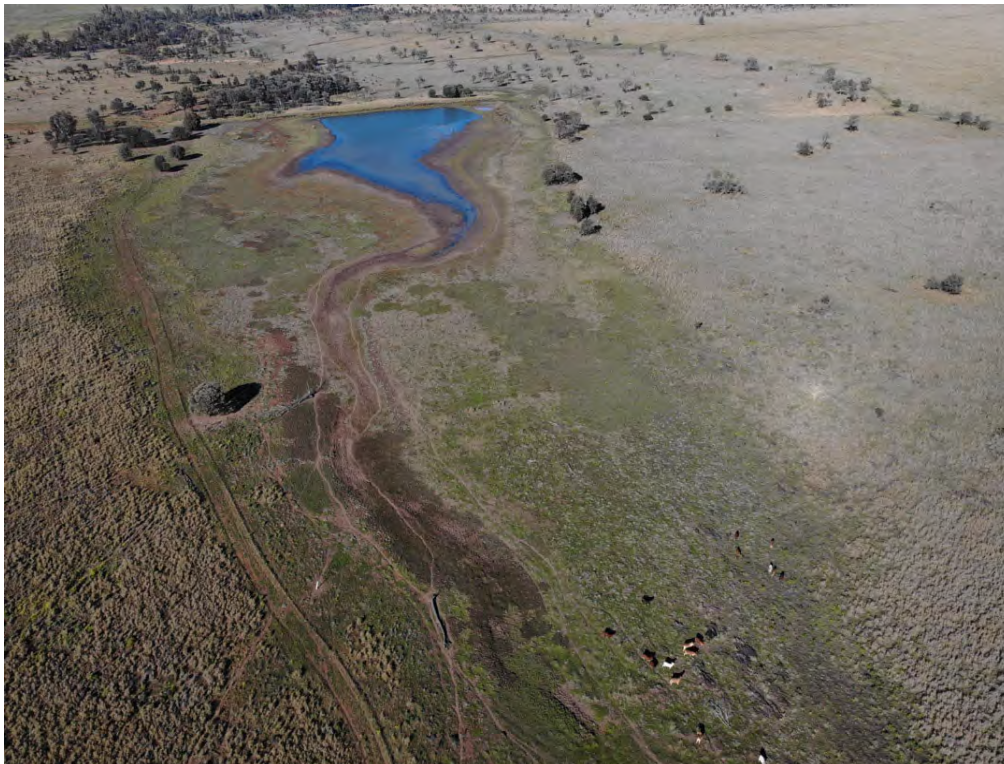
Submerged macrophytes: <i>Other sp.</i> (L)	
Floating macrophytes:	
Emergent macrophytes: <i>Persicaria decipiens</i> (L), <i>Persicaria attenuata</i> (L), <i>Ludwigia peploides</i> subsp. <i>montevidensis</i> (L), <i>Leptochloa digitata</i> (L), <i>Juncus sp.</i> (L), <i>Ottelia ovalifolia</i> (L), <i>Marsilea drummondii</i> (L), <i>Cyperus difformis</i> , <i>Echinochloa colona</i> * (L), <i>Eleocharis plana</i> (L)	
Aquatic biota	
Aquatic macroinvertebrate sampling undertaken: no	
Habitat for platypus: unlikely habitat	
Habitat for EVNT fish species: unlikely	
Fish sampling undertaken: no	
Suitable habitat for EVNT turtle species: unlikely	
Turtle sampling undertaken: no	
Aquatic vertebrates encountered:	
Notes:

Overall aquatic value: Low

Aerial photograph from 100 m above ground level; upstream (left) to downstream (right)

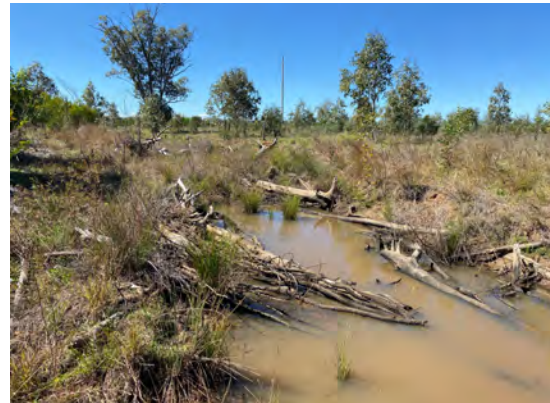
Mean wetted width: 1.5 m	Bankfull width: 4 m
Maximum depth: 0.2 m	Bankfull height: 1 m
Habitat types: 0% riffle, 0% run, 0% sandy pool, 0% rocky pool, 100% dry	
Variety of habitat: large woody debris	
Habitat attributes: detritus (L), sticks (L), branches (L), blanketing silt (L)	
Upstream landuse: moderate grazing	
Adjacent landuse (right bank): moderate grazing, Natural	
Adjacent landuse (left bank): moderate grazing, natural	
Bed, edge and bank characteristics	
Bed substrates: 10% silt/clay (<0.05 mm), 90% sand (0.05-2 mm), 0% gravel (2-4 mm), 0% pebble (4-64 mm), 0% cobble (64-256 mm), 0% boulder (>256 mm), 0% bedrock	
Edge substrates: 10% silt/clay (<0.05 mm), 90% sand (0.05-2 mm), 0% gravel (2-4 mm), 0% pebble (4-64 mm), 0% cobble (64-256 mm), 0% boulder (>256 mm), 0% bedrock	
Bank soils: loamy sand	Bank stability: moderately stable
Bed stability: moderate deposition	Bank shape: concave
Channel shape: U shaped	Recent deposits: silt (L), sand (L)

Local catchment erosion: gully (L), rill (L), bank slumping (L), cattle pugging (L)

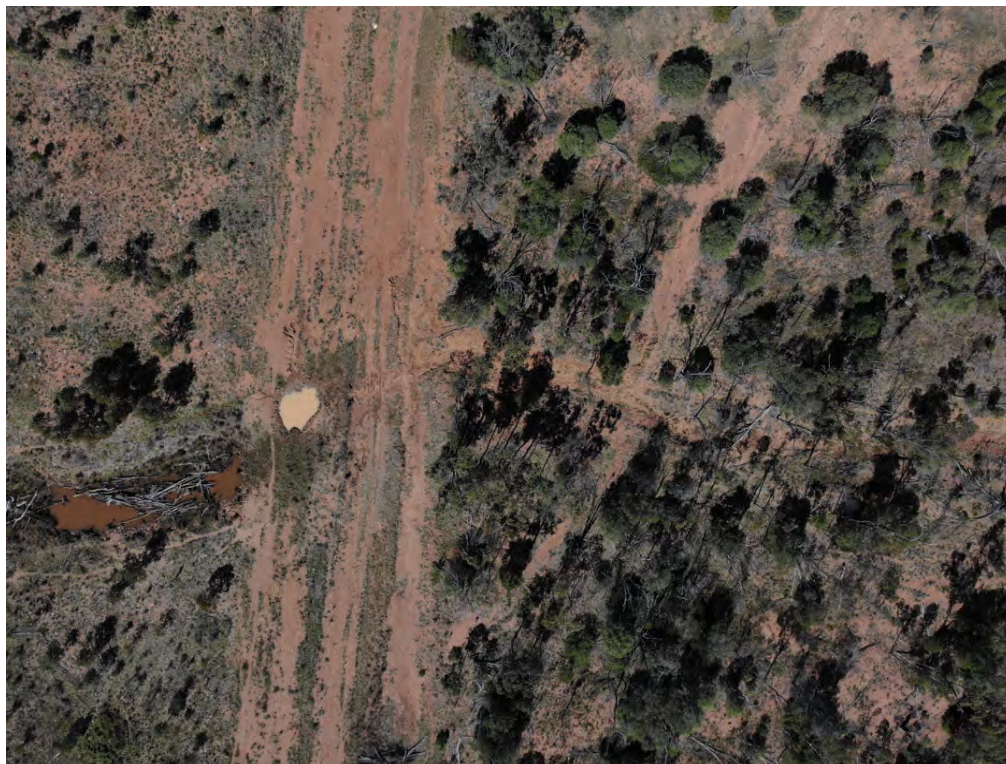
Overall aquatic value: High (mapped HES wetland)

Aerial photograph from 100 m above ground level; upstream (left) to downstream (right)

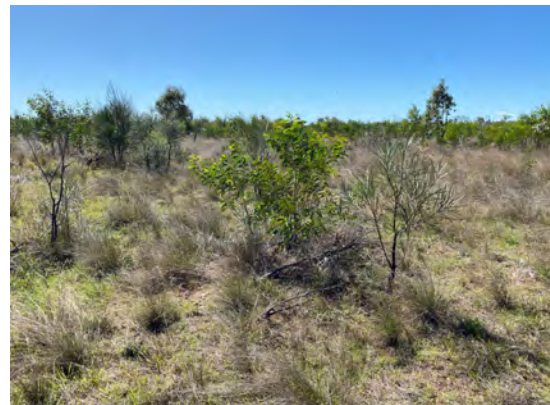
Site code: HES2	Location: HES wetland, Togara Station
Date: 17/08/2022	Season: dry
Assessor: DM	Coordinates: -24.0187; 148.6533 (GDA 2020)
Water level: no flow - dry	Likely flow nature: ephemeral
State-mapped watercourse (DoR 2022): no, not applicable	
Likely a watercourse: no	
State-mapped waterway providing for fish passage (DAF 2020): no	
Water quality	
Time (EST): 11:20	Water temperature: NA/dry
Sp. Conductivity: NA/dry	pH: NA/dry
Dissolved oxygen: NA/dry	Dissolved oxygen: NA/dry
Turbidity: NA/dry	Ion sample collected: no
Observations within 2 m of sampling point	
Shading: NA/dry	Water colour: NA/dry
Water odour: NA/dry	Water surface: NA/dry
Algae on substrate: NA/dry	Algae in water column:
Emergent macrophytes: NA	Submerged macrophytes: NA
Floating macrophytes: NA/dry	
Reach observations (100 m reach, or 10 x modal width)	
Mean wetted width: 0 m	Bankfull width: NA m
Maximum depth: 0 m	Bankfull height: NA m

Habitat types: 0% riffle, 0% run, 0% sandy pool, 0% rocky pool, 100% dry	
Variety of habitat:	
Habitat attributes:	
Upstream landuse: moderate grazing	
Adjacent landuse (right bank): moderate grazing	
Adjacent landuse (left bank): moderate grazing	
Bed, edge and bank characteristics	
Bed substrates: 15% silt/clay (<0.05 mm), 85% sand (0.05-2 mm), 0% gravel (2-4 mm), 0% pebble (4-64 mm), 0% cobble (64-256 mm), 0% boulder (>256 mm), 0% bedrock	
Edge substrates: 15% silt/clay (<0.05 mm), 85% sand (0.05-2 mm), 0% gravel (2-4 mm), 0% pebble (4-64 mm), 0% cobble (64-256 mm), 0% boulder (>256 mm), 0% bedrock	
Bank soils: loamy sand	Bank stability: stable
Bed stability: bed stable	Bank shape:
Channel shape:	Recent deposits: none detected
Local catchment erosion: none detected

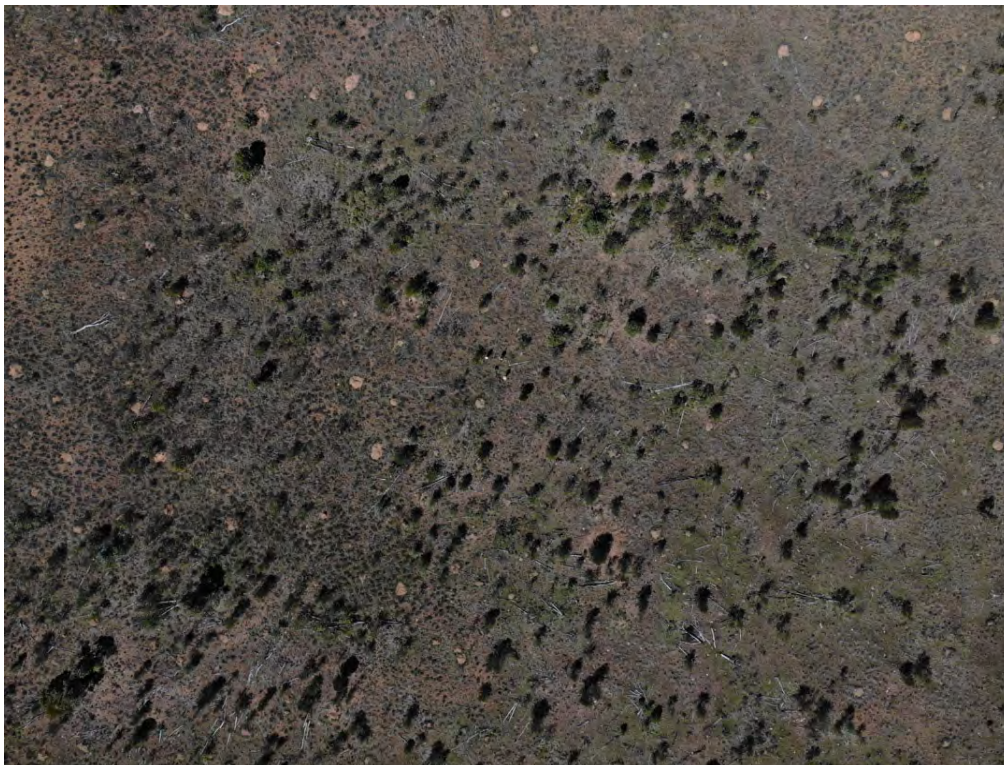
Macrophytes
Submerged macrophytes: none detected
Floating macrophytes: none detected
Emergent macrophytes: none detected
Aquatic biota
Aquatic macroinvertebrate sampling undertaken: no
Habitat for platypus: unlikely
Habitat for EVNT fish species: unlikely
Fish sampling undertaken: no
Suitable habitat for EVNT turtle species: unlikely
Turtle sampling undertaken: no
Aquatic vertebrates encountered:
Notes:
Overall aquatic value: High (mapped HES wetland)

Aerial photograph from 100 m above ground level; upstream (left) to downstream (right)

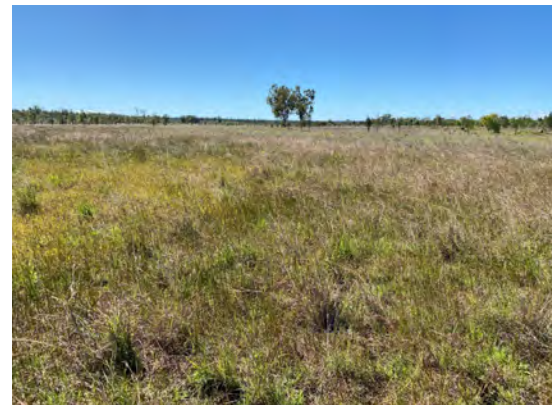
Upstream

Channel shape: **Recent deposits:** silt (N), sand (N) |

Local catchment erosion: cattle pugging (S)

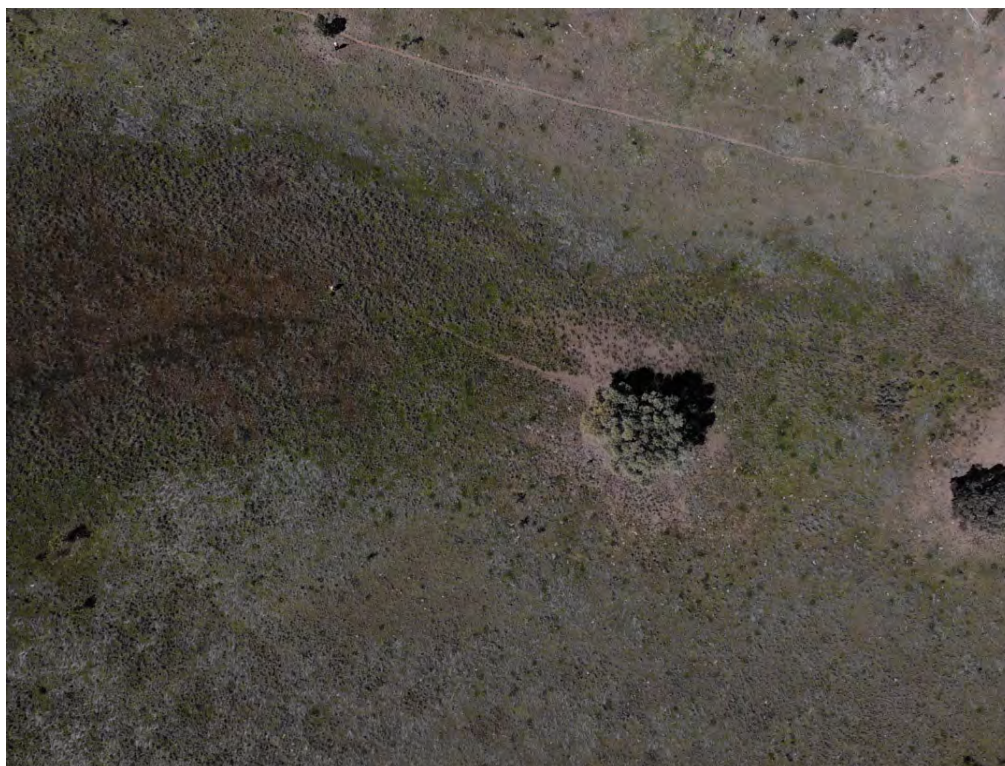
Aquatic biota	
Aquatic macroinvertebrate sampling undertaken: no	
Habitat for platypus: unlikely	
Habitat for EVNT fish species: unlikely	
Fish sampling undertaken: no	
Suitable habitat for EVNT turtle species: unlikely	
Turtle sampling undertaken: no	
Aquatic vertebrates encountered:	
Notes:	
Aquatic habitat assessment scoring	
1. Bottom substrate/available cover	3 (Poor)
2. Embeddedness	3 (Poor)
3. Velocity/depth category	0 (Poor)
4. Channel alteration	12 (Excellent)
5. Bottom scouring and deposition	8 (Good)
6. Pool/riffle, run/bend ratio	1 (Poor)
7. Bank stability	9 (Excellent)
8. Bank vegetative stability	9 (Excellent)
9. Streamside cover	4 (Fair)
Overall score	49 (Fair)
Notes:	
Overall aquatic value: High (mapped HES wetland)

Aerial photograph from 100 m above ground level; upstream (left) to downstream (right)

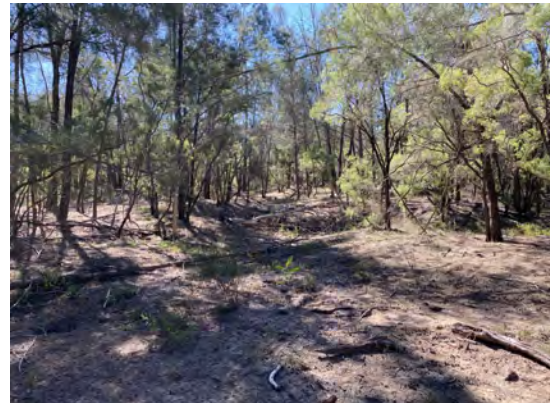
Site code: HES4	Location: HES wetland, Togara Station
Date: 17/08/2022	Season: dry
Assessor: DM	Coordinates: -23.9919; 148.6177 (GDA 2020)
Water level: no flow - dry	Likely flow nature: episodic
State-mapped watercourse (DoR 2022): not applicable	
Likely a watercourse:	
State-mapped waterway providing for fish passage (DAF 2020): no	
Water quality	
Time (EST): 13:32	Water temperature: NA/dry
Sp. Conductivity: NA/dry	pH: NA/dry
Dissolved oxygen: NA/dry	Dissolved oxygen: NA/dry
Turbidity: NA/dry	Ion sample collected: no
Observations within 2 m of sampling point	
Shading: NA/dry	Water colour: NA/dry
Water odour: NA/dry	Water surface: NA/dry
Algae on substrate: NA/dry	Algae in water column:
Emergent macrophytes: NA	Submerged macrophytes: NA
Floating macrophytes: NA/dry	
Reach observations (100 m reach, or 10 x modal width)	
Mean wetted width: 0 m	Bankfull width: NA m
Maximum depth: 0 m	Bankfull height: NA m
Habitat types: 0% riffle, 0% run, 0% sandy pool, 0% rocky pool, 100% dry

Variety of habitat: macrophytes, large woody debris	
Habitat attributes: detritus (L), sticks (L), branches (L), logs (L), macrophytes (L)	
Upstream landuse: natural	
Adjacent landuse (right bank): natural	
Adjacent landuse (left bank): natural	
Bed, edge and bank characteristics	
Bed substrates: 100% silt/clay (<0.05 mm), 0% sand (0.05-2 mm), 0% gravel (2-4 mm), 0% pebble (4-64 mm), 0% cobble (64-256 mm), 0% boulder (>256 mm), 0% bedrock	
Edge substrates: 100% silt/clay (<0.05 mm), 0% sand (0.05-2 mm), 0% gravel (2-4 mm), 0% pebble (4-64 mm), 0% cobble (64-256 mm), 0% boulder (>256 mm), 0% bedrock	
Bank soils: clay	Bank stability: stable
Bed stability: bed stable	Bank shape:
Channel shape:	Recent deposits: none detected
Local catchment erosion: cattle pugging (L)

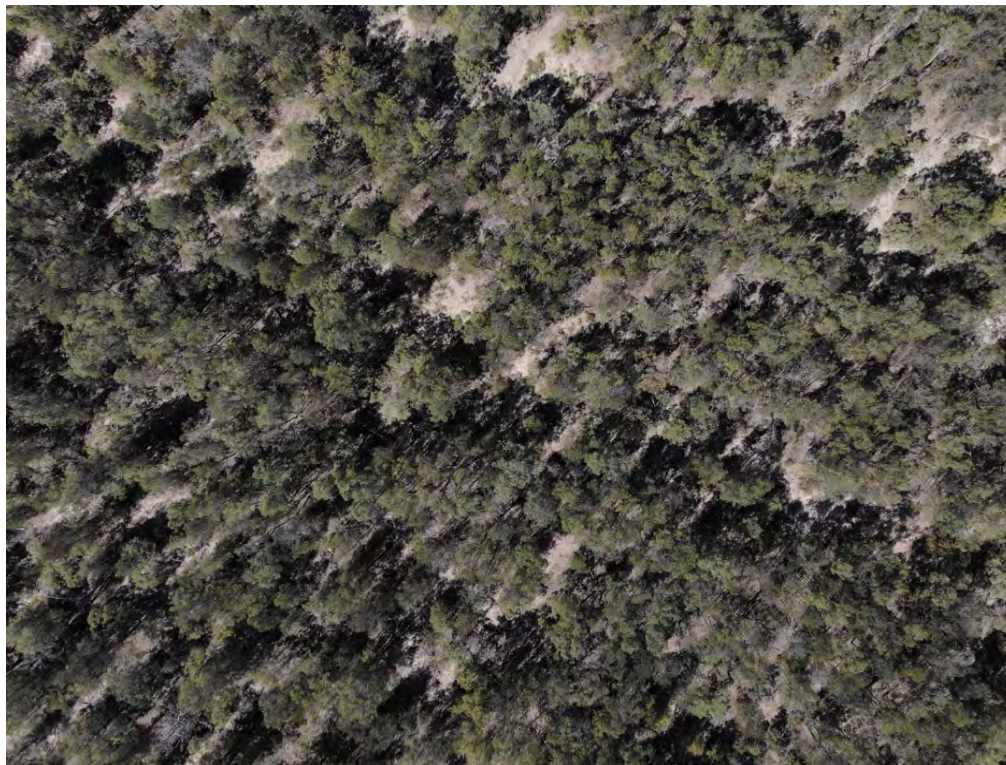
Macrophytes
Submerged macrophytes:
Floating macrophytes:
Emergent macrophytes: <i>Duma florulenta</i> (L), <i>Cyperus concinnus</i> (L), <i>Marsilea sp.</i> (L), <i>Ludwigia peploides</i> subsp. <i>montevidensis</i> (L)
Aquatic biota
Aquatic macroinvertebrate sampling undertaken: no
Habitat for platypus: unlikely
Habitat for EVNT fish species: unlikely
Fish sampling undertaken: no
Suitable habitat for EVNT turtle species: unlikely
Turtle sampling undertaken: no
Aquatic vertebrates encountered:
Notes:
Overall aquatic value: High

Aerial photograph from 100 m above ground level; upstream (left) to downstream (right)

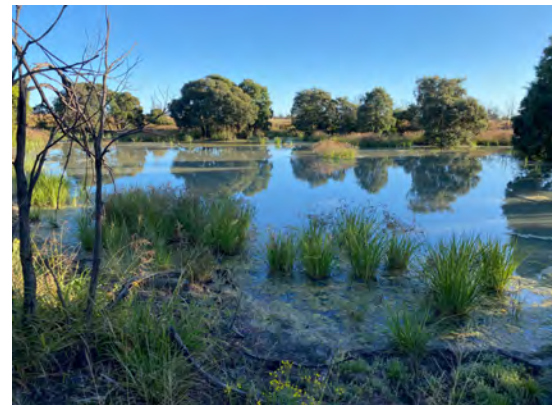
Upstream

Channel shape: U shaped
 Recent deposits: none detected |

Local catchment erosion: cattle pugging (S)

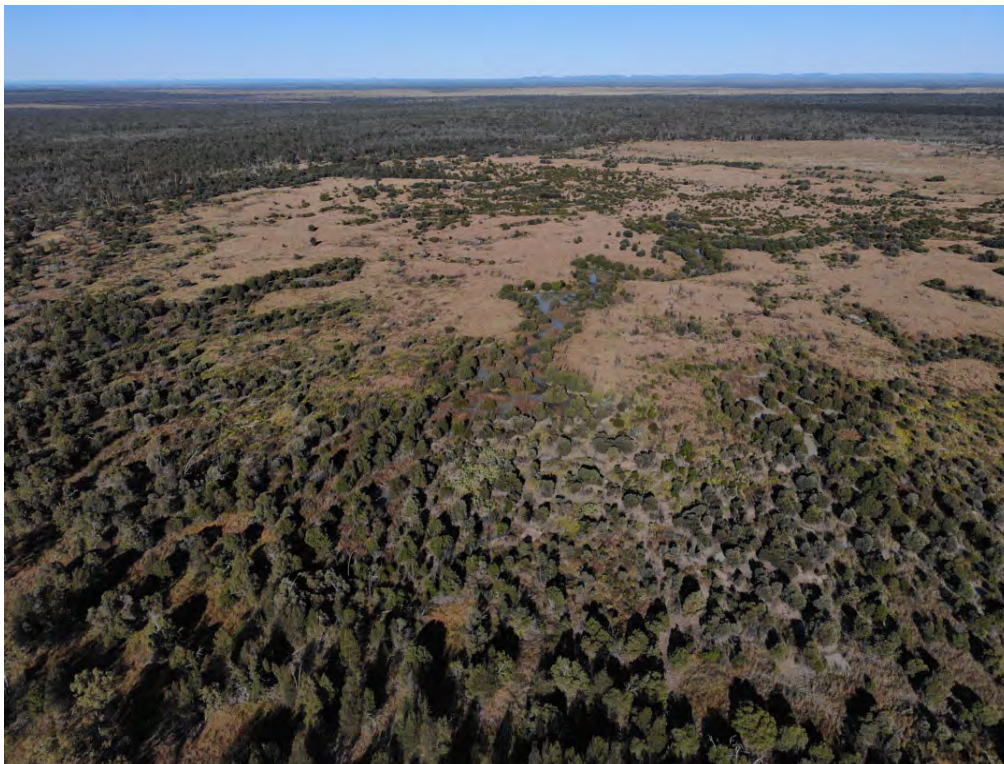
Macrophytes
Submerged macrophytes: none detected
Floating macrophytes: none detected
Emergent macrophytes: <i>Cyperus exaltatus</i> (S), <i>Ludwigia octovalvis</i> (L), <i>Marsilea drummondii</i> (S), <i>Ottelia ovalifolia</i> (L), <i>Duma florulenta</i> (L), <i>Diplachne fusca</i> (L), <i>Juncus sp.</i> (L), <i>Eleocharis blakeana</i> (L)
Aquatic biota
Aquatic macroinvertebrate sampling undertaken: no
Habitat for platypus: unlikely
Habitat for EVNT fish species: unlikely
Fish sampling undertaken: no
Suitable habitat for EVNT turtle species: unlikely
Turtle sampling undertaken: no
Aquatic vertebrates encountered:
Notes: Tree/shrub-lined gilgai depressions within broader cleared wetland.

Overall aquatic value: High (mapped HES wetland)

Aerial photograph from 100 m above ground level; upstream (left) to downstream (right)

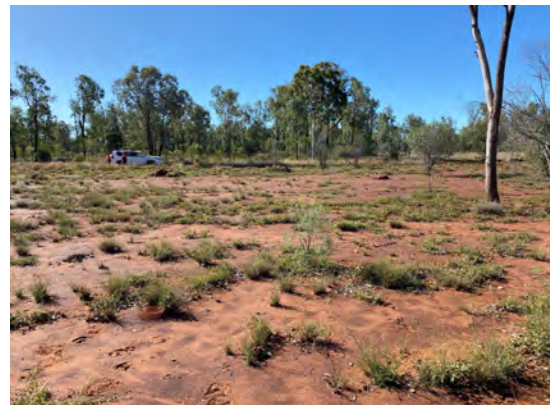
Site code: P1	Location: mapped palustrine waterbody, Togara Station
Date: 18/08/2022	Season: dry
Assessor: DM	Coordinates: -24.0025; 148.6689 (GDA 2020)
Water level: no flow - dry	Likely flow nature: not a wetland
State-mapped watercourse (DoR 2022): not applicable	
Likely a watercourse: no	
State-mapped waterway providing for fish passage (DAF 2020): no	
Water quality	
Time (EST): 14:58	Water temperature: NA/dry
Sp. Conductivity: NA/dry	pH: NA/dry
Dissolved oxygen: NA/dry	Dissolved oxygen: NA/dry
Turbidity: NA/dry	Ion sample collected: no
Observations within 2 m of sampling point	
Shading: NA/dry	Water colour: NA/dry
Water odour: NA/dry	Water surface: NA/dry
Algae on substrate: NA/dry	Algae in water column: NA/dry
Emergent macrophytes: NA	Submerged macrophytes: NA
Floating macrophytes: NA/dry	
Reach observations (100 m reach, or 10 x modal width)	
Mean wetted width: 0 m	Bankfull width: NA m
Maximum depth: 0 m	Bankfull height: NA m

Habitat types: 0% riffle, 0% run, 0% sandy pool, 0% rocky pool, 100% dry	
Variety of habitat:	
Habitat attributes: detritus (L)	
Upstream landuse: light grazing, natural	
Adjacent landuse (right bank): light grazing, natural	
Adjacent landuse (left bank): light grazing, natural	
Bed, edge and bank characteristics	
Bed substrates: 50% silt/clay (<0.05 mm), 50% sand (0.05-2 mm), 0% gravel (2-4 mm), 0% pebble (4-64 mm), 0% cobble (64-256 mm), 0% boulder (>256 mm), 0% bedrock	
Edge substrates: 50% silt/clay (<0.05 mm), 50% sand (0.05-2 mm), 0% gravel (2-4 mm), 0% pebble (4-64 mm), 0% cobble (64-256 mm), 0% boulder (>256 mm), 0% bedrock	
Bank soils: sandy loam	Bank stability: stable
Bed stability: bed stable	Bank shape:
Channel shape:	Recent deposits: none detected
Local catchment erosion: sheet (L)

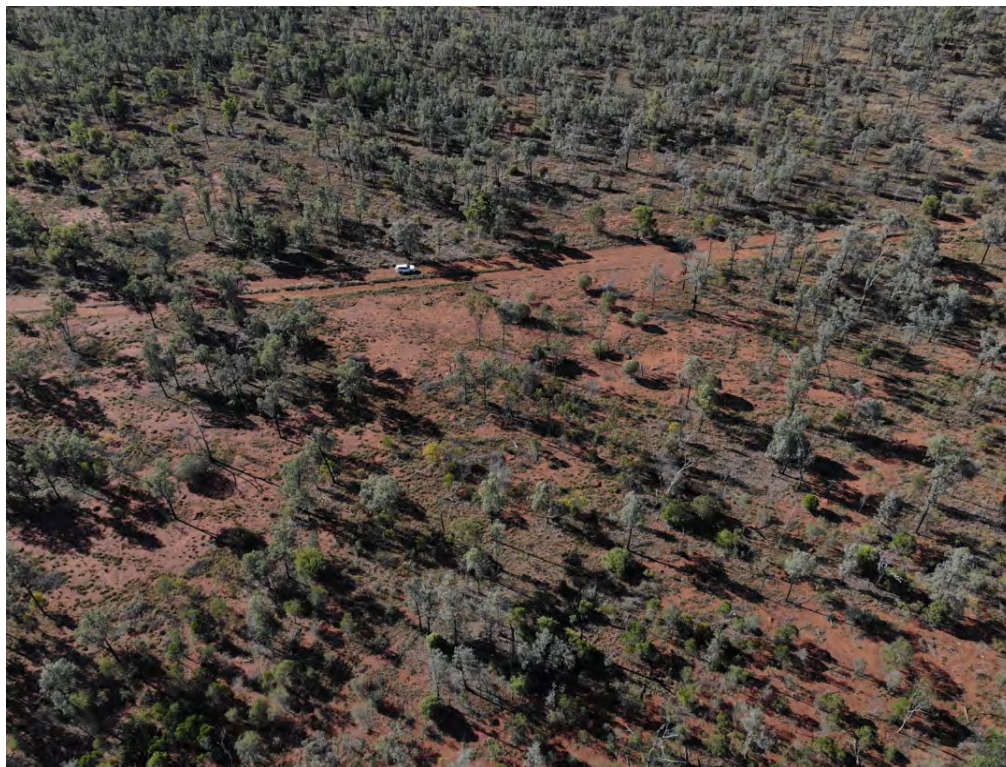
Macrophytes
Submerged macrophytes: none detected
Floating macrophytes: none detected
Emergent macrophytes: none detected
Aquatic biota
Aquatic macroinvertebrate sampling undertaken: no
Habitat for platypus: unlikely
Habitat for EVNT fish species: unlikely
Fish sampling undertaken: no
Suitable habitat for EVNT turtle species: unlikely
Turtle sampling undertaken: no
Aquatic vertebrates encountered:
Notes: no wetland features detected; unlikely to be a wetland

Overall aquatic value: Low

Aerial photograph from 100 m above ground level; upstream (left) to downstream (right)
