APPENDIX E AQUATIC VALUES ASSESSMENT REPORT

Mahalo North Coal Seam Gas Project – Aquatic Values Assessment

14 July 2023

Prepared by:
DPM Envirosiences Pty Ltd
ABN: 54 602 226 460
PO Box 1298, Mooloolaba QLD 4557
Ph: 0427 694 433

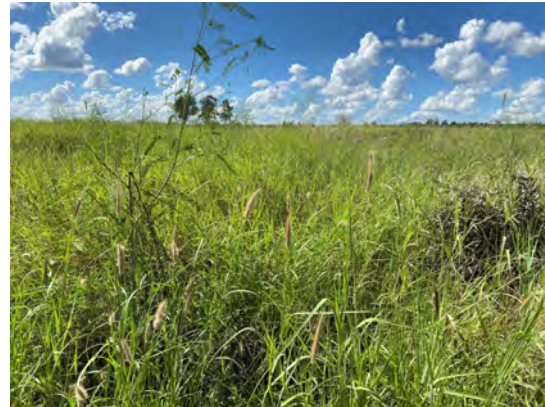
Site code: R1	Location: unnamed tributary of Comet River, Meroo Downs
Date: 15/03/2023	Season: wet
Assessor: DM	Coordinates: -24.0875; 148.6333 (GDA 2020)
Water level: no flow - dry	Likely flow nature: ephemeral
Stream order (Strahler): 1	
State-mapped watercourse (DoR 2022): no, unmapped	
Likely a watercourse: no, likely a drainage feature	
State-mapped waterway providing for fish passage (DAF 2020): yes, low risk of impact	
Water quality	
Time (EST): 15:00	Water temperature: NA/dry
Sp. Conductivity: NA/dry	pH: NA/dry
Dissolved oxygen: NA/dry	Dissolved oxygen: NA/dry
Turbidity: NA/dry	Ion sample collected: no
Observations within 2 m of sampling point	
Shading: NA/dry	Water colour: NA/dry
Water odour: NA/dry	Water surface: NA/dry
Algae on substrate: No	Algae in water column: NA/dry
Emergent macrophytes: No	Submerged macrophytes: NA
Floating macrophytes: NA/dry	
Reach observations (100 m reach, or 10 x modal width)

Mean wetted width: 0 m	Bankfull width: 10 m
Maximum depth: 0 m	Bankfull height: 1 m
Habitat types: 0% riffle, 0% run, 0% sandy pool, 0% rocky pool, 100% dry	
Variety of habitat:	
Habitat attributes:	
Upstream landuse: moderate grazing	
Adjacent landuse (right bank): moderate grazing	
Adjacent landuse (left bank): moderate grazing	
Bed, edge and bank characteristics	
Bed substrates: 91% silt/clay (<0.05 mm), 2% sand (0.05-2 mm), 5% gravel (2-4 mm), 2% pebble (4-64 mm), 0% cobble (64-256 mm), 0% boulder (>256 mm), 0% bedrock	
Edge substrates: 91% silt/clay (<0.05 mm), 2% sand (0.05-2 mm), 5% gravel (2-4 mm), 2% pebble (4-64 mm), 0% cobble (64-256 mm), 0% boulder (>256 mm), 0% bedrock	
Bank soils: gravelly clay	Bank stability: stable
Bed stability: bed stable	Bank shape: concave
Channel shape: U shaped	Recent deposits: None detected
Local catchment erosion: cattle pugging (S)

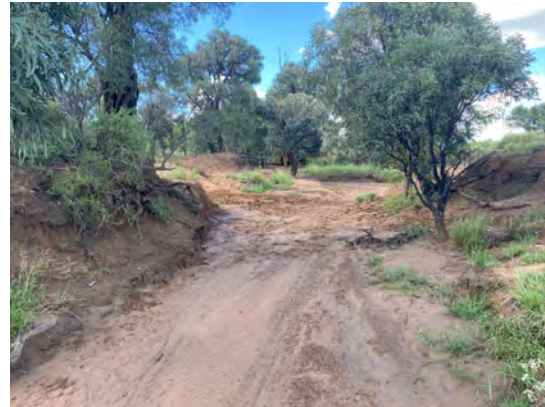
Mean wetted width: 0.5 m	Bankfull width: 20 m
Maximum depth: 0.2 m	Bankfull height: 1.7 m
Habitat types: 0% riffle, 0% run, 3% sandy pool, 0% rocky pool, 97% dry	
Variety of habitat: shallow (<0.5 m) pool, large woody debris	
Habitat attributes: detritus (L), sticks (L), branches (L), bank overhang (L), blanketing silt (L)	
Upstream landuse: moderate grazing	
Adjacent landuse (right bank): moderate grazing	
Adjacent landuse (left bank): moderate grazing	
Bed, edge and bank characteristics	
Bed substrates: 40% silt/clay (<0.05 mm), 54% sand (0.05-2 mm), 5% gravel (2-4 mm), 1% pebble (4-64 mm), 0% cobble (64-256 mm), 0% boulder (>256 mm), 0% bedrock	
Edge substrates: 60% silt/clay (<0.05 mm), 34% sand (0.05-2 mm), 5% gravel (2-4 mm), 1% pebble (4-64 mm), 0% cobble (64-256 mm), 0% boulder (>256 mm), 0% bedrock	
Bank soils: sandy clay	Bank stability: unstable
Bed stability: extensive deposition	Bank shape: concave

Channel shape: U shaped	Recent deposits: silt (S), sand (E)
Local catchment erosion: gully (E), rill (S), tunnel (L), sheet (L), bank slumping (L), cattle pugging (L)

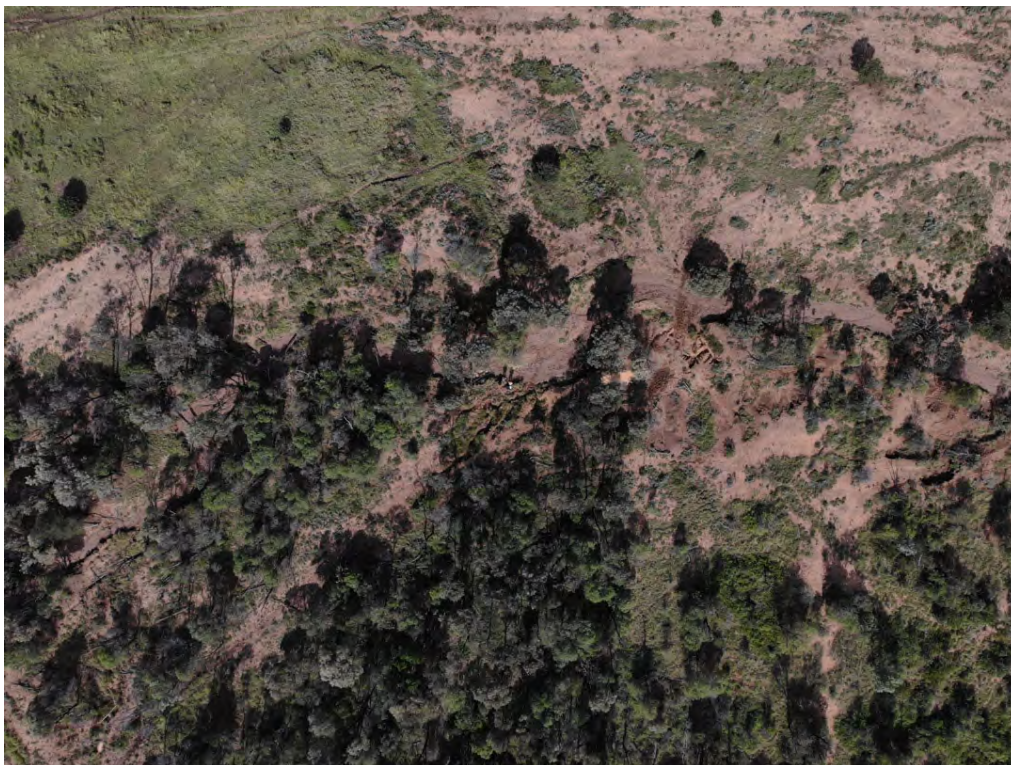
Aerial photograph from 100 m above ground level; upstream (left) to downstream (right)

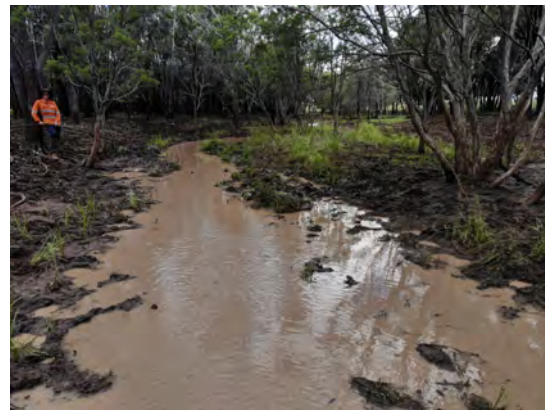
Upstream

Bed, edge and bank characteristics	
Bed substrates: 60% silt/clay (<0.05 mm), 39% sand (0.05-2 mm), 1% gravel (2-4 mm), 0% pebble (4-64 mm), 0% cobble (64-256 mm), 0% boulder (>256 mm), 0% bedrock	
Edge substrates: 80% silt/clay (<0.05 mm), 19% sand (0.05-2 mm), 1% gravel (2-4 mm), 0% pebble (4-64 mm), 0% cobble (64-256 mm), 0% boulder (>256 mm), 0% bedrock	
Bank soils: clay	Bank stability: stable
Bed stability: moderate erosion	Bank shape: concave
Channel shape: U shaped	Recent deposits: silt (E), sand (S)

Local catchment erosion: cattle pugging (E)

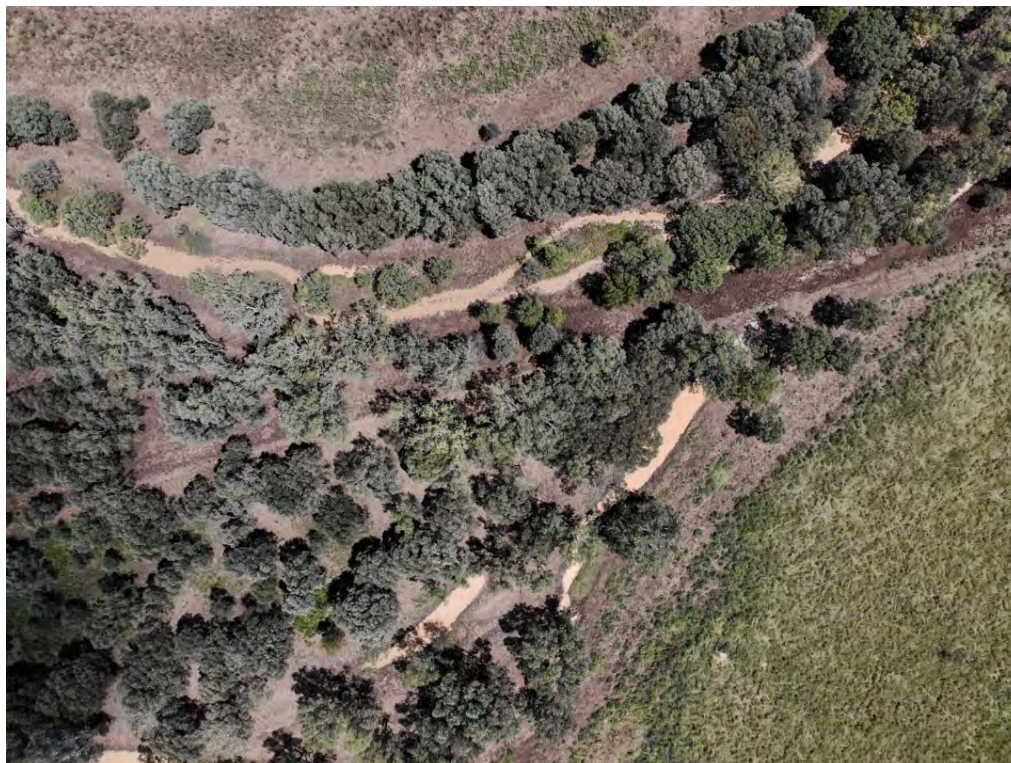
Aquatic biota	
Aquatic macroinvertebrate sampling undertaken: no	
Habitat for platypus: unlikely	
Habitat for EVNT fish species: unlikely	
Fish sampling undertaken: no	
Suitable habitat for EVNT turtle species: unlikely	
Turtle sampling undertaken: no	
Aquatic vertebrates encountered:	
Notes:	
Aquatic habitat assessment scoring	
1. Bottom substrate/available cover	5 (Poor)
2. Embeddedness	5 (Poor)
3. Velocity/depth category	6 (Fair)
4. Channel alteration	2 (Poor)
5. Bottom scouring and deposition	3 (Poor)
6. Pool/riffle, run/bend ratio	5 (Fair)
7. Bank stability	8 (Good)
8. Bank vegetative stability	2 (Poor)
9. Streamside cover	9 (Excellent)
Overall score	45 (Fair)
Notes:	
Overall aquatic value: Moderate

Aerial photograph from 100 m above ground level; upstream (left) to downstream (right)

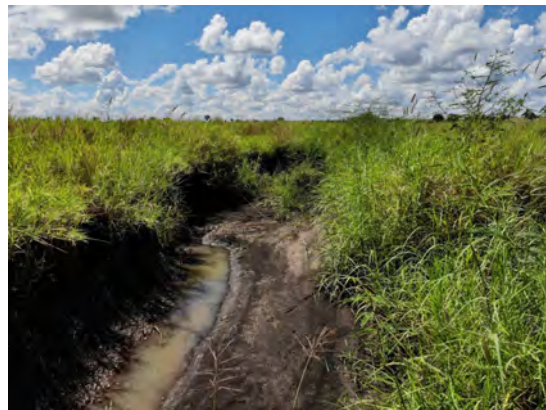
Upstream

Recent deposits: silt (L), sand (L)

Local catchment erosion: rill (L), bank slumping (L)

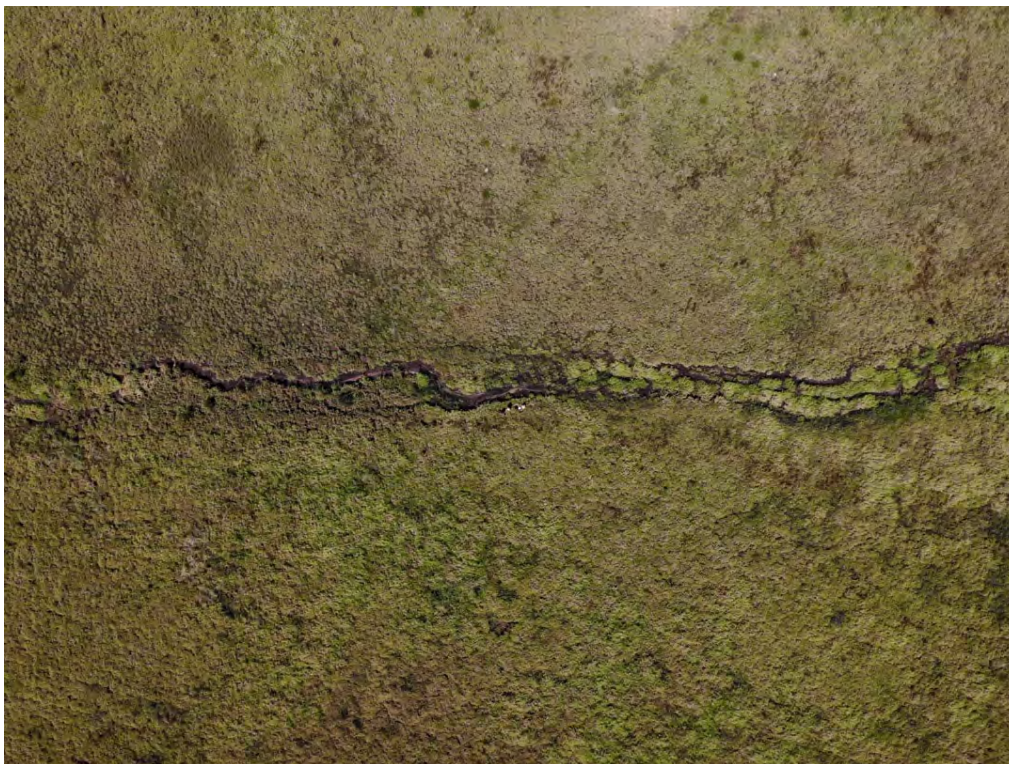
Aquatic biota	
Aquatic macroinvertebrate sampling undertaken: no	
Habitat for platypus: unlikely	
Habitat for EVNT fish species: unlikely	
Fish sampling undertaken: no	
Suitable habitat for EVNT turtle species: unlikely	
Turtle sampling undertaken: no	
Aquatic vertebrates encountered:	
Notes: I	
Aquatic habitat assessment scoring	
1. Bottom substrate/available cover	1 (Poor)
2. Embeddedness	1 (Poor)
3. Velocity/depth category	1 (Poor)
4. Channel alteration	3 (Poor)
5. Bottom scouring and deposition	3 (Poor)
6. Pool/riffle, run/bend ratio	1 (Poor)
7. Bank stability	8 (Good)
8. Bank vegetative stability	9 (Excellent)
9. Streamside cover	3 (Fair)
Overall score	30 (Poor)
Notes: Blade-ploughed paddock	
Overall aquatic value: Low

Aerial photograph from 100 m above ground level; upstream (left) to downstream (right)

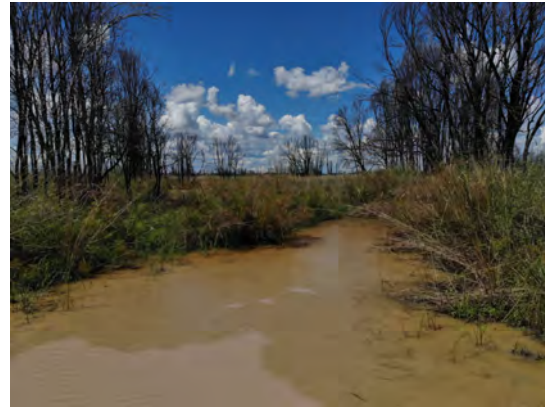
Maximum depth: 0.5 m	Bankfull height: 1 m
Habitat types: 0% riffle, 0% run, 100% sandy pool, 0% rocky pool, 0% dry	
Variety of habitat: shallow (<0.5 m) pool, macrophytes	
Habitat attributes: detritus (L), sticks (L), branches (L), periphyton (L), filamentous algae (S), macrophytes (S), bank overhang (L), trailing bank vegetation (M), blanketing silt (S)	
Upstream landuse: moderate grazing	
Adjacent landuse (right bank): moderate grazing	
Adjacent landuse (left bank): moderate grazing	
Bed, edge and bank characteristics	
Bed substrates: 95% silt/clay (<0.05 mm), 5% sand (0.05-2 mm), 0% gravel (2-4 mm), 0% pebble (4-64 mm), 0% cobble (64-256 mm), 0% boulder (>256 mm), 0% bedrock	
Edge substrates: 95% silt/clay (<0.05 mm), 5% sand (0.05-2 mm), 0% gravel (2-4 mm), 0% pebble (4-64 mm), 0% cobble (64-256 mm), 0% boulder (>256 mm), 0% bedrock	
Bank soils: clay	Bank stability: moderately stable
Bed stability: moderate deposition	Bank shape: concave

Channel shape: U shaped	Recent deposits: silt (S), sand (L)
Local catchment erosion: gully (L), rill (L), cattle pugging (S)

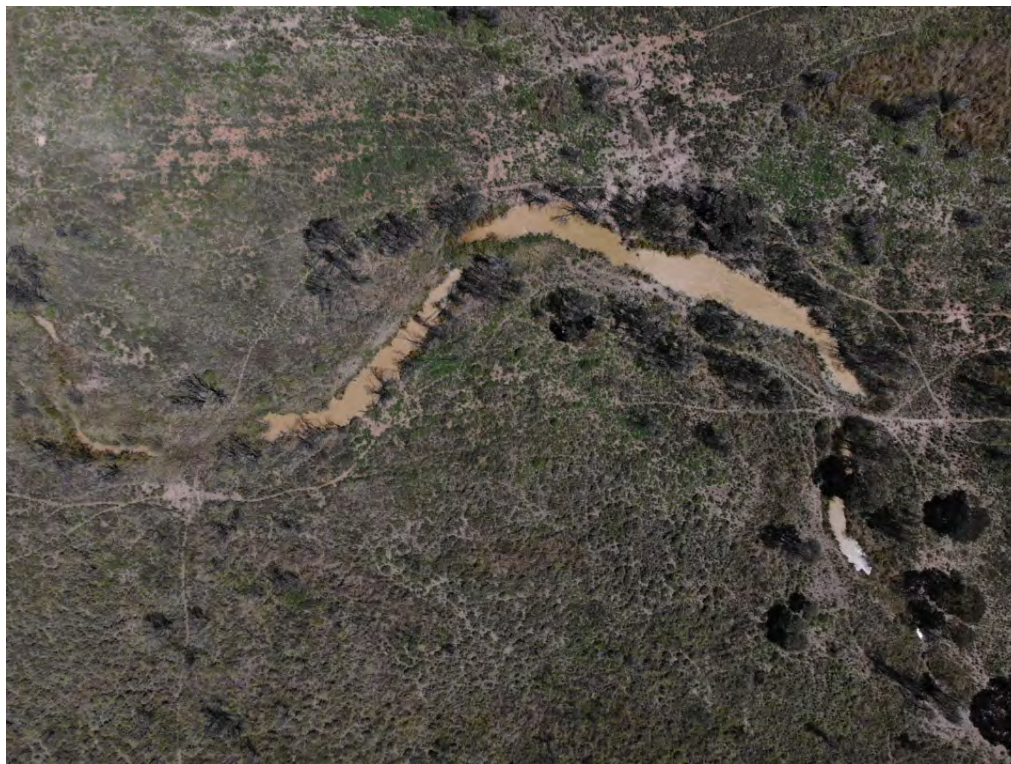
Aquatic biota	
Aquatic macroinvertebrate sampling undertaken: no	
Habitat for platypus: unlikely	
Habitat for EVNT fish species: unlikely	
Fish sampling undertaken: no	
Suitable habitat for EVNT turtle species: unlikely	
Turtle sampling undertaken: no	
Aquatic vertebrates encountered:	
Notes:	
Aquatic habitat assessment scoring	
1. Bottom substrate/available cover	1 (Poor)
2. Embeddedness	1 (Poor)
3. Velocity/depth category	3 (Poor)
4. Channel alteration	3 (Poor)
5. Bottom scouring and deposition	3 (Poor)
6. Pool/riffle, run/bend ratio	4 (Fair)
7. Bank stability	7 (Good)
8. Bank vegetative stability	8 (Good)
9. Streamside cover	5 (Fair)
Overall score	35 (Poor)
Notes:	
Overall aquatic value: Low

Aerial photograph from 100 m above ground level; upstream (left) to downstream (right)

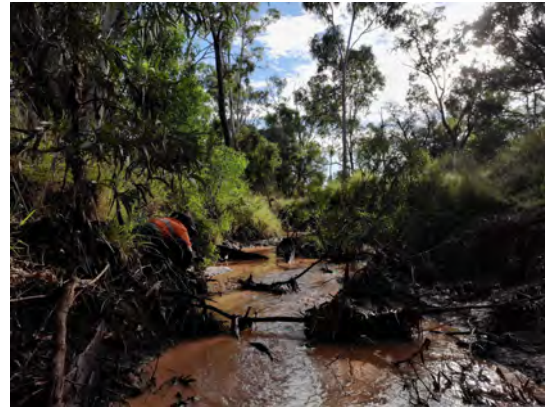
Mean wetted width: 2.5 m	Bankfull width: 12 m
Maximum depth: 0.5 m	Bankfull height: 2 m
Habitat types: 10% riffle, 70% run, 10% sandy pool, 10% rocky pool, 0% dry	
Variety of habitat: shallow (<0.5 m), pool, run, riffle, large woody debris	
Habitat attributes: detritus (L), sticks (L), branches (L), logs (L), bank overhang (L), blanketing silt (L)	
Upstream landuse: moderate grazing	
Adjacent landuse (right bank): moderate grazing, natural	
Adjacent landuse (left bank): moderate grazing, natural	
Bed, edge and bank characteristics	
Bed substrates: 45% silt/clay (<0.05 mm), 10% sand (0.05-2 mm), 2% gravel (2-4 mm), 40% pebble (4-64 mm), 3% cobble (64-256 mm), 0% boulder (>256 mm), 0% bedrock	
Edge substrates: 82% silt/clay (<0.05 mm), 15% sand (0.05-2 mm), 1% gravel (2-4 mm), 1% pebble (4-64 mm), 1% cobble (64-256 mm), 0% boulder (>256 mm), 0% bedrock	
Bank soils: sandy loam	Bank stability: moderately unstable

Bed stability: bed stable	Bank shape: concave
Channel shape: U shaped	Recent deposits: silt (S), sand (L)
Local catchment erosion: gully (L), rill (L), bank slumping (S), cattle pugging (L)

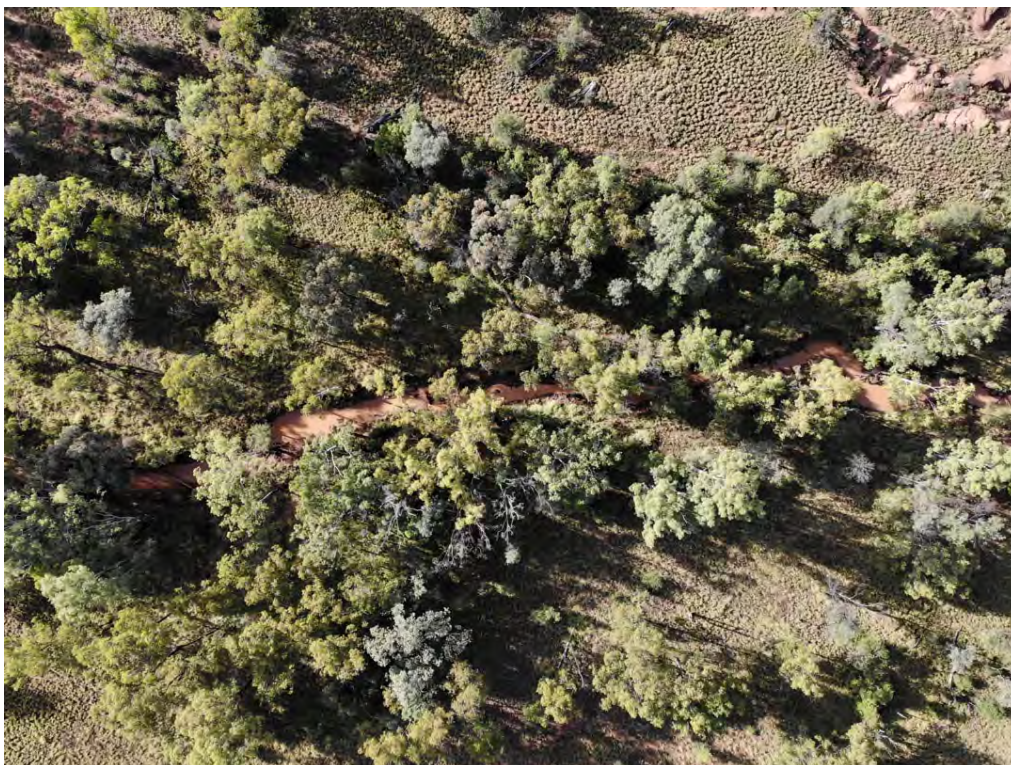
Aquatic habitat assessment scoring	
1. Bottom substrate/available cover	15 (Good)
2. Embeddedness	15 (Good)
3. Velocity/depth category	10 (Fair)
4. Channel alteration	10 (Good)
5. Bottom scouring and deposition	7 (Fair)
6. Pool/riffle, run/bend ratio	5 (Fair)
7. Bank stability	5 (Fair)
8. Bank vegetative stability	7 (Good)
9. Streamside cover	9 (Excellent)
Overall score	83 (Good)
Notes:

Overall aquatic value: Moderate

Aerial photograph from 100 m above ground level; upstream (left) to downstream (right)

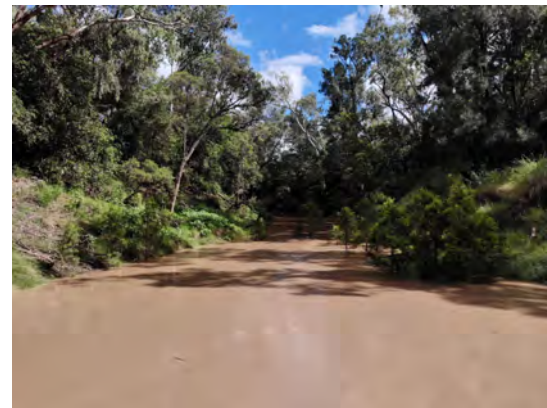
Upstream

Channel shape: U shaped
 Recent deposits: silt (S), sand (S) |

Local catchment erosion: bank slumping (L)

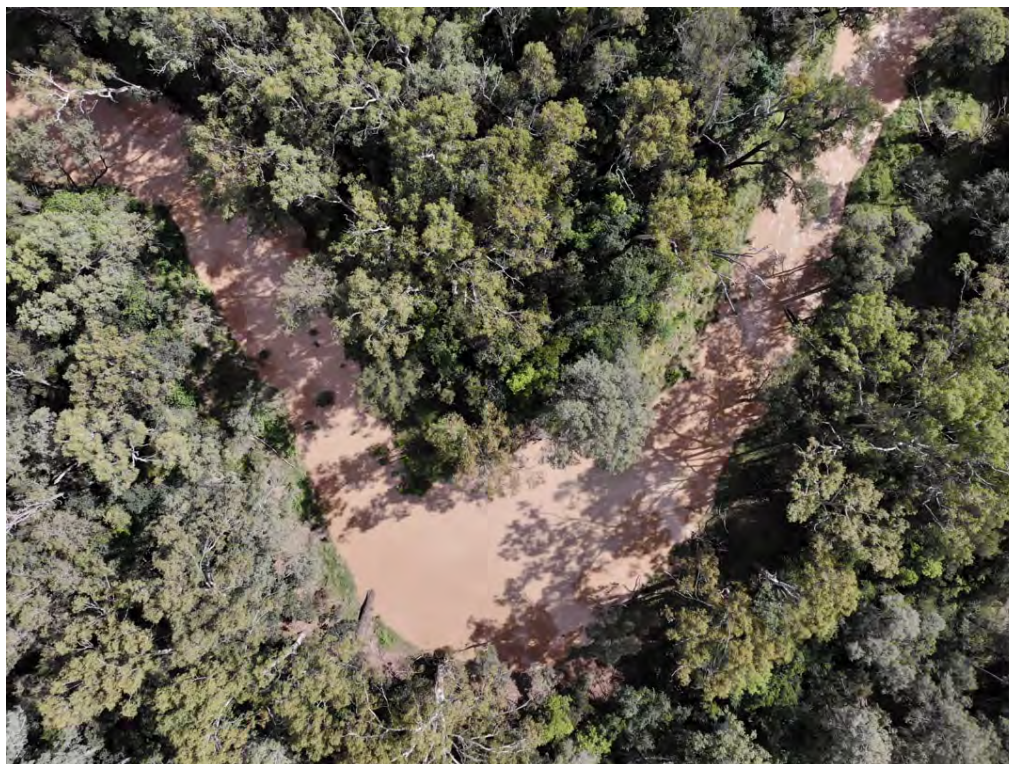
1. Bottom substrate/available cover	3 (Poor)
2. Embeddedness	3 (Poor)
3. Velocity/depth category	16 (Excellent)
4. Channel alteration	5 (Fair)
5. Bottom scouring and deposition	3 (Poor)

6. Pool/riffle, run/bend ratio	6 (Fair)
7. Bank stability	8 (Good)
8. Bank vegetative stability	10 (Excellent)
9. Streamside cover	10 (Excellent)
Overall score	64 (Fair)
Notes: 2 x baited fyke nets deployed for 1 night	
Overall aquatic value: High

Aerial photograph from 100 m above ground level; upstream (left) to downstream (right)

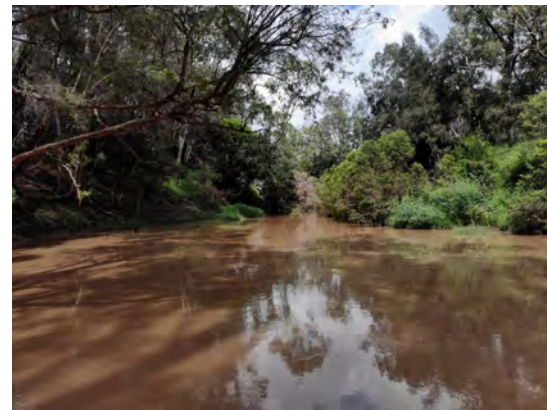
Upstream

Channel shape: U shaped
 Recent deposits: silt (S), sand (S) |

Local catchment erosion: cattle pugging (L)

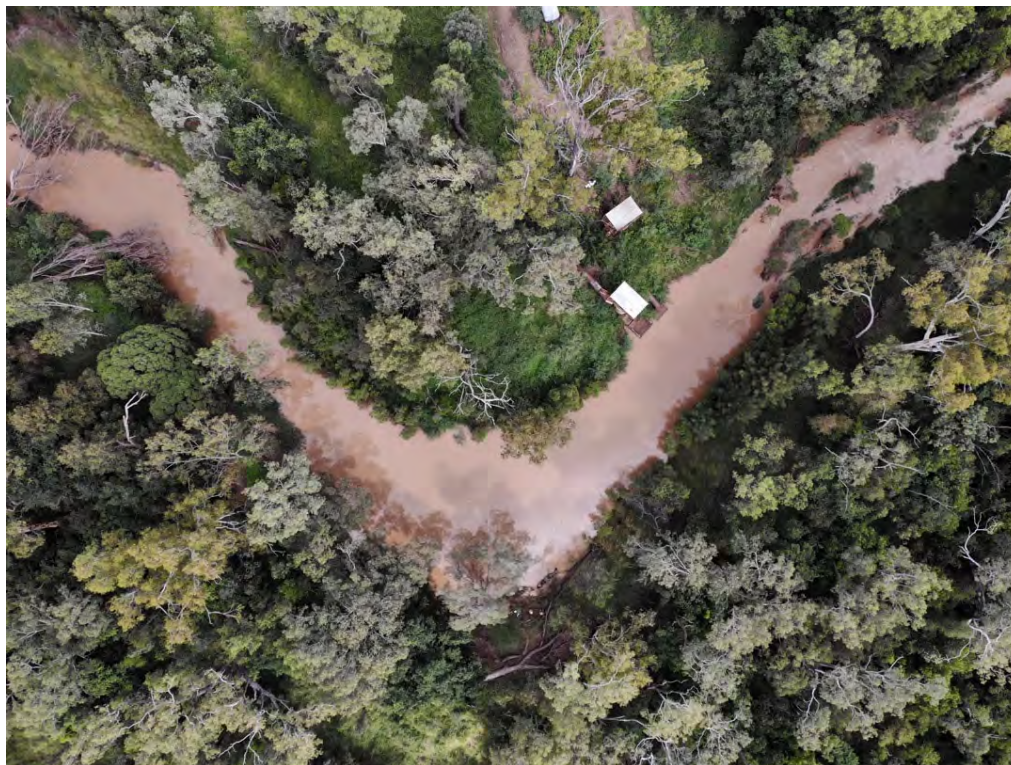
Aquatic habitat assessment scoring	
1. Bottom substrate/available cover	3 (Poor)
2. Embeddedness	3 (Poor)
3. Velocity/depth category	12 (Good)
4. Channel alteration	5 (Fair)
5. Bottom scouring and deposition	3 (Poor)
6. Pool/riffle, run/bend ratio	6 (Fair)
7. Bank stability	8 (Good)
8. Bank vegetative stability	10 (Excellent)
9. Streamside cover	10 (Excellent)
Overall score	60 (Fair)

Notes:
 Overall aquatic value: High

Aerial photograph from 100 m above ground level; upstream (left) to downstream (right)

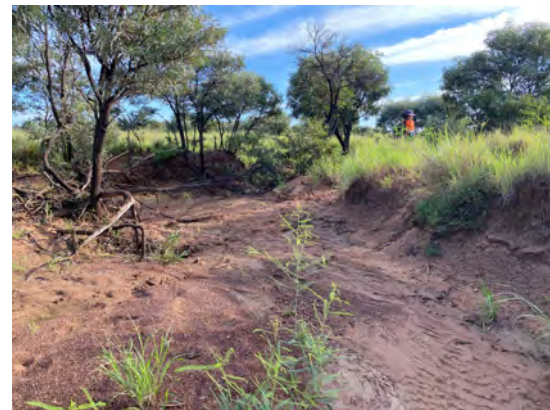
Upstream

Bed substrates: 20% silt/clay (<0.05 mm), 70% sand (0.05-2 mm), 5% gravel (2-4 mm), 5% pebble (4-64 mm), 0% cobble (64-256 mm), 0% boulder (>256 mm), 0% bedrock	
Edge substrates: 50% silt/clay (<0.05 mm), 40% sand (0.05-2 mm), 5% gravel (2-4 mm), 5% pebble (4-64 mm), 0% cobble (64-256 mm), 0% boulder (>256 mm), 0% bedrock	
Bank soils: loamy clay	Bank stability: unstable
Bed stability: moderate deposition	Bank shape: concave
Channel shape: U shaped	Recent deposits: silt (S), sand (S)

Local catchment erosion: gully (M), rill (S), tunnel (L), bank slumping (S), cattle pugging (S)

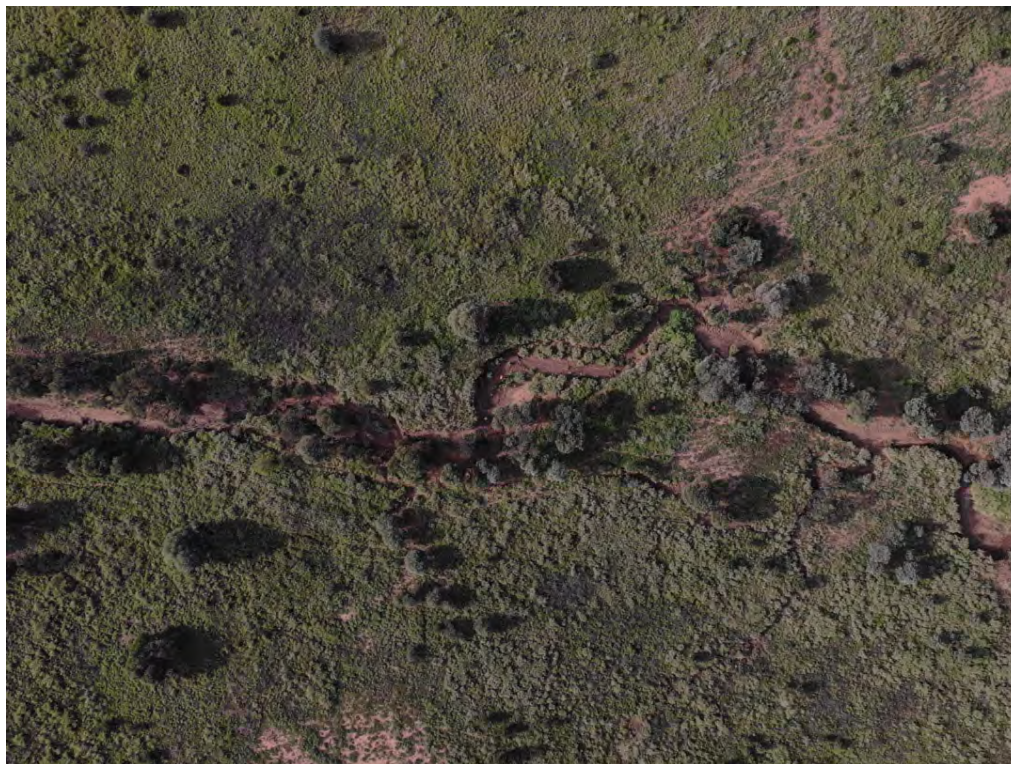
Aquatic biota	
Aquatic macroinvertebrate sampling undertaken: no	
Habitat for platypus: unlikely	
Habitat for EVNT fish species: unlikely	
Fish sampling undertaken: no	
Suitable habitat for EVNT turtle species: unlikely	
Turtle sampling undertaken: no	
Aquatic vertebrates encountered:	
Notes:	
Aquatic habitat assessment scoring	
1. Bottom substrate/available cover	2 (Poor)
2. Embeddedness	2 (Poor)
3. Velocity/depth category	0 (Poor)
4. Channel alteration	5 (Fair)
5. Bottom scouring and deposition	3 (Poor)
6. Pool/riffle, run/bend ratio	4 (Fair)
7. Bank stability	2 (Poor)
8. Bank vegetative stability	5 (Fair)
9. Streamside cover	9 (Excellent)
Overall score	32 (Poor)
Notes:	
Overall aquatic value: Low

Aerial photograph from 100 m above ground level; upstream (left) to downstream (right)

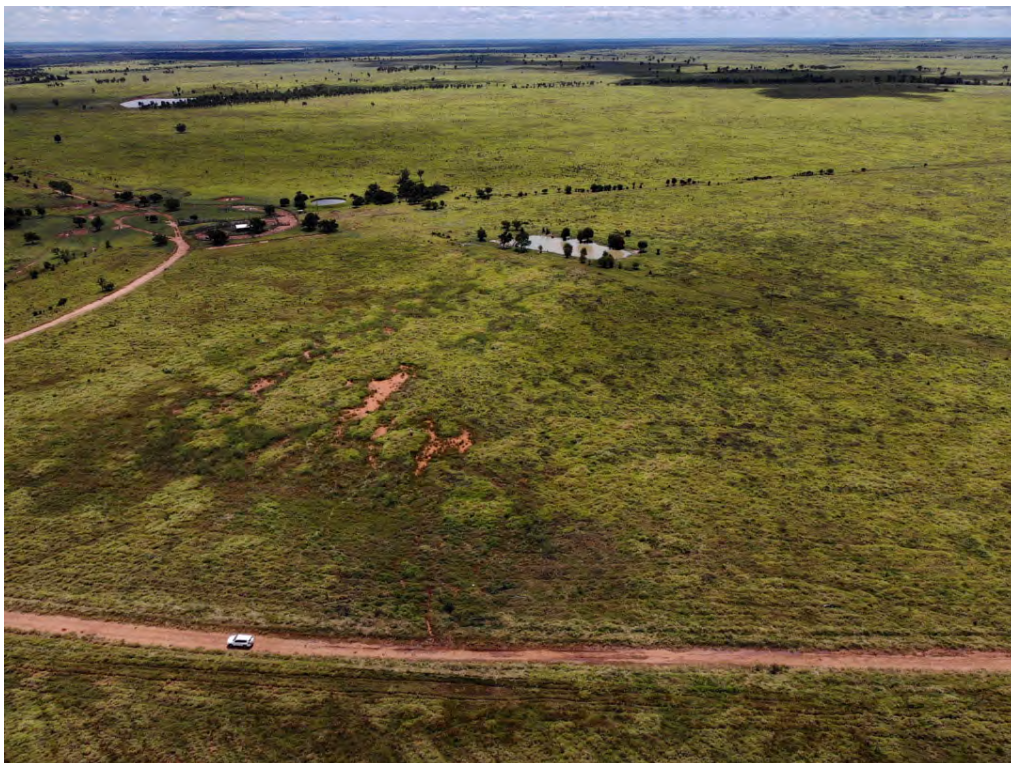
Overall aquatic value: Low

Aerial photograph from 100 m above ground level; upstream (left) to downstream (right)

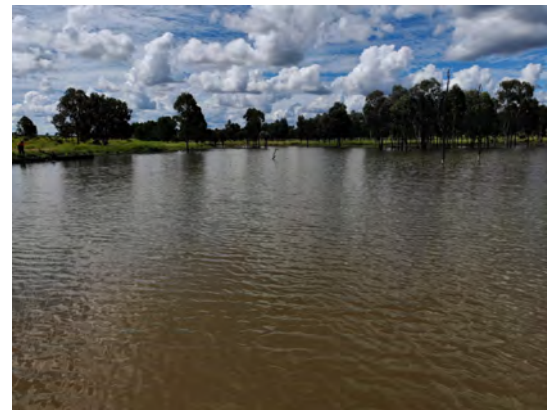
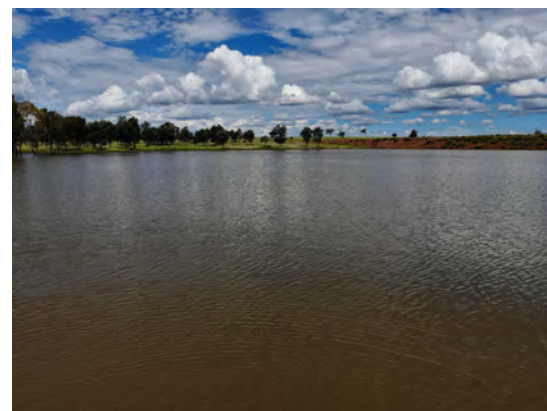
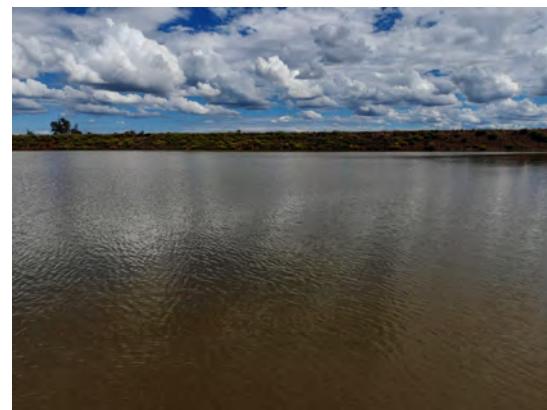
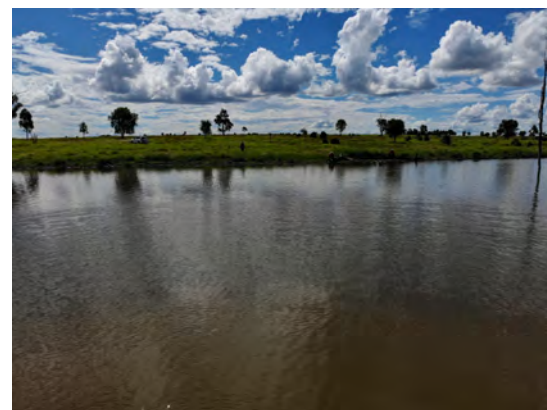
Bed substrates: 80% silt/clay (<0.05 mm), 20% sand (0.05-2 mm), 0% gravel (2-4 mm), 0% pebble (4-64 mm), 0% cobble (64-256 mm), 0% boulder (>256 mm), 0% bedrock	
Edge substrates: 80% silt/clay (<0.05 mm), 20% sand (0.05-2 mm), 0% gravel (2-4 mm), 0% pebble (4-64 mm), 0% cobble (64-256 mm), 0% boulder (>256 mm), 0% bedrock	
Bank soils: sandy clay	Bank stability: moderately unstable
Bed stability: bed stable	Bank shape: concave
Channel shape: U shaped	Recent deposits: none detected

Local catchment erosion: sheet (L), cattle pugging (L)

Riparian vegetation	
Cover	
Width of riparian zone on left bank: 5 m	Width of riparian zone on right bank: 5 m
Bare ground: L	Grasses/forbs: E
Shrubs: L	Trees <10 m: S
Trees >10m: N	Exotic riparian species: E
Composition and health	
State-mapped RE: Non-remnant	Verified RE: Non-remnant
Vegetation status: regrowth	Dominant stratum: tree
Health: average	Dieback: not detected
EDL height: 8 m	EDL cover: 35%
Canopy species: <i>Eucalyptus populnea</i> (D), <i>Acacia harpophylla</i> (O), <i>Acacia salicina</i> (O)	
Sub-canopy species:	
Shrub species: <i>Acacia harpophylla</i> (R), <i>Ficus opposita</i> (O)	
Ground species: <i>Cenchrus ciliaris</i> * (D), <i>Urochloa mosambicensis</i> * (F), <i>Bothriochloa</i> sp. (O), <i>Glinus lotoides</i> (O), <i>Gomphrena celosioides</i> * (O), <i>Eragrostis</i> sp. (O), <i>Centipeda minima</i> (O), <i>Cynodon dactylon</i> var. <i>dactylon</i> * (O)

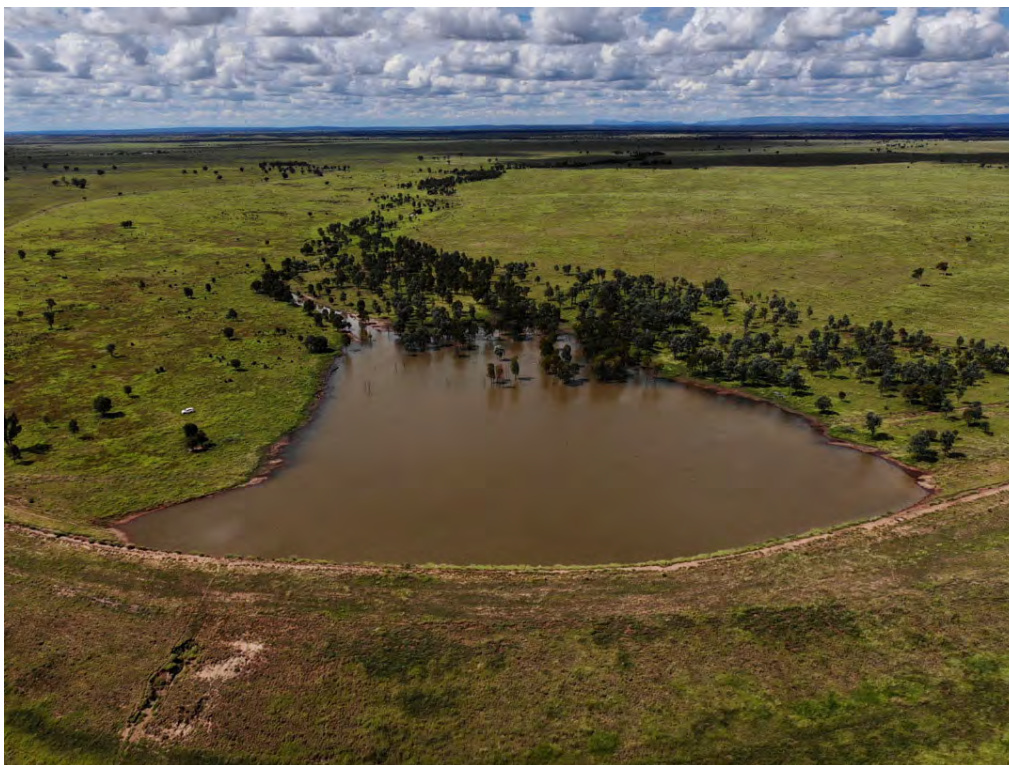
Macrophytes
Submerged macrophytes: None detected
Floating macrophytes: None detected
Emergent macrophytes: None detected
Aquatic biota
Aquatic macroinvertebrate sampling undertaken: no
Habitat for platypus: unlikely
Habitat for EVNT fish species: unlikely
Fish sampling undertaken: no
Suitable habitat for EVNT turtle species: unlikely
Turtle sampling undertaken: no
Aquatic vertebrates encountered:
Notes:
Notes:
Overall aquatic value: Low

Aerial photograph from 100 m above ground level; upstream (left) to downstream (right)

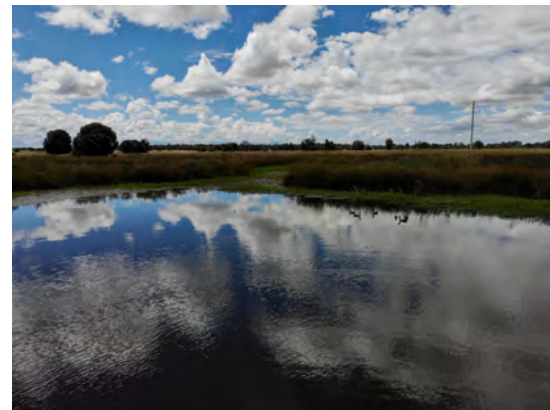
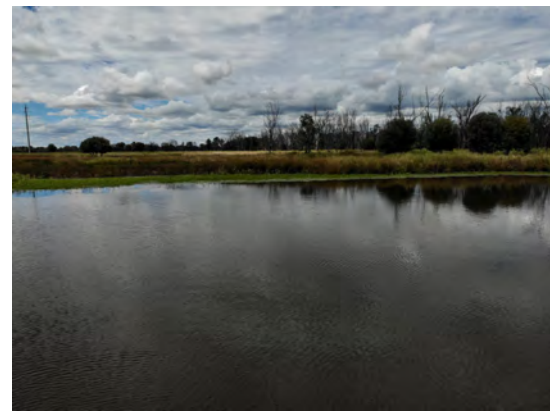
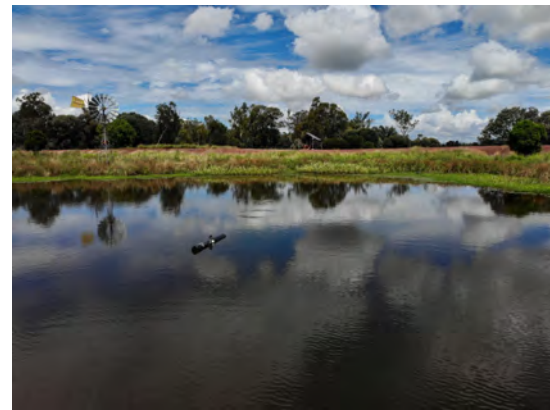
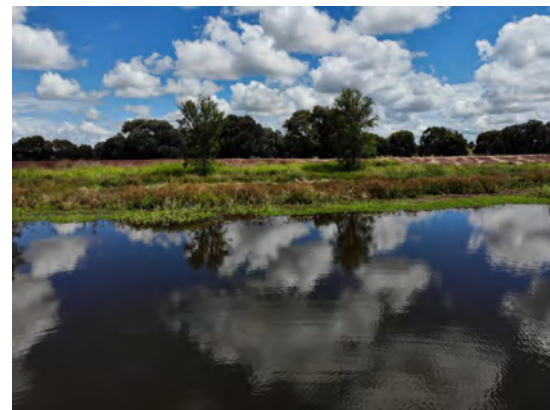
Recent deposits: None detected

Local catchment erosion: gully (L), rill (L), bank slumping (L)

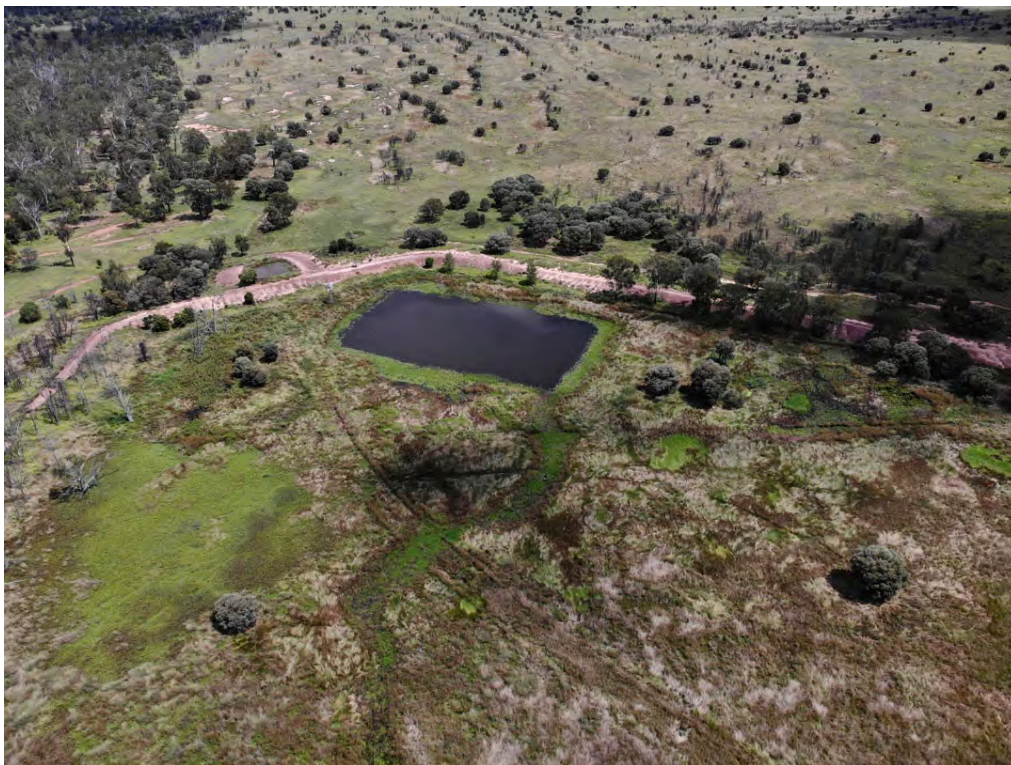
Aquatic vertebrates encountered:
Notes:
Overall aquatic value: Low

Aerial photograph from 100 m above ground level; upstream (left) to downstream (right)

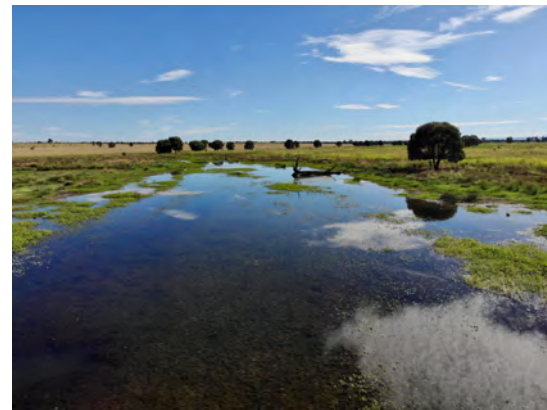
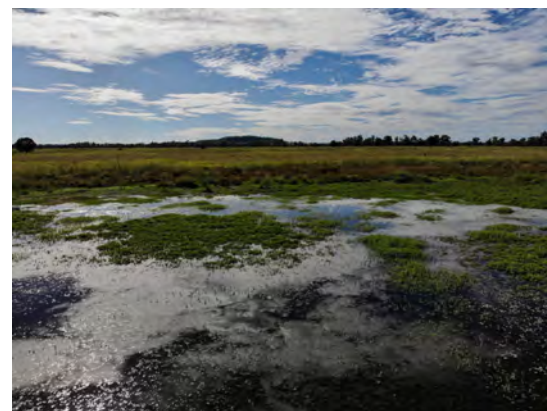
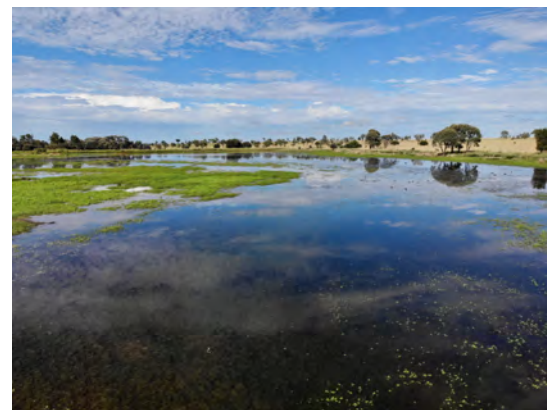
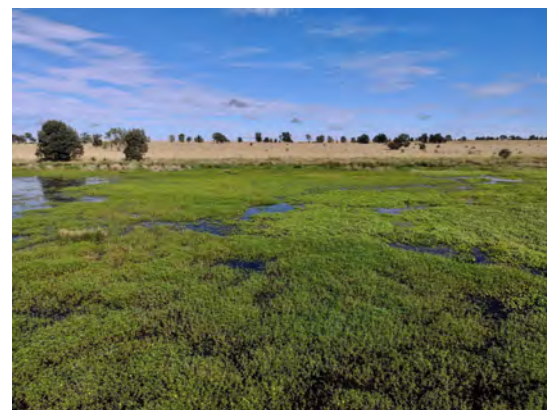
Bank soils: sandy clay	Bank stability: stable
Bed stability: bed stable	Bank shape: concave
Channel shape: U shaped	Recent deposits: none detected

Local catchment erosion: cattle pugging (L)

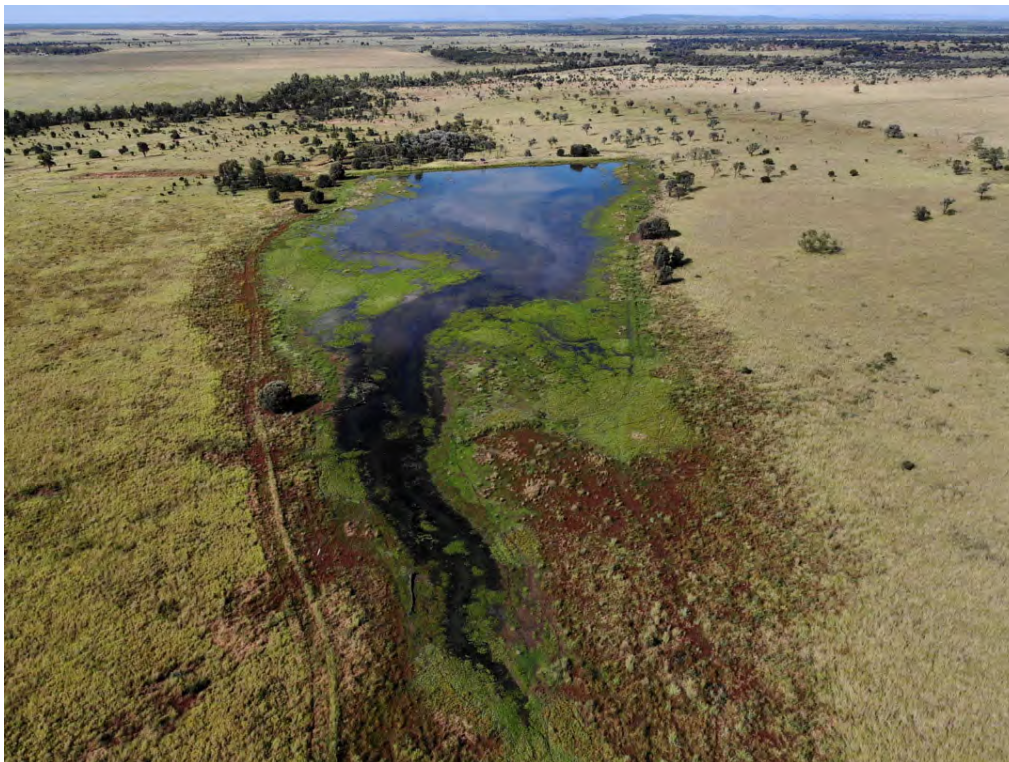
Aquatic vertebrates encountered:
Notes:
Overall aquatic value: Low

Aerial photograph from 100 m above ground level; upstream (left) to downstream (right)

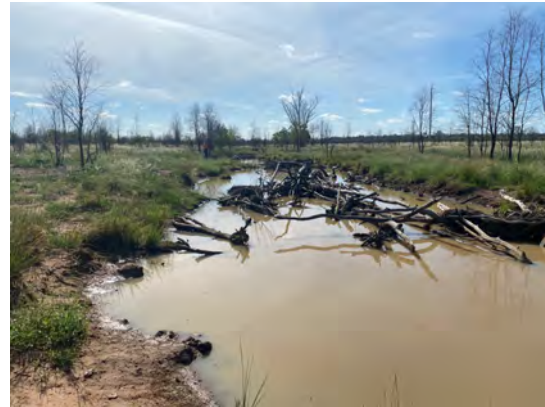
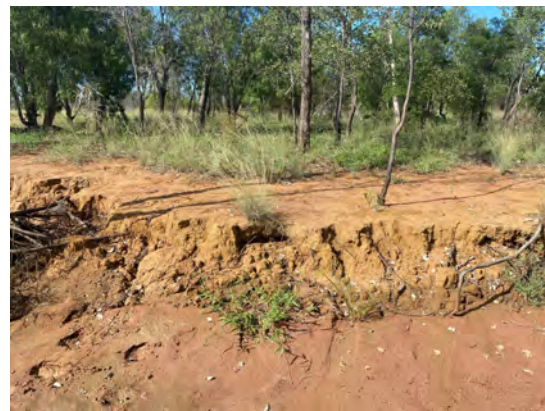
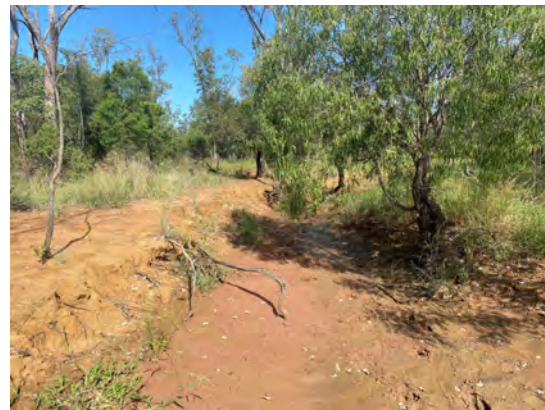
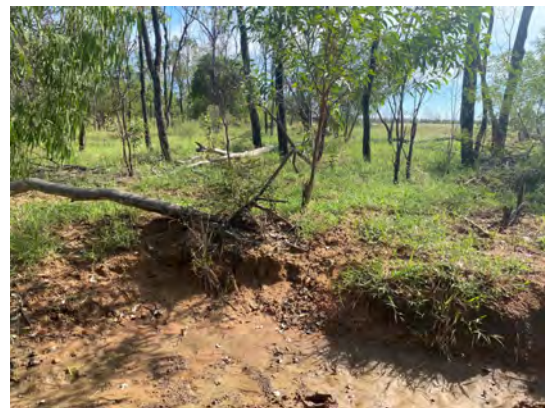
Mean wetted width: 2.5 m	Bankfull width: 4 m
Maximum depth: 0.4 m	Bankfull height: 1 m
Habitat types: 0% riffle, 0% run, 20% sandy pool, 0% rocky pool, 80% dry	
Variety of habitat: large woody debris	
Habitat attributes: detritus (L), sticks (L), branches (L) blanketing silt (L)	
Upstream landuse: moderate grazing	
Adjacent landuse (right bank): moderate grazing	
Adjacent landuse (left bank): moderate grazing	
Bed, edge and bank characteristics	
Bed substrates: 10% silt/clay (<0.05 mm), 90% sand (0.05-2 mm), 0% gravel (2-4 mm), 0% pebble (4-64 mm), 0% cobble (64-256 mm), 0% boulder (>256 mm), 0% bedrock	
Edge substrates: 10% silt/clay (<0.05 mm), 90% sand (0.05-2 mm), 0% gravel (2-4 mm), 0% pebble (4-64 mm), 0% cobble (64-256 mm), 0% boulder (>256 mm), 0% bedrock	
Bank soils: loamy sand	Bank stability: moderately stable
Bed stability: moderate deposition	Bank shape: concave
Channel shape: U shaped	Recent deposits: Silt (L), sand (M)

Local catchment erosion: gully (L), rill (L), bank slumping (L), cattle pugging (L)

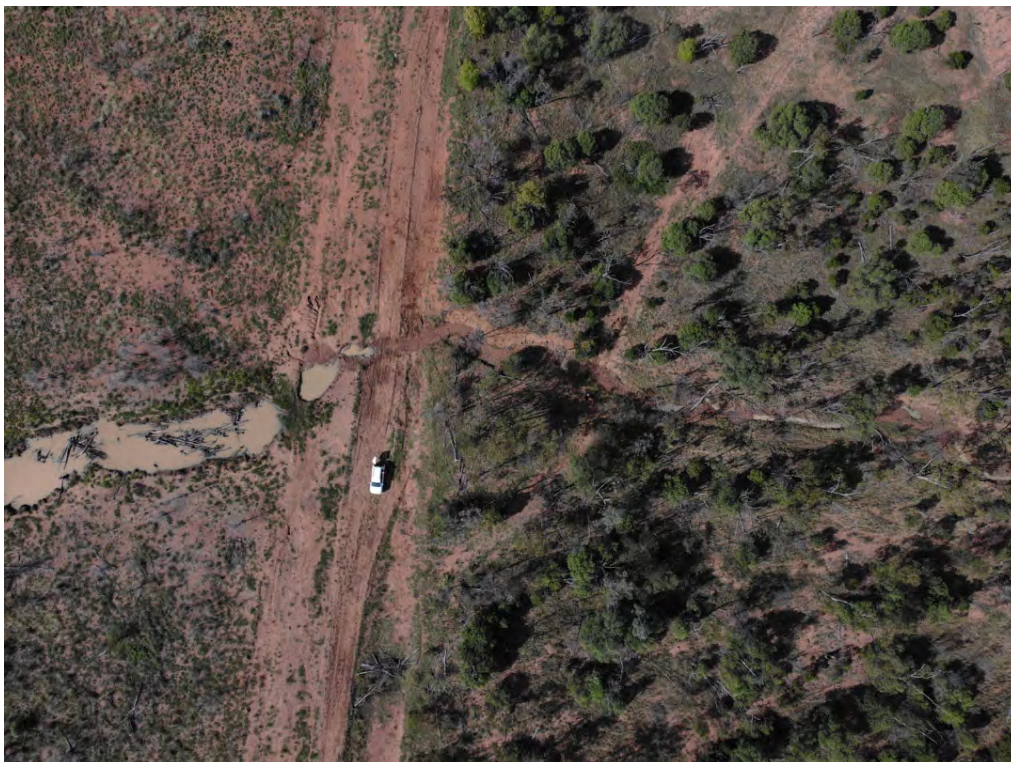
Overall aquatic value: High (mapped HES wetland)

Aerial photograph from 100 m above ground level; upstream (left) to downstream (right)

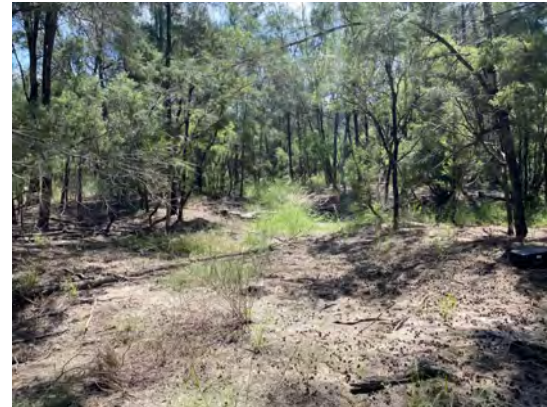
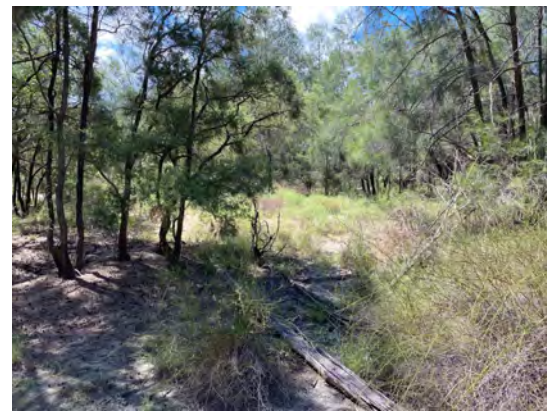
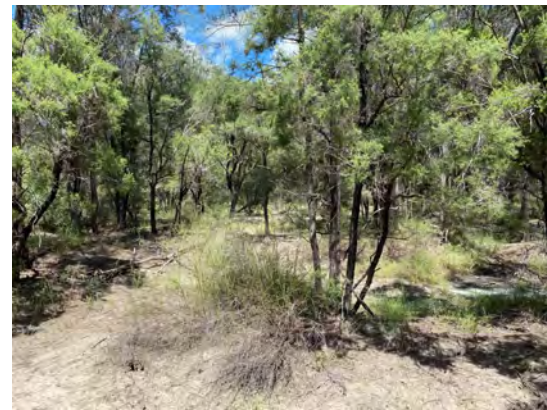
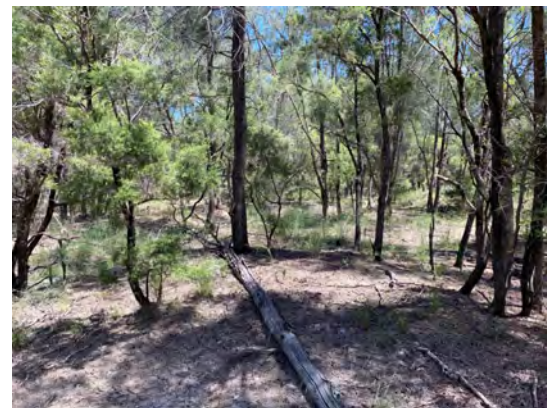
Site code: HES4	Location: HES wetland, Togara Station
Date: 16/03/2023	Season: wet
Assessor: DM	Coordinates: -23.9917; 148.6177 (GDA 2020)
Water level: no flow - isolated	Likely flow nature: episodic
State-mapped watercourse (DoR 2022): not applicable	
Likely a watercourse:	
State-mapped waterway providing for fish passage (DAF 2020): no	
Water quality	
Time (EST): 11:53	Water temperature: 31°C
Sp. Conductivity: 121 µS/cm	pH: 6.5
Dissolved oxygen: 51.1%	Dissolved oxygen: 3.71 mg/L
Turbidity: NTU	Ion sample collected: yes
Observations within 2 m of sampling point	
Shading: 10%	Water colour: opaque
Water odour: none detected	Water surface: normal
Algae on substrate: N	Algae in water column: N
Emergent macrophytes: L	Submerged macrophytes: N
Floating macrophytes: N	
Reach observations (100 m reach, or 10 x modal width)	
Mean wetted width: 1 m	Bankfull width: NA m
Maximum depth: 0.2 m	Bankfull height: NA m
Habitat types: 0% riffle, 0% run, 1% sandy pool, 0% rocky pool, 99% dry

Variety of habitat: shallow (<0.5 m) pool, macrophytes, large woody debris	
Habitat attributes: detritus (L), sticks (L), branches (L), logs (L), macrophytes (L)	
Upstream landuse: natural	
Adjacent landuse (right bank): natural	
Adjacent landuse (left bank): natural	
Bed, edge and bank characteristics	
Bed substrates: 100% silt/clay (<0.05 mm), 0% sand (0.05-2 mm), 0% gravel (2-4 mm), 0% pebble (4-64 mm), 0% cobble (64-256 mm), 0% boulder (>256 mm), 0% bedrock	
Edge substrates: 100% silt/clay (<0.05 mm), 0% sand (0.05-2 mm), 0% gravel (2-4 mm), 0% pebble (4-64 mm), 0% cobble (64-256 mm), 0% boulder (>256 mm), 0% bedrock	
Bank soils: clay	Bank stability: stable
Bed stability: bed stable	Bank shape:
Channel shape:	Recent deposits: none detected
Local catchment erosion: none detected

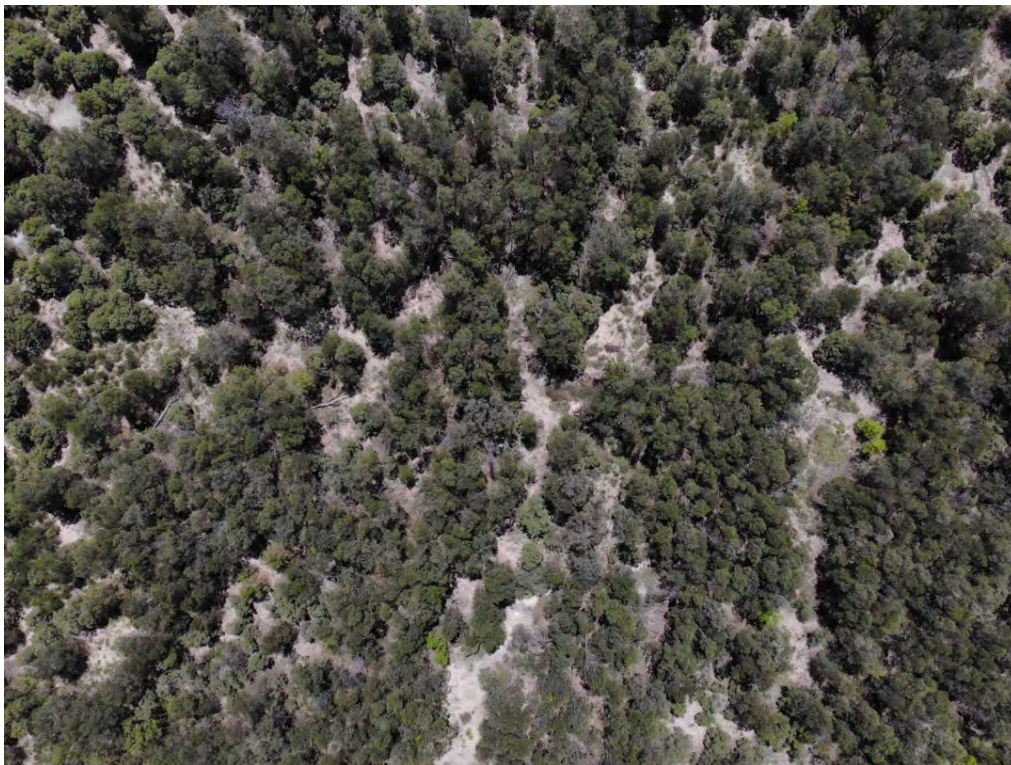
Macrophytes
Submerged macrophytes:
Floating macrophytes:
Emergent macrophytes: <i>Duma florulenta</i> (L), <i>Cyperus concinnus</i> (L), <i>Marsilea</i> sp. (L), <i>Diplachne fusca</i> (L), <i>Walwhalleya subxerophila</i> (L)
Aquatic biota
Aquatic macroinvertebrate sampling undertaken: no
Habitat for platypus: unlikely
Habitat for EVNT fish species: unlikely
Fish sampling undertaken: no
Suitable habitat for EVNT turtle species: unlikely
Turtle sampling undertaken: no
Aquatic vertebrates encountered:
Notes:
Overall aquatic value: high

Aerial photograph from 100 m above ground level; upstream (left) to downstream (right)
