APPENDIX E AQUATIC VALUES ASSESSMENT REPORT

Mahalo North Coal Seam Gas Project – Aquatic Values Assessment

14 July 2023

Prepared by:
DPM Envirosiences Pty Ltd
ABN: 54 602 226 460
PO Box 1298, Mooloolaba QLD 4557
Ph: 0427 694 433

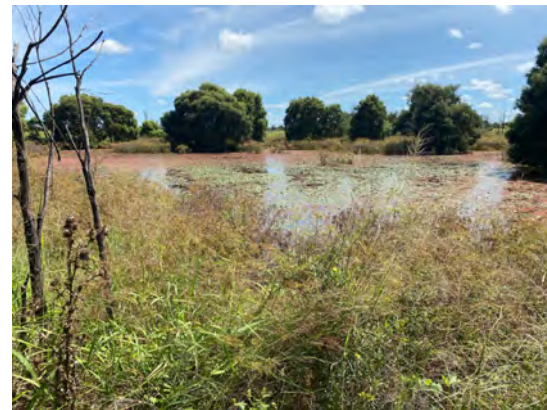
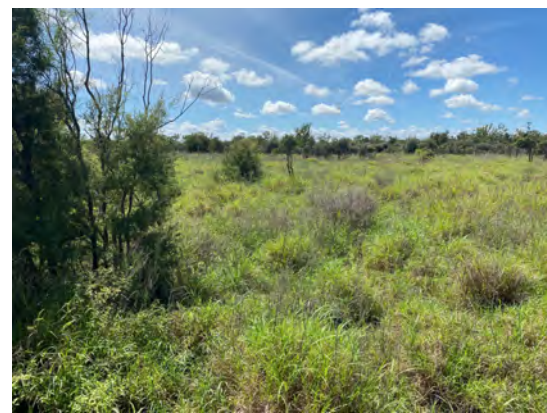
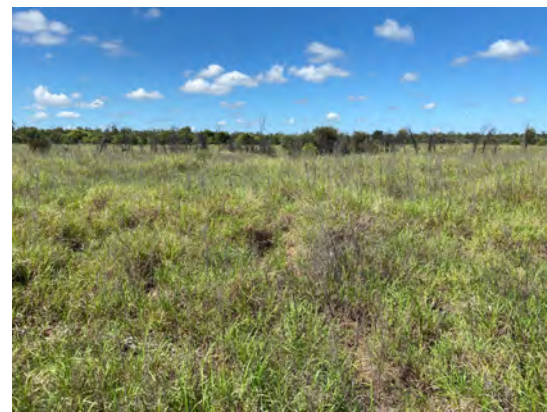
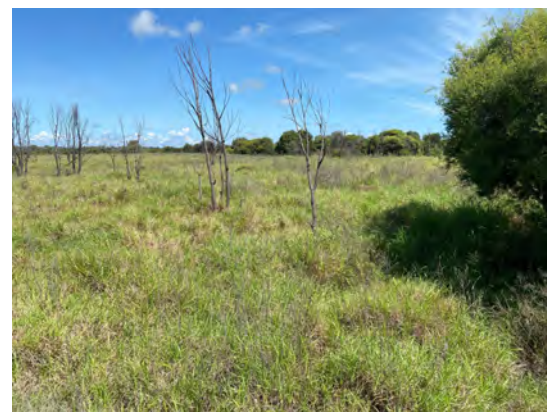
Recent deposits: none detected

Local catchment erosion: cattle pugging (L)

Riparian vegetation	
Cover	
Width of riparian zone on left bank: 10 m	Width of riparian zone on right bank: 10 m
Bare ground: L	Grasses/forbs: E
Shrubs: S	Trees <10 m: L
Trees >10m: N	Exotic riparian species: E
Composition and health	
State-mapped RE: Non-remnant	Verified RE: Non-remnant
Vegetation status: cleared	Dominant stratum: shrubland
Health: poor	Dieback: 26-75
EDL height: 5 m	EDL cover: 20%
Canopy species: <i>Melaleuca bracteata</i> (D), <i>Acacia harpophylla</i> (F)	
Sub-canopy species:	
Shrub species: <i>Melaleuca bracteata</i> (O), <i>Duma florulenta</i> (O)	
Ground species: <i>Cenchrus ciliaris</i> * (D), <i>Cyperus exaltatus</i> (F), <i>Sida</i> sp. (O), <i>Parthenium hysterophorus</i> * (F), <i>Megathyrsus maximus</i> * (O), <i>Basilicum polystachyon</i> (O)

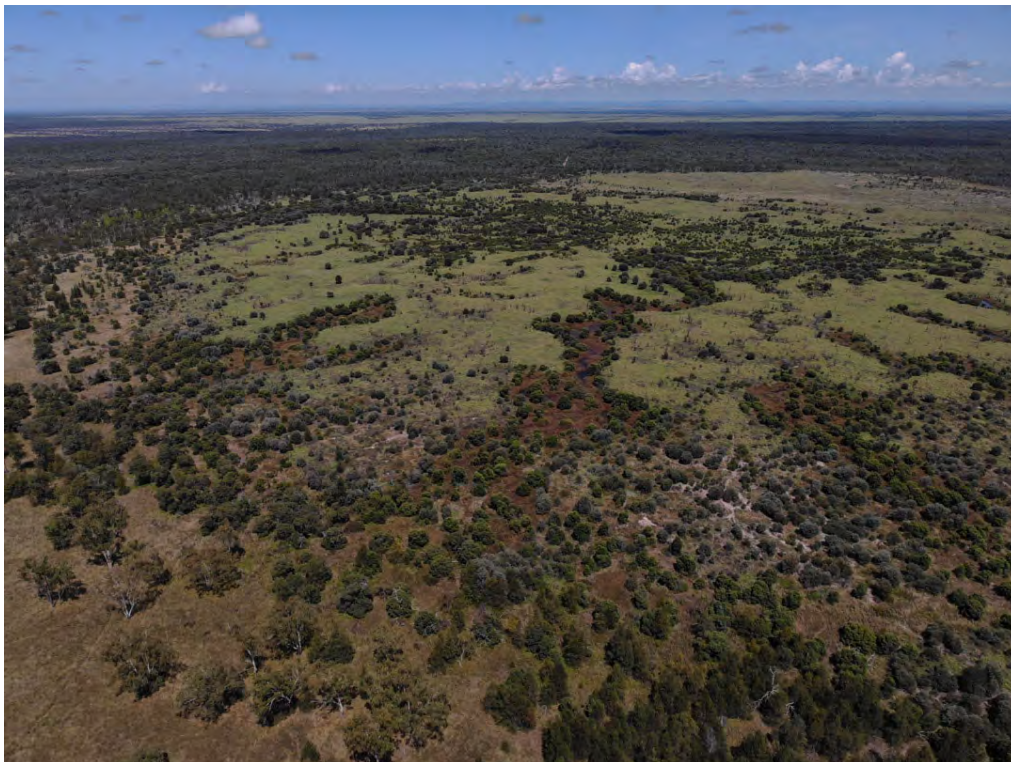
Macrophytes
Submerged macrophytes: <i>Najas tenuifolia</i> (E)
Floating macrophytes: <i>Azolla filiculoides</i> (E), <i>Ottelia ovalifolia</i> (E)
Emergent macrophytes: <i>Cyperus exaltatus</i> (M), <i>Ludwigia octovalvis</i> (L), <i>Cyperus difformis</i> (L), <i>Marsilea drummondii</i> (S), <i>Duma florulenta</i> (L), <i>Monochoria cyanea</i> (L), <i>Cyperus betchei</i> (L), <i>Cyperus concinnus</i> (L), <i>Philydrum lanuginosum</i> (L), <i>Diplachne fusca</i> (L)
Aquatic biota
Aquatic macroinvertebrate sampling undertaken: no
Habitat for platypus: unlikely habitat
Habitat for EVNT fish species: unlikely
Fish sampling undertaken: no
Suitable habitat for EVNT turtle species: unlikely
Turtle sampling undertaken: no
Aquatic vertebrates encountered:
Notes: Tree/shrub-lined gilgai depressions within broader cleared wetland.
Overall aquatic value: High (mapped HES wetland)

Aerial photograph from 100 m above ground level; upstream (left) to downstream (right)
