# Severe Tropical Cyclone Debbie (March 2017)

## Natural Disaster Relief and Recovery Arrangements Category D Environmental Recovery Package: Riparian, mapping and watercourse recovery

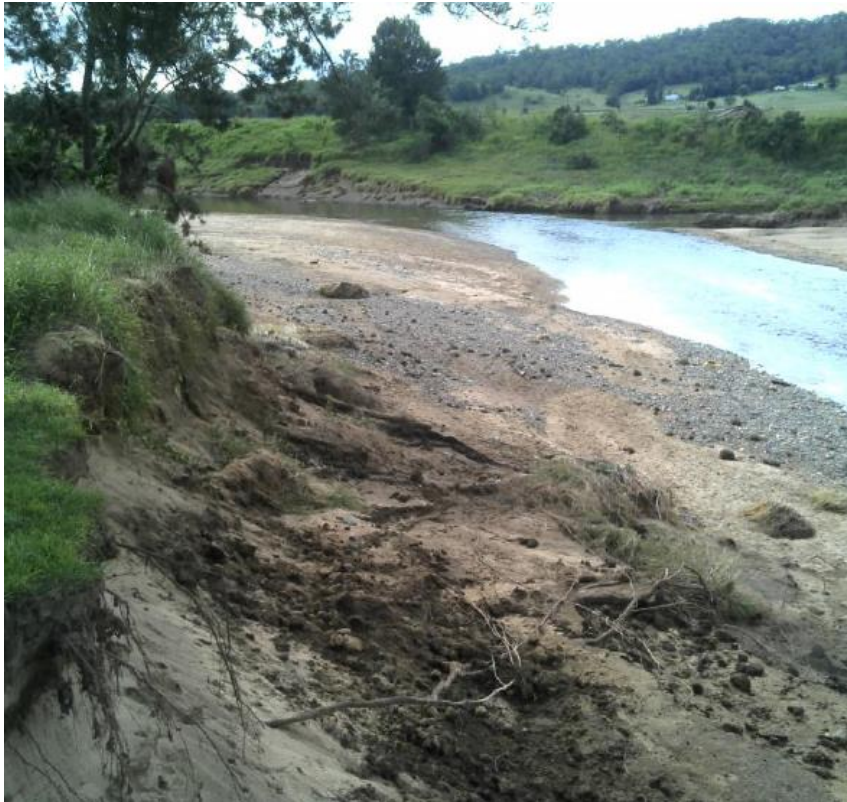
Figure 2 - Erosion caused by TSC Debbie at the Elliot Site

The works undertaken at the Elliot and Boundary sites on the Mary River aimed to stabilise 100 metres of streambank to prevent ongoing erosion causing sediment mobilisation, land loss and threatening existing riparian vegetation (Figure 2).

The eroded riverbank was reprofiled to its former natural slope, allowing for the re-establishment of native vegetation. Pile fields, consisting of rows of 6-metre-long logs driven vertically into the ground, were installed across the face of the new slope (Figure 3)

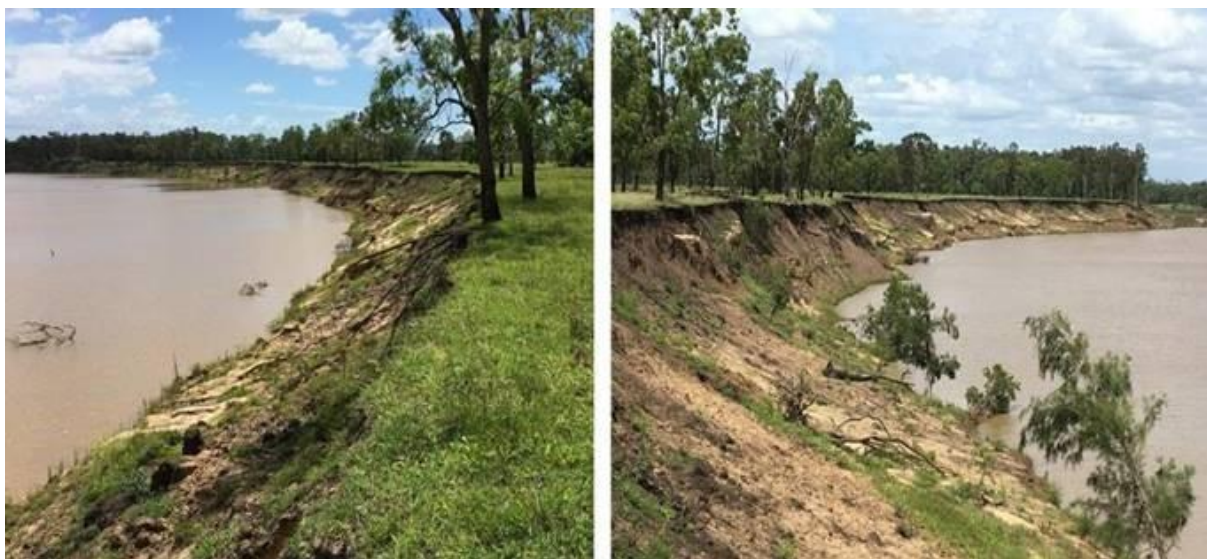
Figure 4 - Erosion at Site 7 before works

The STC Debbie flood event caused significant erosion to the riverbanks at the site, resulting in a steep, 15 metre high streambank along a length of about 1200 metres (Figure 4). The riverbank is estimated to have retreated approximately 20 metres during the flooding event, resulting in the mobilisation of 266,000 tonnes of fine sediment into the Fitzroy River and subsequently the Great Barrier Reef lagoon.

The objective of the management intervention was to create an environment for vegetation to re-establish and to provide natural bank stability and future erosion protection. The works for this site included a combination of pile fields, bank reprofiling and revegetation along the length of the bank (Figures 5 and 6). For six months, the project created twelve full-time jobs in the region. In addition, effective collaboration with Rockhampton Regional Council and Livingstone Shire Council saw more than 75,000 native trees supplied to FBA to further stabilise the banks.

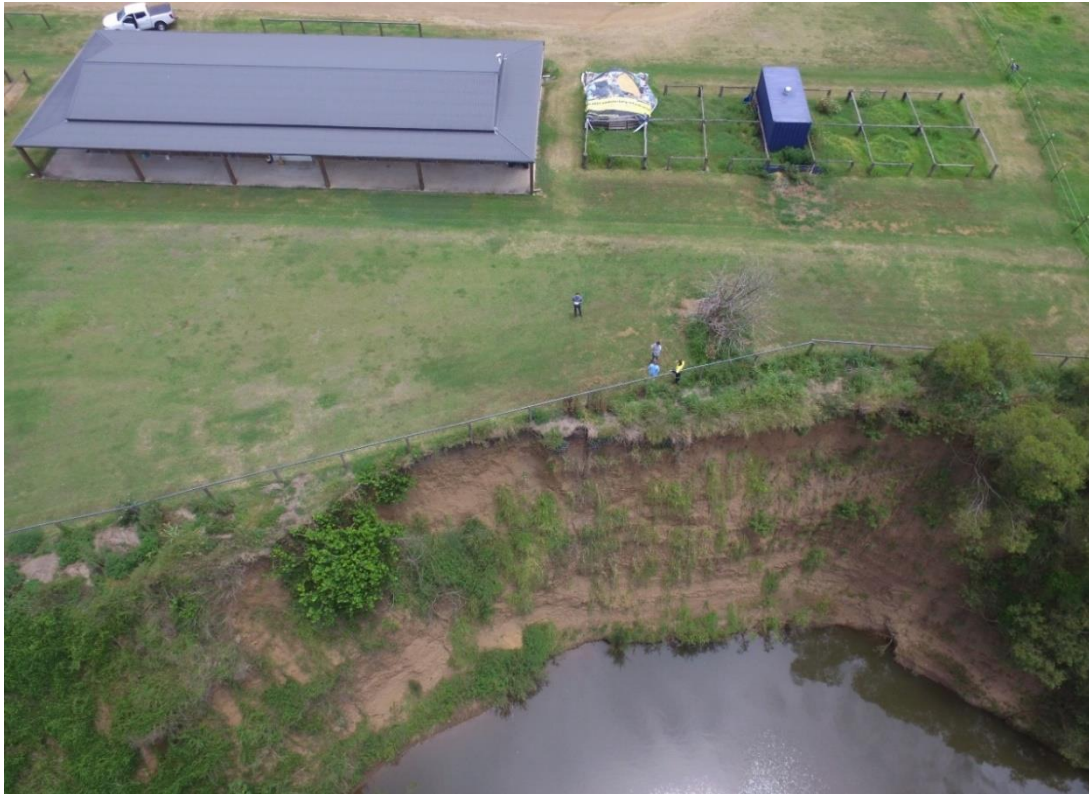
Figure 7 - Major erosion on the Logan River at Illbogan, before works

At this location, flooding caused by STC Debbie left sections of the riverbank severely eroded. The erosion posed a significant threat to nearby infrastructure, including an Energex powerline and a residential property (Figure 7).

Works to stabilise 440 metres of streambank included reshaping 40,500 tonnes of soil and using 10,400 tonnes of rock to stabilise the stream bank. Approximately 3,500 trees were planted to improve bank stability and restore connectivity within the riparian zone.

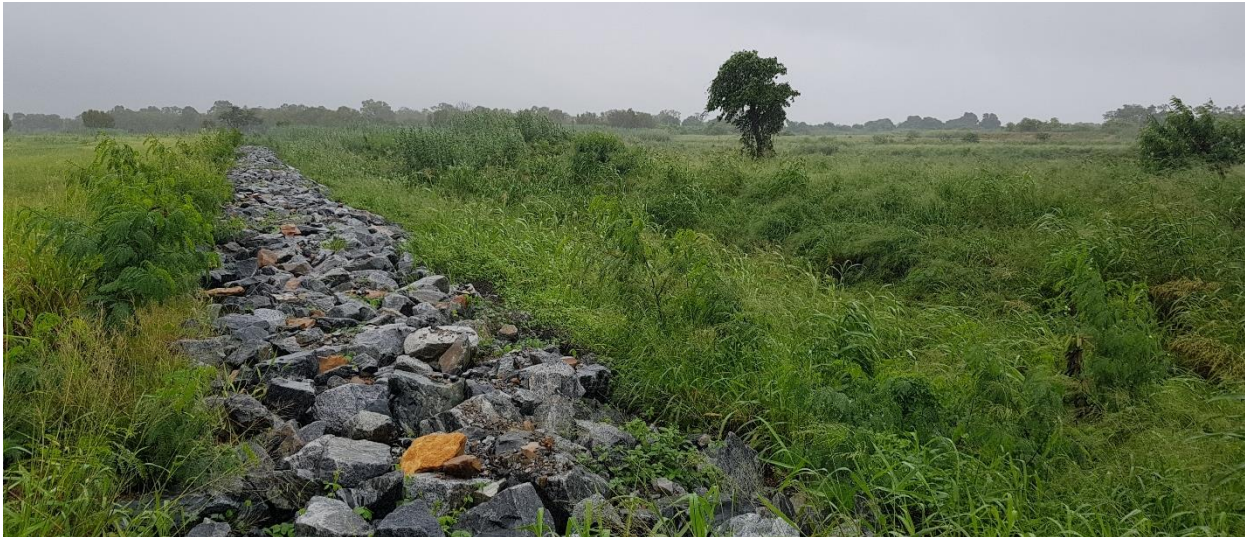
Figure 10 - Reibel's bank works after the 2019 North and Far North Queensland Monsoon Trough

During the North Queensland Monsoon Trough in 2019, the works funded under the STC Debbie NDRRA Environmental Recovery Package held up during flooding, demonstrating the enhanced resilience in the catchment produced through the investment (Figure 10)

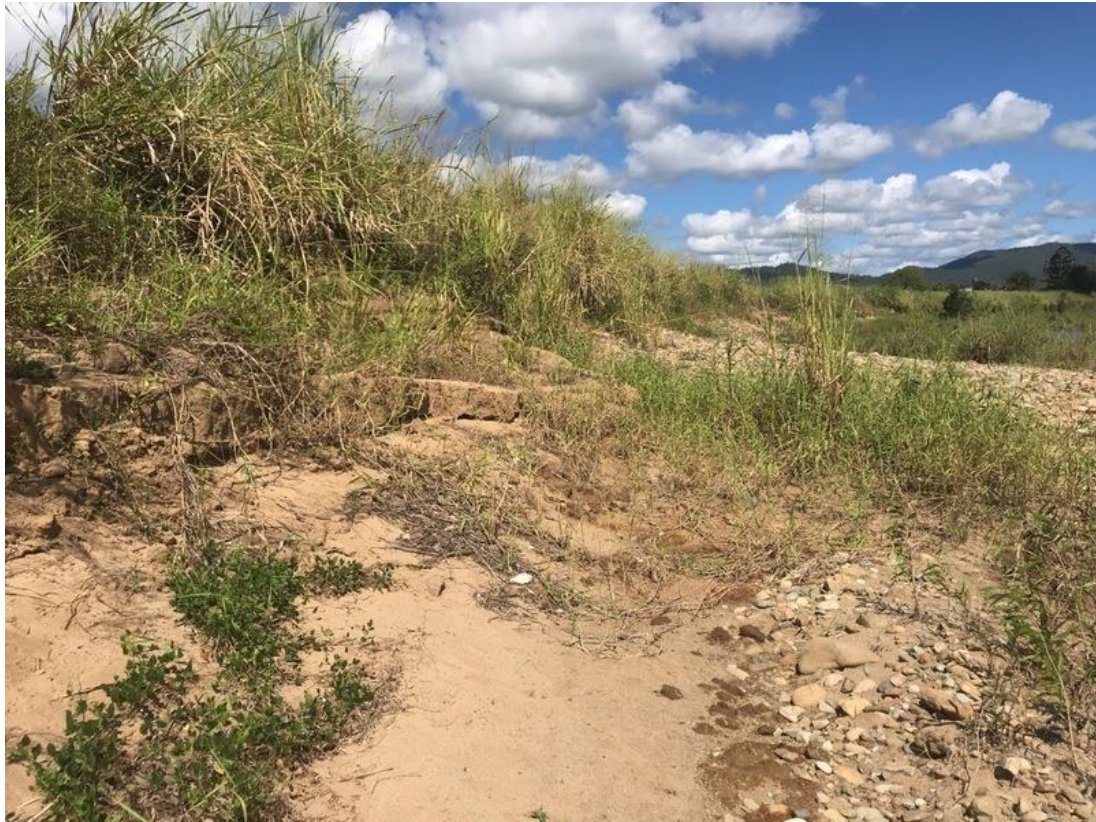
Figure 11 - Erosion at a St Helens Creek site before works

Major erosion occurred on St Helens Creek, with 5 to 35 metres of bank retreat at each of the six sites for up to 225 metres along the length of the bank (Figure 11). Banks were left near-vertical to vertical, with heights of up to 6 metres. The bank retreat resulted in the loss of approximately 24,300m<sup>2</sup> of productive sugarcane and grazing land along St Helens Creek.

Following consultation between Reef Catchments, the landholder and the river restoration engineer, a combination of earthworks, rock toes and pile fields were agreed as the best solution to restore the sites.

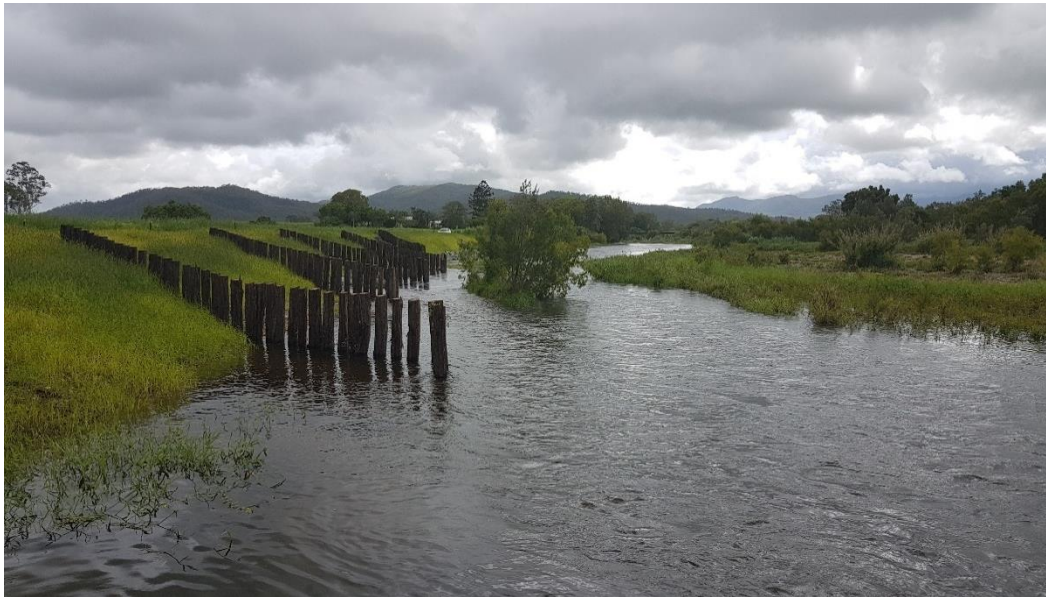
Figure 13 - St Helens Creek site during the 2019 North and Far North Monsoon Trough

During the North Queensland Monsoon Trough in 2019, St Helens Creek was impacted by major flooding, with flood waters covering up to two thirds of the pile field sites. All sites on St Helens Creek held up well during the flooding and demonstrated increased resilience in the region from the investment.

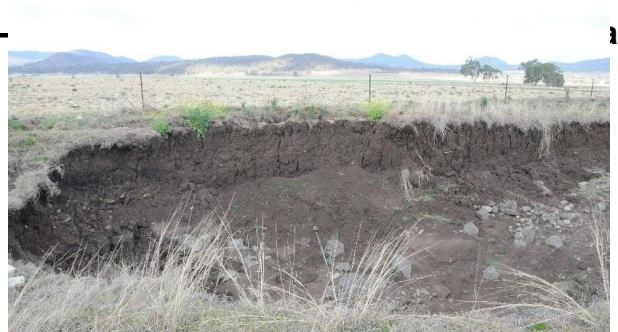
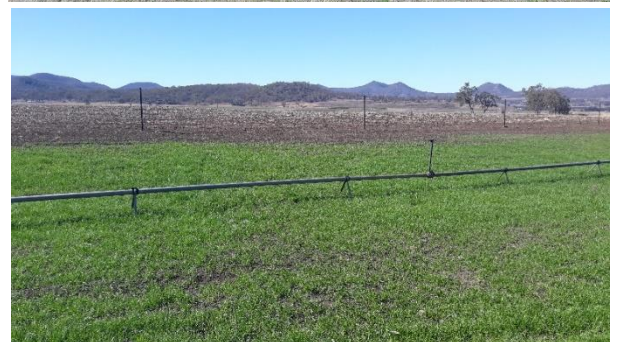
Figures 14 and 15 - The active gully head area before and after NDRRA battering and revegetation

This project, for a total value of \$29,280, repaired a 200-metre gully section in Goomburra, which experienced significant erosion as a result of flooding associated with STC Debbie. The gully reached a depth of over two metres and up to 13 metres wide, mobilising many tonnes of valuable, black cracking-clay soil into the waterways.

Works included battering 100 metres upstream and downstream of the active gully head (Figures 14 and 15), fencing out livestock, rapidly establishing grass cover using an irrigation system, and installing coir log weirs (Figure 16). This resulted in a stabilised channel with more controlled water flow, reducing future soil mobilisation. Figures 17 and 18 highlights the gully transformation, showing the change from severe erosion into a more resilient system able to withstand future large rainfall events.
