PAJINGO GOLD MINE

EA Amendment Sewage Treatment Plant, Borrow Pits and Post Mining Land Uses

SLR Ref: 626.30122.00000-R01
Version No: -v1.0
March 2023

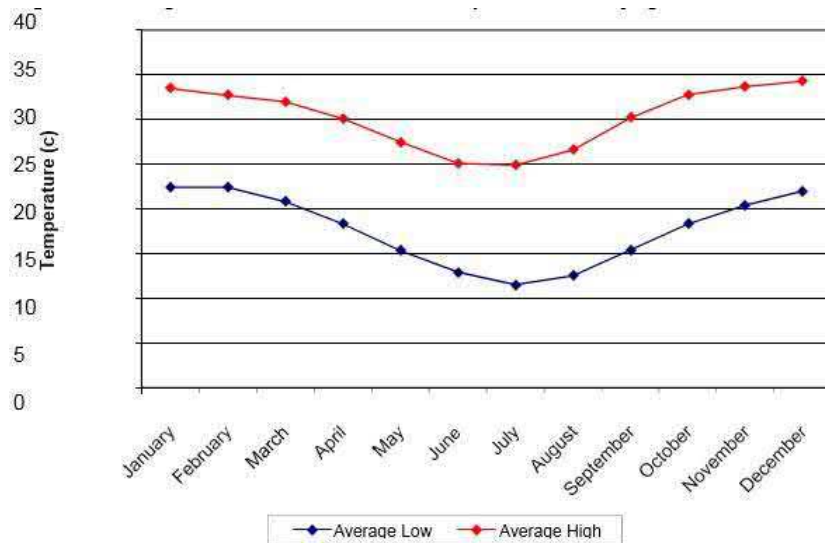
Figure 3-2 Average maximum and minimum temperatures at Pajingo (Minjar Gold, 2018b)

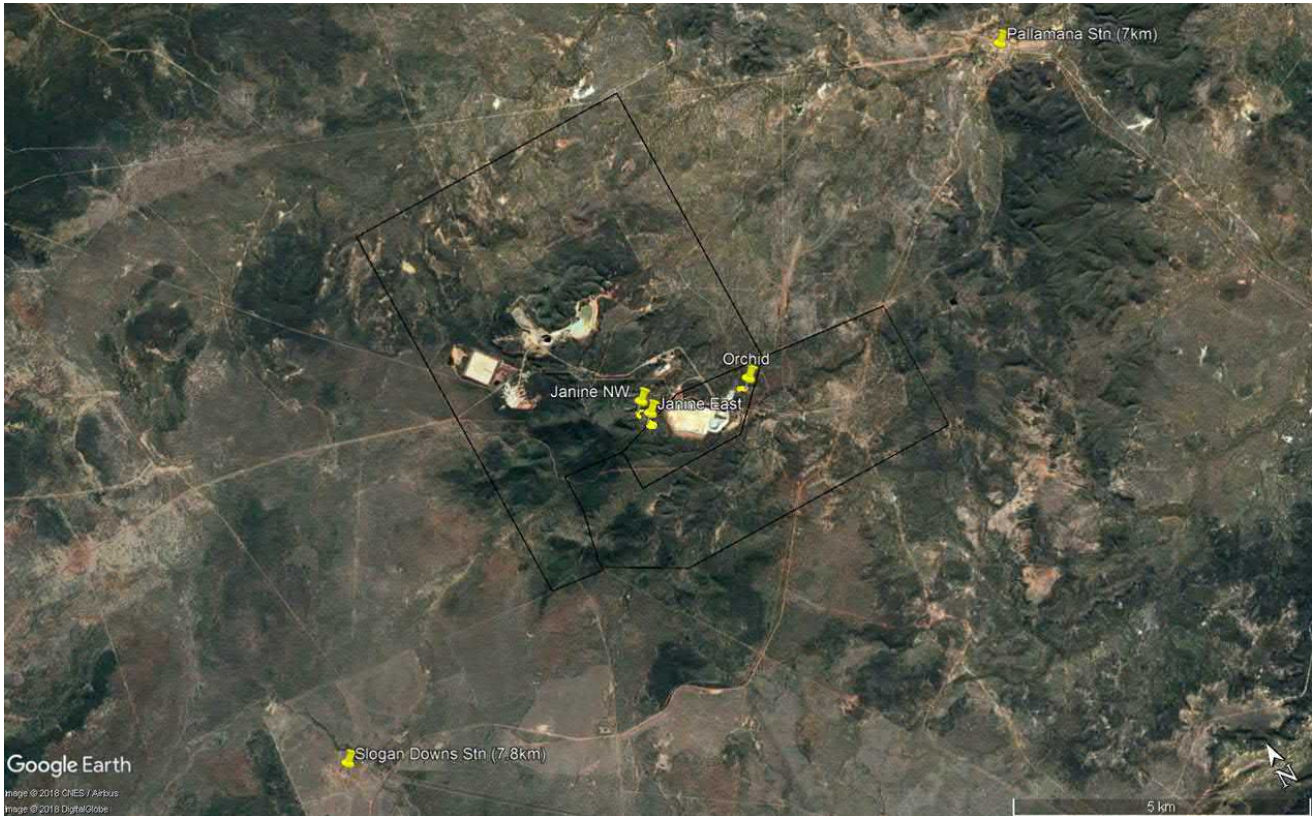
Figure 3-5 Sensitive receptors

There are three sensitive receptors within 10 km of PJO. The closest is Doongara Station which is 5 km southeast of the activities and is owned by NQM. The closest sensitive receptors not owned by NQM are Slogan Downs (approximately 7 km southwest) and Pallamana (approximately 9.5 km east) (**Figure 3-5**).

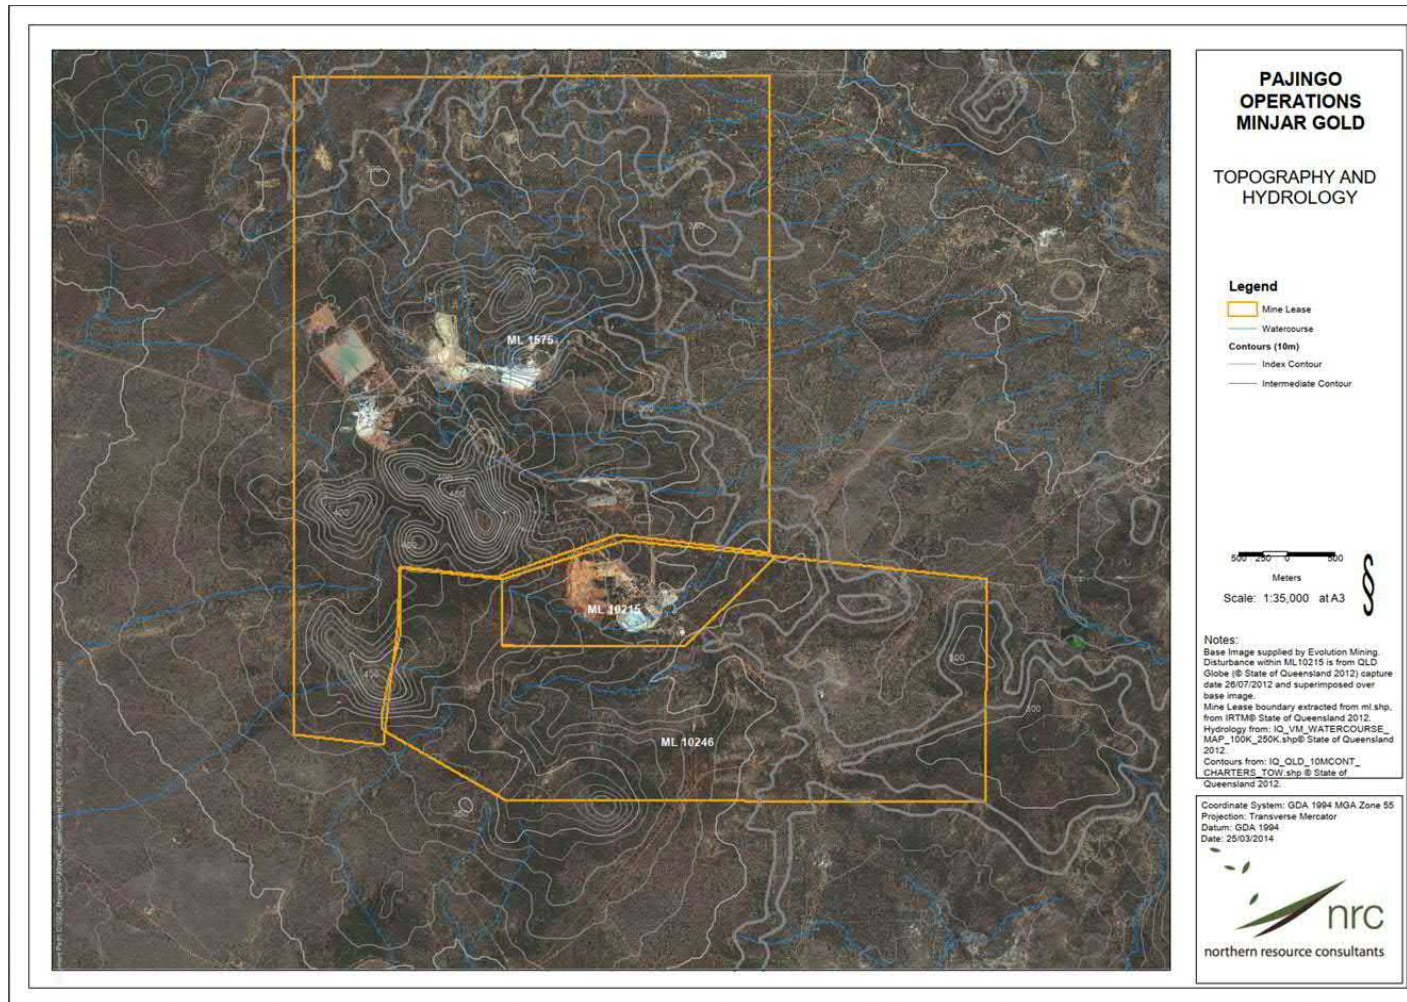
Figure 3-6 Site and Surrounding Area Drainage Features

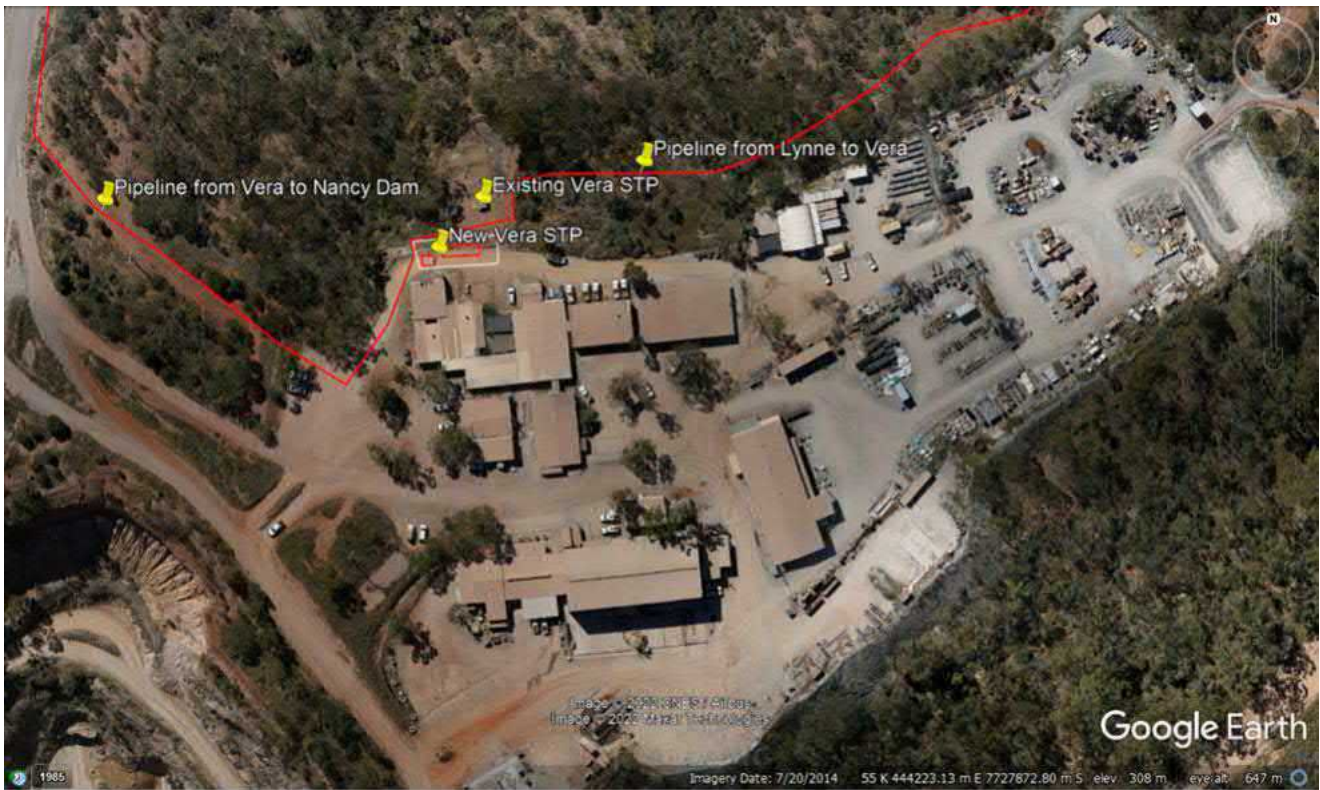
Figure 5-2 New Vera STP Location

There are no wetlands or drainage lines proximate to the new STP locations. The proposed STP replacement are not likely to cumulatively increase the potential for environmental harm. Furthermore, the new STPs will utilise modern technology and materials, further reducing the likelihood for uncontrolled spills or releases.

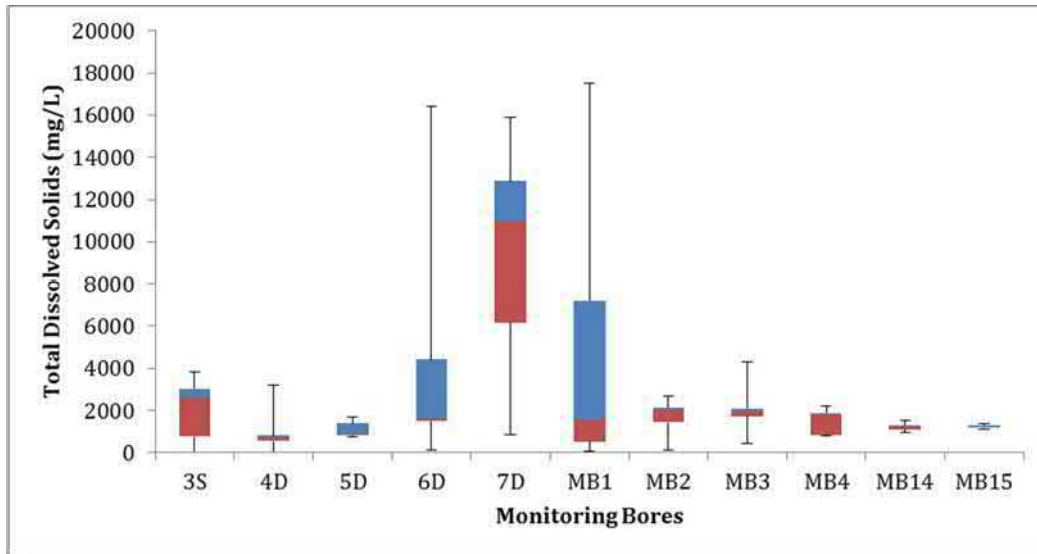
The total dissolved solids of groundwater samples measured at Pajingo over the life of the mine have been plotted in Figure 7. TDS varies widely spatially across the site. Temporal variation in TDS is high at bores 6D, 7D and MB1. At other bores, temporal variation of TDS is limited. Investigations previously undertaken on the high salinity of groundwater occurring on Pajingo mine lease have indicated that the groundwater quality in the receiving bedrock aquifer (Molly Darling Sandstone) shows naturally high TDS and sulphate concentrations. This has been attributed to the high residence time of groundwater in the low permeability bedrock (NRC, 2012).

Figure 7: TDS Concentrations of Pajingo groundwater (NRC 2012)

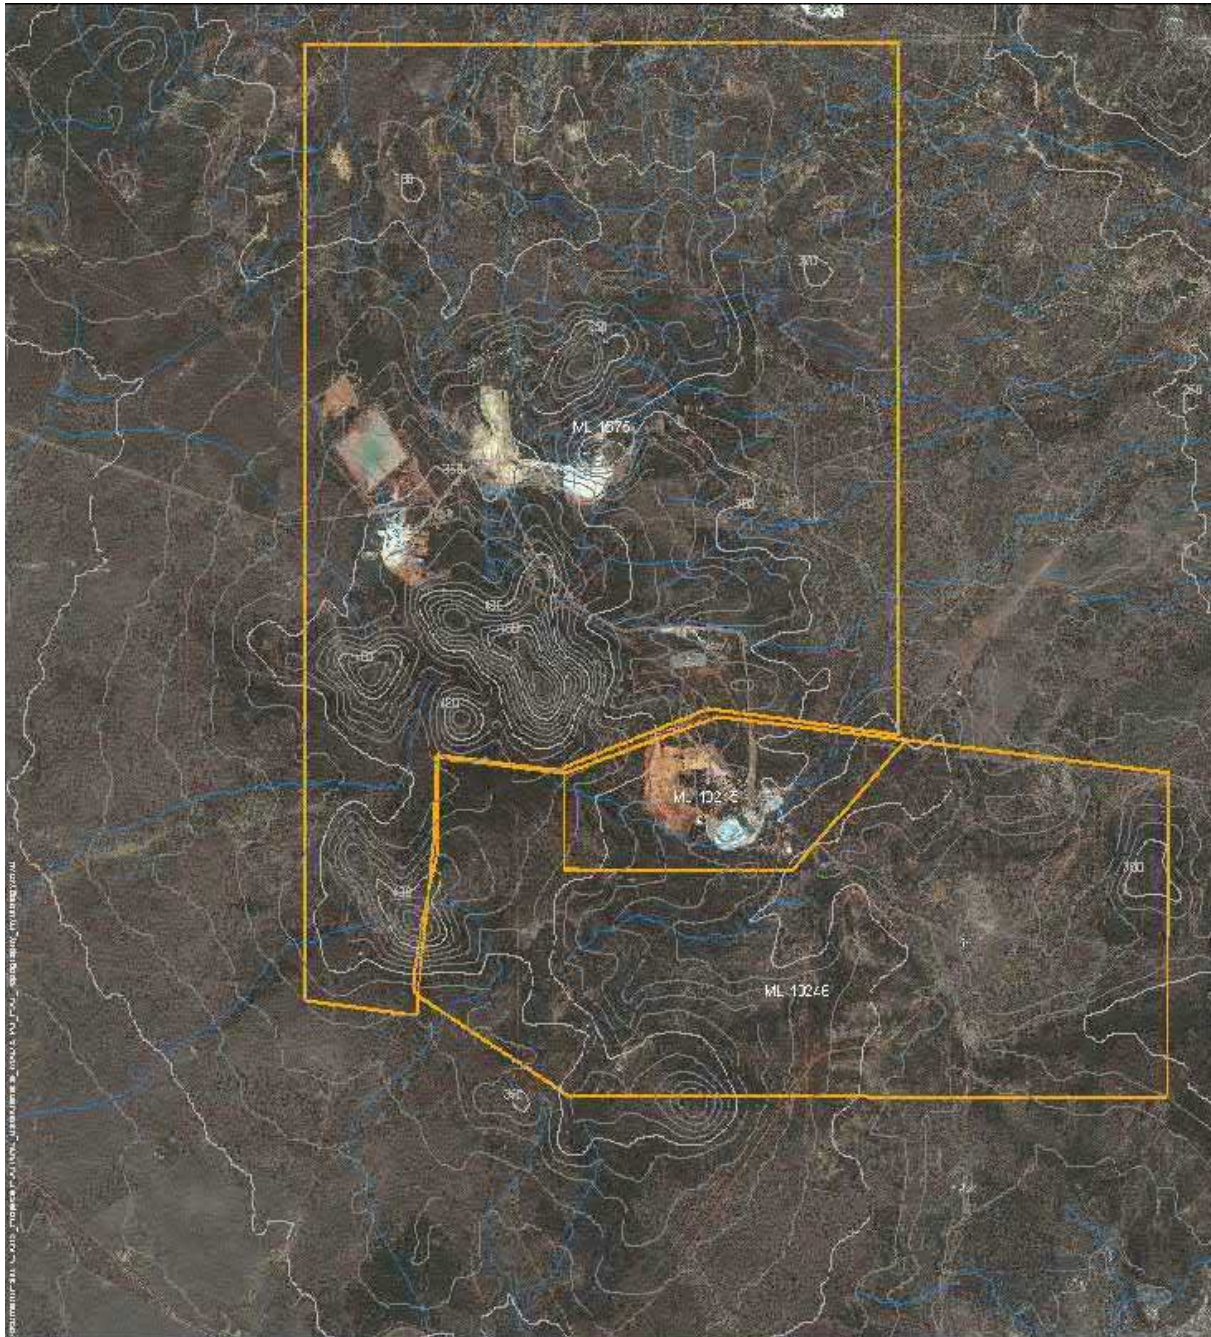
Figure 3: Topographical map of mine site location – for a full map, please refer to the map appendix accompanying this report.

The area draining into Molly Darling Creek can be broken up into two catchments on-site, the Northern Catchment and the Eastern Catchment. The Northern Catchment drains the areas around the Tailings Storage Facility, Site Admin Office and seepage dam. The Madigans Dam, if overflows occur, will also drain into this catchment. A catchment divide occurs between this area and the Scott Lode Dam separating all areas towards the east.

This Eastern Catchment contains the Scott Lode and A Lode Dams, the Cindy and Nancy Dams as well as the Venue Pit, VNU Pit and the Vera Pit. This area drains directly towards the east into Molly Darling Creek, further downstream than where waters from the Northern Catchment enter the creek.
