Aquatic Ecology Assessment

Caval Ridge Mine

Horse Pit Extension Project Aquatic Ecology Assessment

August 2021

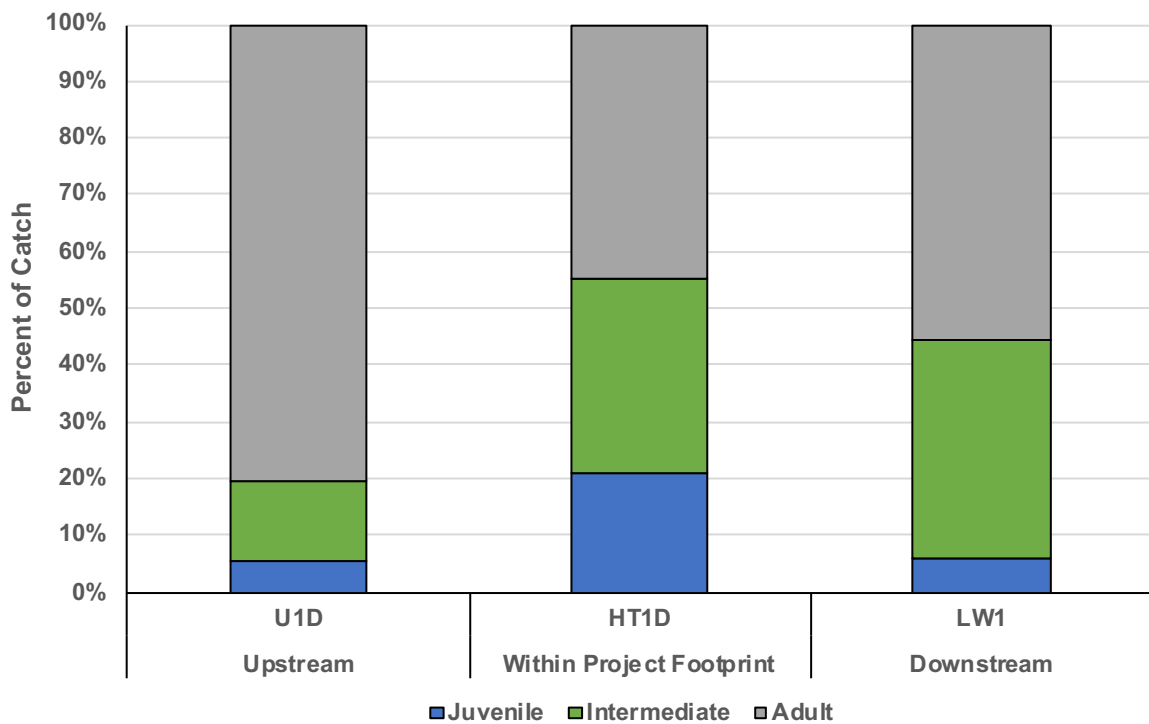
Figure 4.14 Proportion of native fish from juvenile, intermediate and adult life stages caught at sites in December 2019

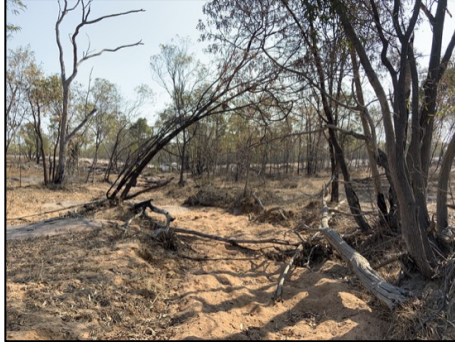
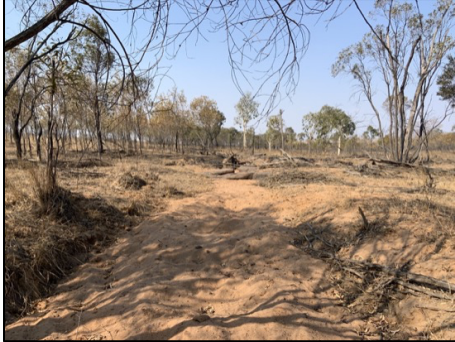
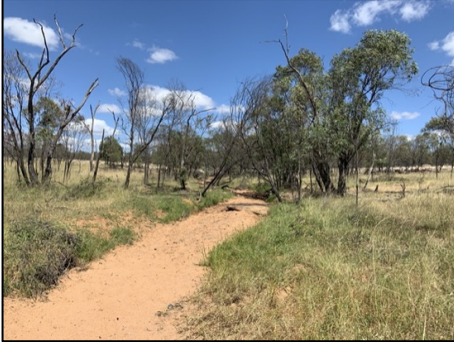
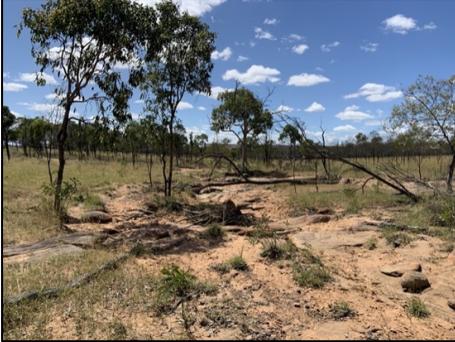
Site: U2		Location: Upstream		Stream Order: 1		Waterway: Unnamed tributary of Caval Creek																						
Upstream: December 2019		Downstream: December 2019		Upstream: April 2020		Downstream: April 2020

Aquatic Ecosystem Value: Low		MNES/MSES: None present or likely to occur		Dry season refuge: No		Connectivity: Limited due to location in catchment and presence of CVM downstream																						
<p>In-stream condition: Fair</p> <p>Key potential habitat features included:</p> <ul style="list-style-type: none"> • ephemeral channel • some woody debris • predominately sandy sediments with some cobbles and boulders, and • little trailing and overhanging bank vegetation. <p>The site was dry during both the December and April surveys.</p>		<p>Riparian condition: Poor</p> <p>The riparian zone was semi-continuous around the perimeter of the waterway, although the extent of the vegetation had been reduced due to historic clearing. Vegetation consisted of trees, grasses and weeds. Banks were low (approximately 1 m high) and gently sloping with some erosion. There were some exotic terrestrial riparian species at the site.</p>		<p>External Impacts: High</p> <p>External impacts at the site were mostly associated with the surrounding land-use and included:</p> <ul style="list-style-type: none"> • reduced riparian vegetation as a result of land clearing • grazing by livestock, and • feral animals. 		<p>Water Quality: N/A</p>

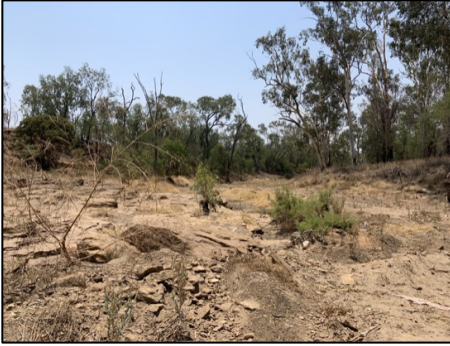
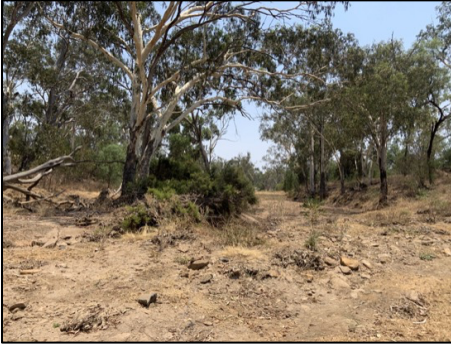
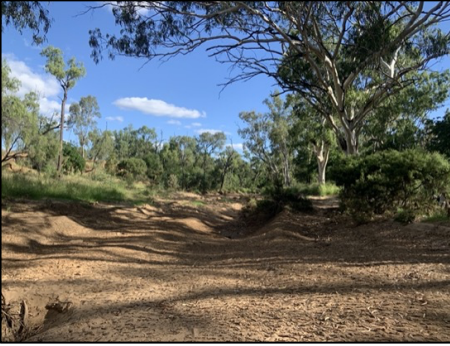
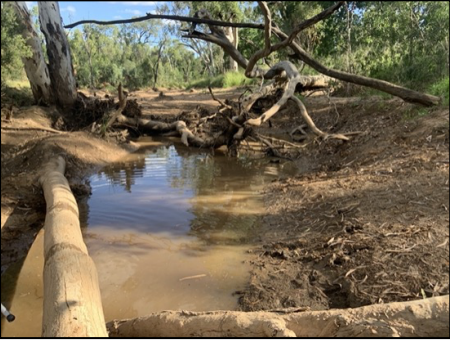
Site: Ch2		Location: Upstream		Stream Order: 5		Waterway: Cherwell Creek																						
Upstream: December 2019		Downstream: December 2019		Upstream: April 2020		Downstream: April 2020

Aquatic Ecosystem Value: Moderate		MNES/MSES: None present or likely to occur		Dry season refuge: No		Connectivity: Good, during periods of flow.																						
In-stream condition: Fair Key habitat features in April included: <ul style="list-style-type: none"> • wide sandy ephemeral channel • some woody debris & detritus • predominately sandy sediments with some silt/clay, and • some overhanging and trailing bank vegetation. The site was dry during the December survey.		Riparian condition: Fair The riparian zone was semi-continuous around the perimeter of the waterway, although the extent of the vegetation had been reduced due to historic clearing. Vegetation consisted of trees, grasses and weeds. Banks were intermediate (3 m – 4 m high) and gently sloping with moderate erosion. There were some exotic terrestrial riparian species at the site.		External Impacts: High External impacts at the site were mostly associated with the surrounding land-use and included: <ul style="list-style-type: none"> • reduced riparian vegetation as a result of land clearing • grazing by livestock, and • feral animals. 		Water Quality: Fair

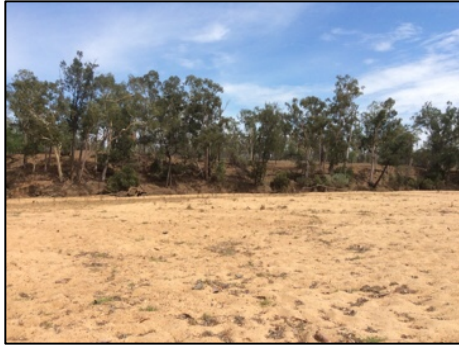
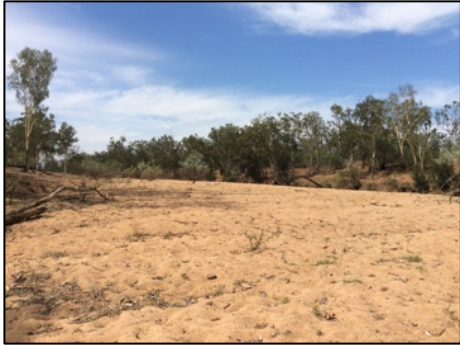
Site: IR01		Location: Upstream		Stream Order: 5		Waterway: Isaac River	
Upstream: November 2020		Downstream: November 2020

Aquatic Ecosystem Value: Moderate		MNES/MSES: None present or likely to occur		Dry season refuge: N/A		Connectivity: N/A	
In-stream condition: Poor Key habitat features in November 2020 included: <ul style="list-style-type: none"> • ephemeral channel • predominately sandy sediments with some pebbles, gavel and clay/silt • little shading of reach • no trailing vegetation, and • some large snags, woody debris & branches. The site was dry during the November survey.		Riparian condition: Good The riparian zone was a scattered semi-continuous/continuous mix around the perimeter of the waterway, and the extent of the vegetation had been reduced. Vegetation consisted grasses, trees, and weeds. Left bank height was low (approximately 0.5 m high) and gently sloping; the right bank was higher (approximately 15 m high), steep banks with moderate erosion. There were some exotic terrestrial riparian species at the site. Site was wide (approximately 60 m wide).		External Impacts: Moderate External impacts at the site were mostly associated with the surrounding land-use and included: <ul style="list-style-type: none"> • reduced terrestrial vegetation as a result of land clearing • grazing by livestock, and • feral animals. 		Water Quality: N/A Survey: Nov-20

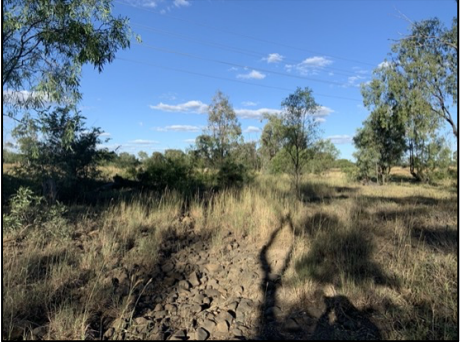
Downstream: April 2020

Aquatic Ecosystem Value: Low		MNES/MSES: None present or likely to occur		Dry season refuge: No		Connectivity: Limited, during periods of flow																						
<p>In-stream condition: Poor</p> <p>Key potential habitat features in April included:</p> <ul style="list-style-type: none"> • ephemeral waterway • rocky narrow channel • predominately cobbled sediments with some sand • little snags and woody debris, and • little trailing & overhanging vegetation. <p>The site was not sampled during the December survey and was dry during the April survey.</p>		<p>Riparian condition: Fair</p> <p>The riparian zone was semi-continuous around the perimeter of the waterway, and the extent of the vegetation had been reduced. Vegetation consisted grasses, trees and weeds. Banks were low (approximately 1 m high) and gently sloping with moderate erosion. There were some exotic terrestrial riparian species at the site.</p>		<p>External Impacts: High</p> <p>External impacts at the site were mostly associated with the surrounding land-use and included:</p> <ul style="list-style-type: none"> • reduced riparian vegetation as a result of land clearing • grazing by livestock, and • feral animals. 		<p>Water Quality: N/A</p>

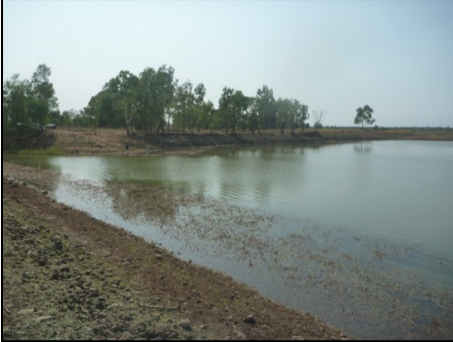
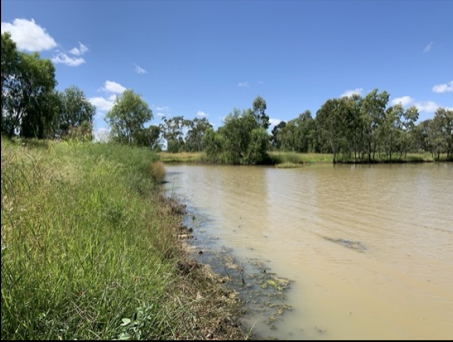
Site: LW1		Location: Downstream		Stream Order: 3		Waterway: Mapped lacustrine wetland on Horse Creek																						
Upstream: December 2019		Downstream: December 2019		Upstream: April 2020		Downstream: April 2020

Aquatic Ecosystem Value: Moderate		MNES/MSES: None present or likely to occur		Dry season refuge: Yes		Connectivity: Limited due to high dam walls																						
In-stream condition: Fair Key habitat features included: <ul style="list-style-type: none"> • shallow & deep pools • aquatic plants • predominately fine sediments (sand & silt/clay) • little trailing & overhanging vegetation, and • some snags, woody debris & detritus. 		Riparian condition: Fair The riparian zone was a scattered continuous mix with isolated trees around the perimeter of the waterway, and the extent of the vegetation had been reduced. Vegetation consisted grasses, shrubs, trees and weeds. Banks were low (approximately 3 m high) and gently sloping with moderate erosion. There were some exotic terrestrial riparian species at the site.		External Impacts: High External impacts at the site were mostly associated with the surrounding land-use and included: <ul style="list-style-type: none"> • reduced riparian vegetation as a result of land clearing • grazing by livestock • feral animals, and • presence of an artificial dam. 		Water Quality: Poor

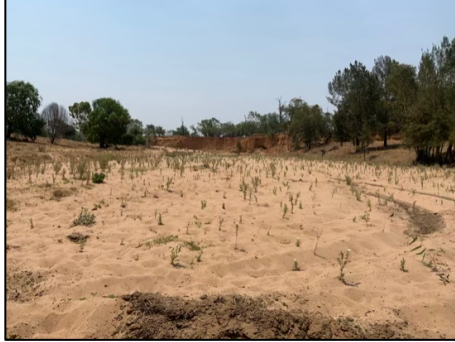
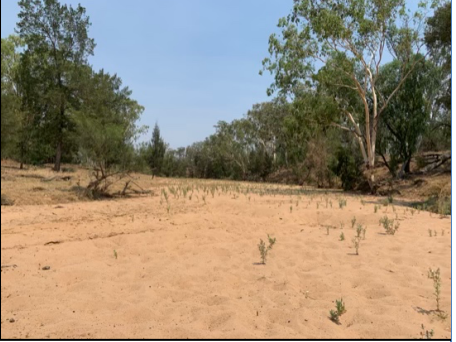
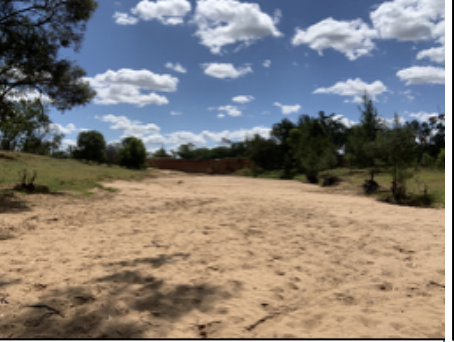
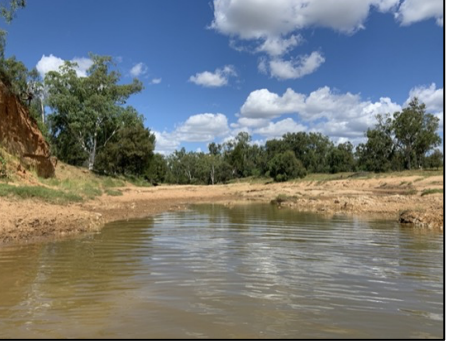
Site: Ch4		Location: Downstream		Stream Order: 5		Waterway: Cherwell Creek																						
Upstream: December 2019		Downstream: December 2019		Upstream: April 2020		Downstream: April 2020

Aquatic Ecosystem Value: Moderate		MNES/MSES: None present or likely to occur		Dry season refuge: No		Connectivity: Good, during periods of flow																						
In-stream condition: Good Key habitat features in April included: <ul style="list-style-type: none"> • ephemeral channel • predominately sandy sediments with some clay/silt • some overhanging vegetation • little snags, woody debris & branches • shallow pool at eroded bend. The site was dry during the December survey.		Riparian condition: Fair The riparian zone was a semi-continuous/ continuous mix around the perimeter of the waterway, and the extent of the vegetation had been reduced. Vegetation consisted grasses, shrubs, trees, ferns and weeds. Banks were low (2.5 m – 3.5 m high) and gently sloping with extensive erosion. There were some exotic terrestrial riparian species at the site.		External Impacts: Moderate External impacts at the site were mostly associated with the surrounding land-use and included: <ul style="list-style-type: none"> • reduced riparian vegetation as a result of land clearing • grazing by livestock, and • feral animals. 		Water Quality: Fair

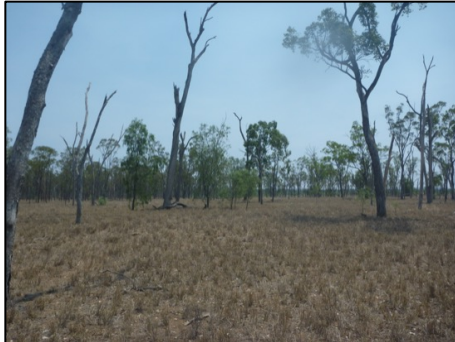
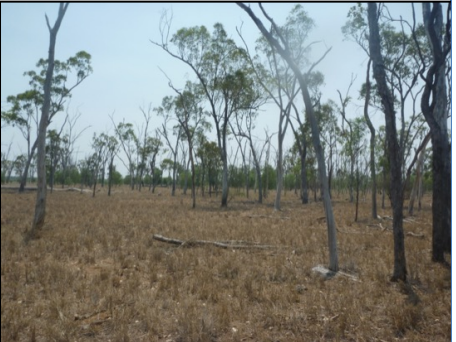
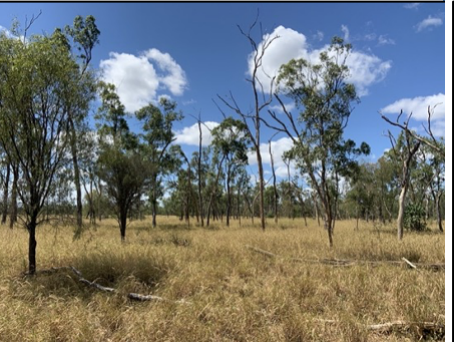
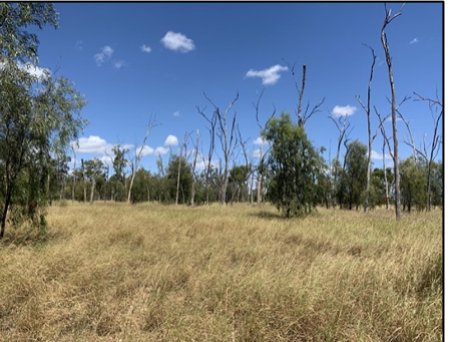
Site: PW2		Location: Downstream		Stream Order: N/A		Waterway: Mapped palustrine wetland																						
December 2019		December 2019		April 2020		April 2020

Aquatic Ecosystem Value: N/A		MNES/MSES: N/A		Dry season refuge: N/A		Connectivity: N/A																						
<p>In-stream condition: N/A</p> <p>No aquatic habitat features recorded at this site. Site is likely incorrectly mapped as a palustrine wetland, with terrestrial ecological values only.</p>		<p>Riparian condition: Fair</p> <p>This site did not feature a riparian zone as no aquatic ecological features were evident, however, terrestrial vegetation in the broader region consisted grasses, shrubs, trees, and weeds. There some exotic terrestrial species at the site.</p>		<p>External Impacts: Moderate</p> <p>External impacts at the site were mostly associated with the surrounding land-use and included:</p> <ul style="list-style-type: none"> • reduced terrestrial vegetation as a result of land clearing • grazing by livestock, and • feral animals. 		<p>Water Quality: N/A</p>
