AQUATIC ECOLOGY ASSESSMENT

VECCO CRITICAL MINERALS PROJECT

PREPARED FOR
VECCO GROUP PTY LTD

26 April 2023

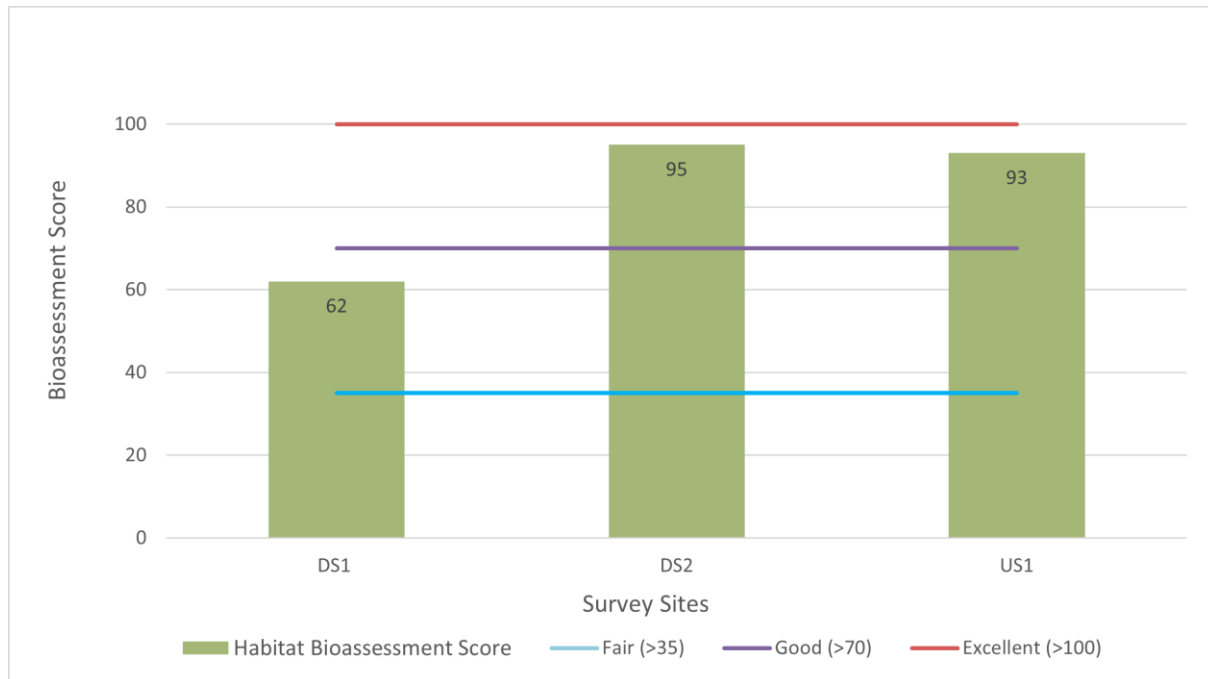
Figure 10: Habitat Bioassessment Scores

This assessment considered the morphological characteristics of waterways (as specified in Section 6.3.2), with 135 representing a perfect score for a healthy waterway.

The habitat bioassessment scores from the aquatic sites within the sampling environment fell into the fair and good categories described in Table 6 (Figure 10). These results are indicative of the general health of the river and the surrounding systems, it does not consider the quality of the water present.

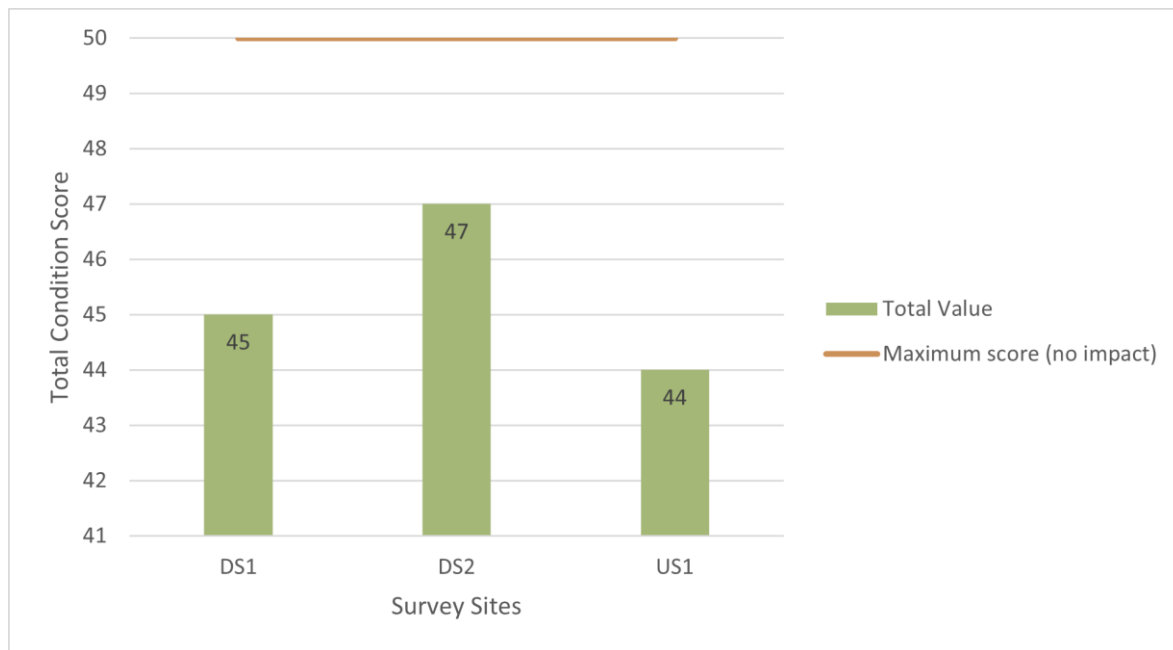
Figure 11: Condition assessment scores of survey sites

The condition assessment considered the impact/influence of ten different upstream activities on the waterways (as outlined in Section 6.3.3) with 50 representing the maximum score (no impact) and 10 representing the minimum score (full impact). Impact assessments were completed at all sites and site assessment scores are presented in Figure 11.

Condition assessment scores ranged from 44 (US1) to 48 (DS2) with a mean of 46. Of the sites surveyed, all three sites had condition scores above 40 indicating that the influence of activities upstream has had minimal impact.

The most significant alteration to stream flow was identified as influence of agriculture upstream. The current land use of the study area is low intensity cattle grazing and, in the absence of regular watering stations stock are reliant on natural waterways.

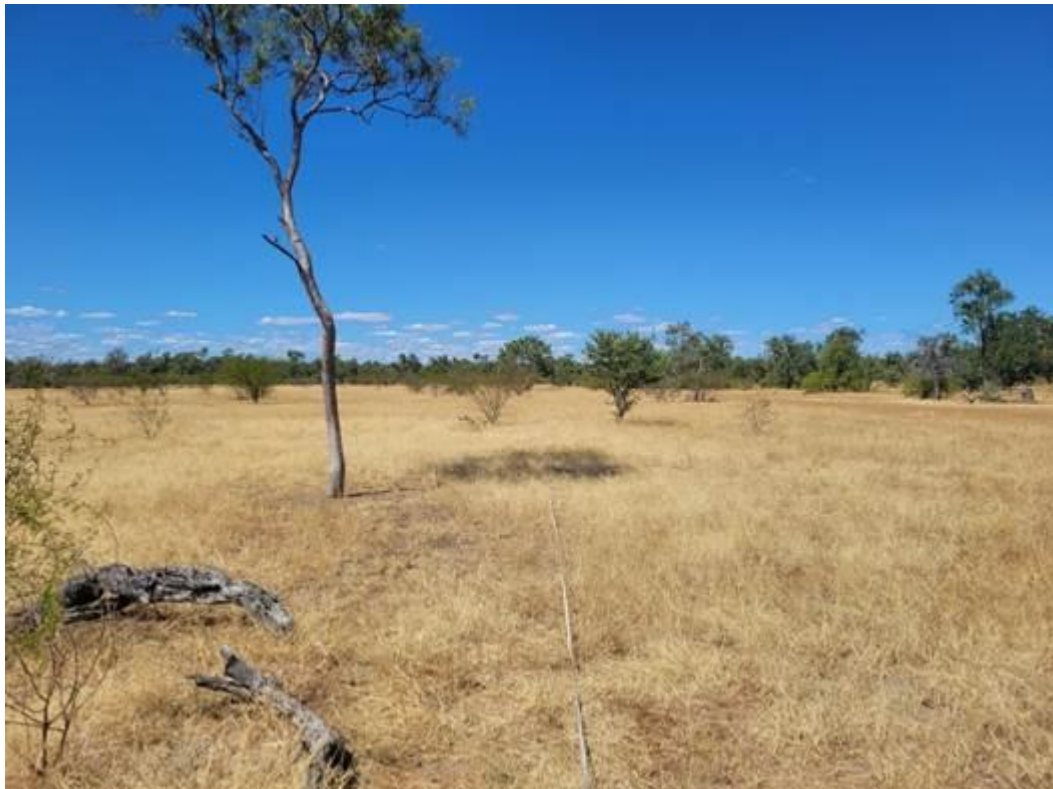
Photo Plate 3: Circular depression wetland areas

- topographical depressions forming ephemeral wetlands and waterbodies that fill irregularly following local rainfall and overland flow;
- trees are typically absent or sparse, with occasional Gutta-percha (*Excoecaria parvifolia*);
- shrubs are also sparse and represented by scattered Currant Bush (*Carissa spinarum*) only; and
- the ground layer is dominated by Native Couch (*Brachyachne convergens*).

Historic satellite image analysis shows the wetlands are rarely inundated in the dry season and only occasionally inundated in the wet season, following local rainfall. For example, the wetland that is partially located within the Transport ML was found to contain water in 1 in 25 dry seasons and 2 out of 9 wet seasons.

The ephemeral wetland features are not fed by any groundwater source or open bore drain.

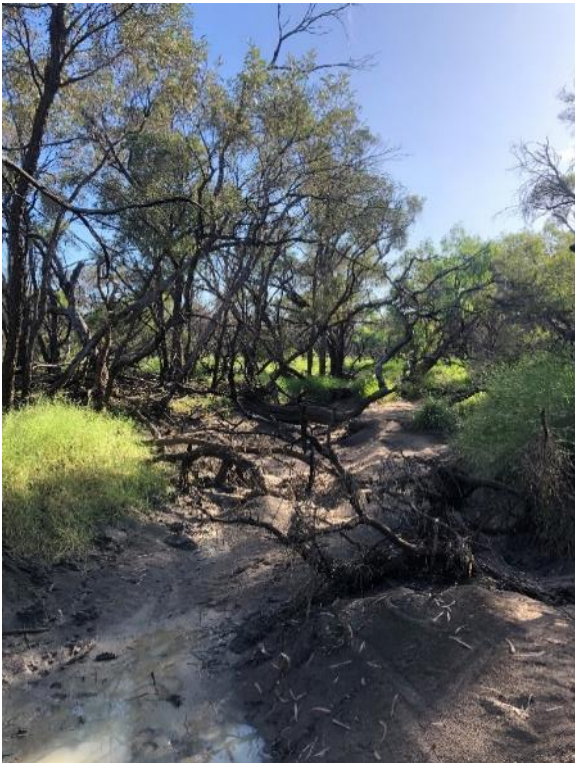
| Photographs | Site Description |
|--|---|
| <p data-bbox="199 380 287 414">Site DS1</p> | <p data-bbox="880 380 1364 582">Site DS1 was located on the Saxby River downstream of the Project area. The Saxby River is identified as a watercourse under the Water Act. During the February survey, this site was characterised by small pools of standing water with a damp waterlogged stream bed where pools were absent.</p> <p data-bbox="880 600 1348 716">The stream bed comprised of fine silts and clay. The bank was moderately stable and, in some sections, absent, comprising of small flat flood plain zones.</p> <p data-bbox="880 734 1189 768">Surrounding land use is grazing.</p> <p data-bbox="880 779 1268 835">Overall, DS1 scored 'fair' in the Habitat Bioassessment.</p> |

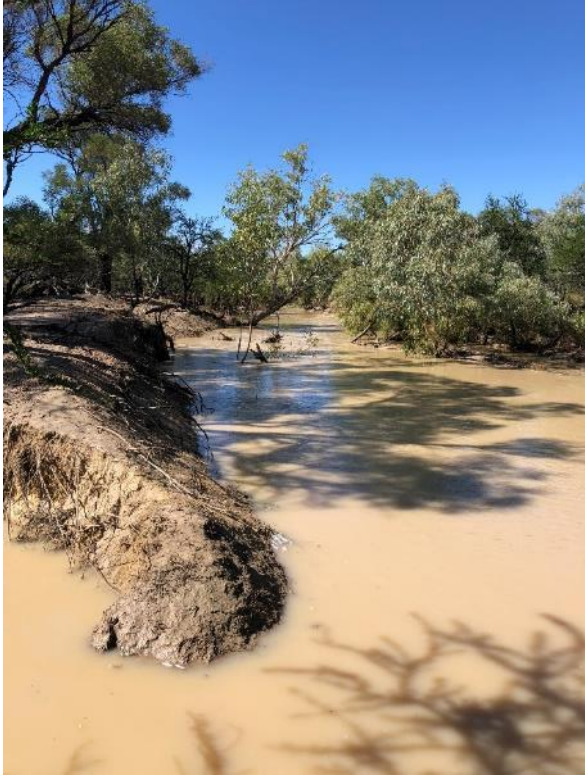
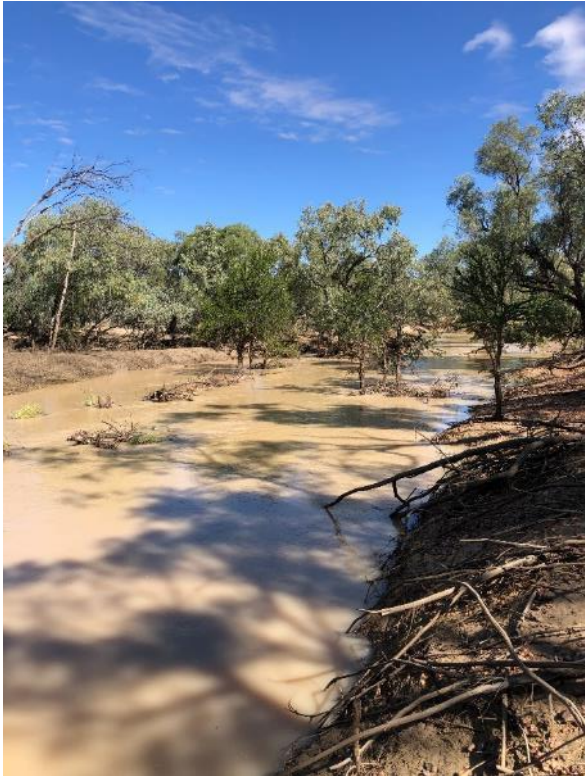
| Photographs | Site Description |
|--|--|
| <p data-bbox="199 275 288 300">Site DS4</p> | <p data-bbox="863 275 1350 450">Site DS4 was located on the Saxby River downstream of the Project area. The Saxby River is identified as a watercourse under the Water Act. During the May survey, this site was characterised by a deep and wide channel of flowing turbid water.</p> <p data-bbox="863 465 1358 611">The stream bed comprised of fine silts and sand. The bank was somewhat stable with cattle access surrounding the sample location causing some erosion. The banks were lightly vegetated though overall bare.</p> <p data-bbox="863 627 1177 656">Surrounding land use is grazing.</p> |

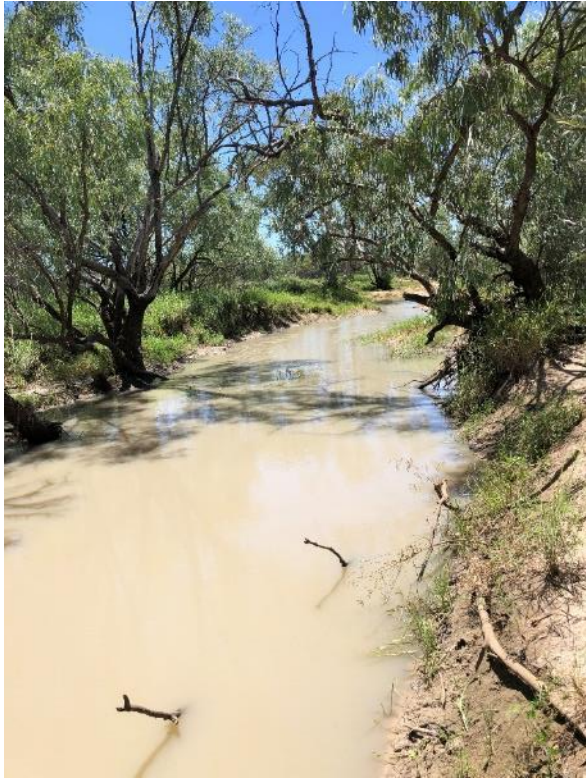
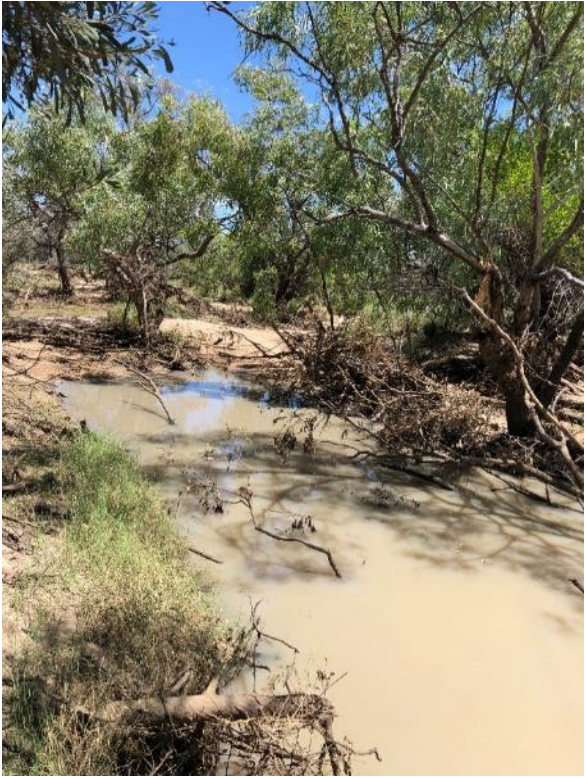
| Photographs | Site Description |
|--|---|
| <p data-bbox="199 275 288 300">Site US1</p> | <p data-bbox="863 275 1366 450">Site US1 was located on the Saxby River upstream of the Project area. The Saxby River is identified as a watercourse under the Water Act. During the February survey, this site was characterised by a large standing pool of highly turbid water with several fallen logs and branch debris.</p> <p data-bbox="863 465 1366 584">The stream bed comprised of fine silts, sand and clay. The bank was somewhat stable with cattle access and an access road upstream of the sample location causing some erosion.</p> <p data-bbox="863 600 1177 629">Surrounding land use is grazing.</p> <p data-bbox="863 645 1270 703">Overall, US1 scored 'good' in the Habitat Bioassessment.</p> |

The effects of erosion on the banks of the receiving waters were minimal across surveyed sites DS1 and DS2. The leading cause of local erosion at site US1 appeared to be stock access, with edge effects from historic clearing and an access road crossing the watercourse 50 m upstream. Overall bank stability was determined to be sound.

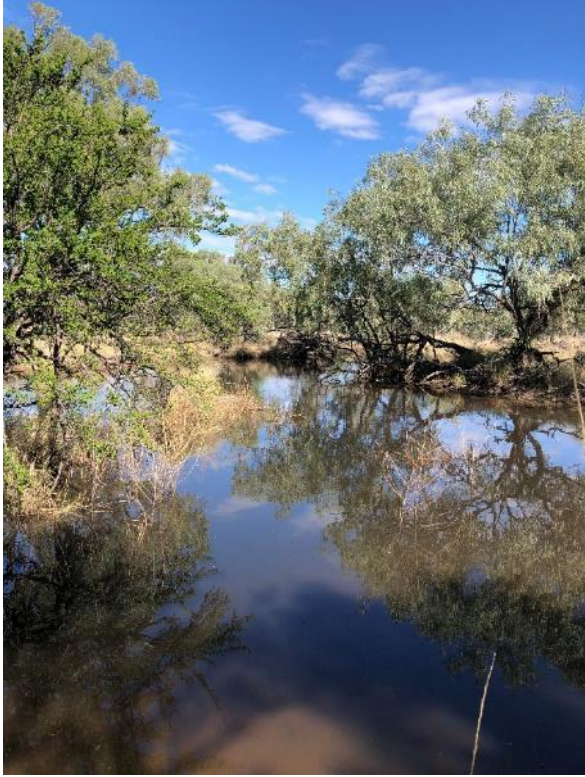
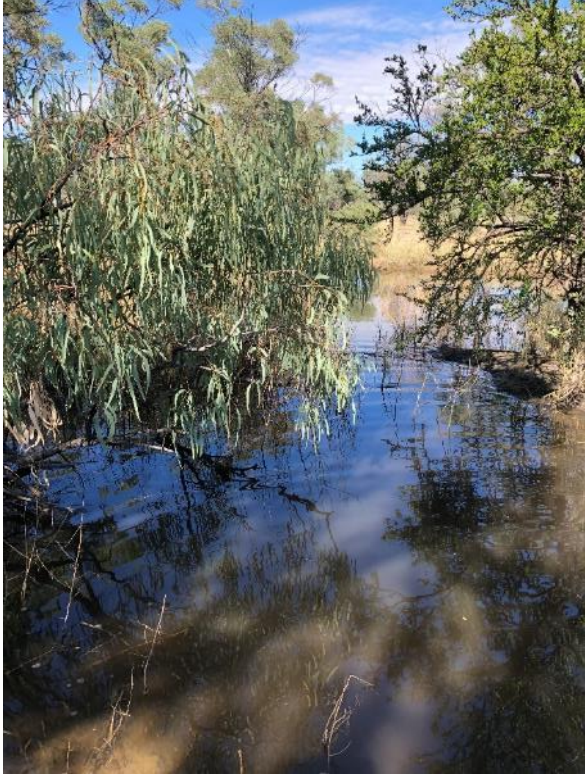
| Photographs | Site Description |
|--|--|
| <p data-bbox="199 275 288 302">Site US2</p> | <p data-bbox="863 275 1366 421">Site US2 was located on the Saxby River upstream of the Project area. The Saxby River is identified as a watercourse under the Water Act. During the May survey, this site was characterised by a wide pool of opaque to clear standing water.</p> <p data-bbox="863 439 1345 584">The stream bed comprised of fine silts and sand. The bank was stable with cattle access surrounding the sample location causing some erosion. The banks were vegetated with grasses and riparian shrubs and trees.</p> <p data-bbox="863 602 1179 629">Surrounding land use is grazing.</p> |

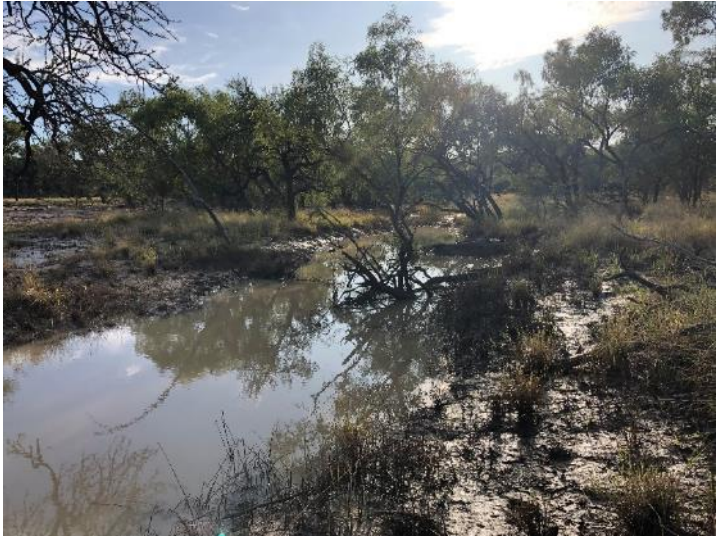
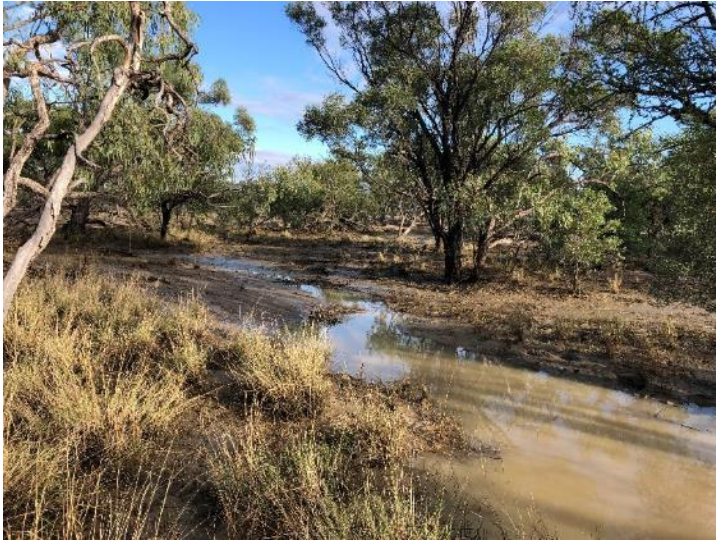
| Photographs | Site Description |
|--|--|
| <p data-bbox="193 322 288 360">Site US3</p> | <p data-bbox="943 322 1402 510">Site US3 was located on the Saxby River upstream of the Project area. The Saxby River is identified as a watercourse under the Water Act. During the May survey, this site was characterised by a shallow standing pool of highly turbid water.</p> <p data-bbox="943 521 1402 674">The stream bed comprised of fine silts, sand and gravel. The bank was level to the ground at many points and somewhat stable with cattle access surrounding the sample location causing some erosion.</p> <p data-bbox="943 685 1402 723">Surrounding land use is grazing.</p> |
